Part 6- Clinical application of AQB implants

Chapter 1- Examples of the single to multiple implantation treatment – Lack of intermediary teeth

1. A case of implant prosthesis installed into a missing mandibular molar

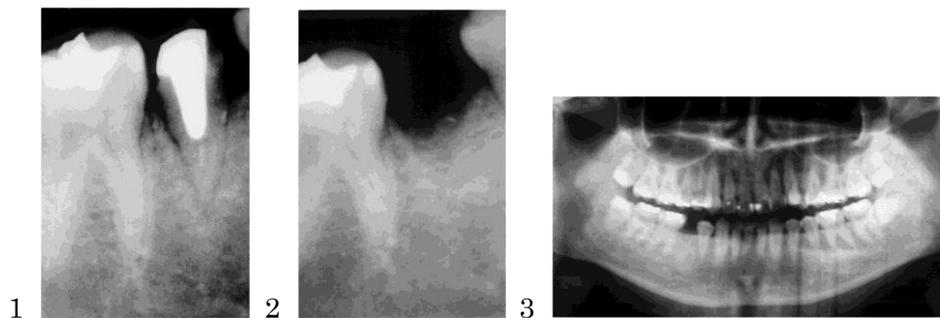
Image 1: Dental radiograph at the first medical examination.

Advanced case of bone resorption was observed around No. 20, and was decided, this should not be left untreated.

Image 2: Dental radiograph 2 months after the tooth extraction. The wound healing process had made a satisfactory outcome.

This showed sufficient bone quantity to be present for implant prosthesis. There were no traces of past dental treatment, and as the dental bridges would have required the milling of adjacent teeth, implant prosthesis was suggested to the patient instead. To which she gave consent.

No. 20 was removed due to an advanced case of periodontal disease. Having waited two months for the wound to heal, the state of the bone was examined under X-ray radiography. Patient consented to the treatment after explaining what it entailed (Image-1 to 3).

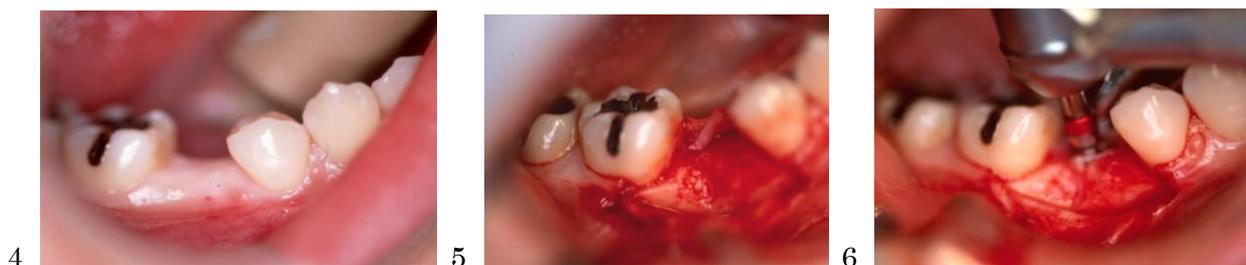
Image 4: Photograph of the oral cavity pre-surgery.

Image 6: The pre-surgical examination indicated the suitability of 4SM size implant. The implant cavity was drilled 2 mm deeper than the standard, totaling to 10 mm in depth.

The implant cavity was constructed with the usual drilling technique once gaining sufficient amount of view from the alveolar crest incision and a longitudinal incision. The bone quantity was adequate in terms of height and width, and the buccal exposure of the HA coating layer was able to be avoided by implanting the 4 SM size, 2 mm deeper in by than what had been originally planned (Image-4 to 9).

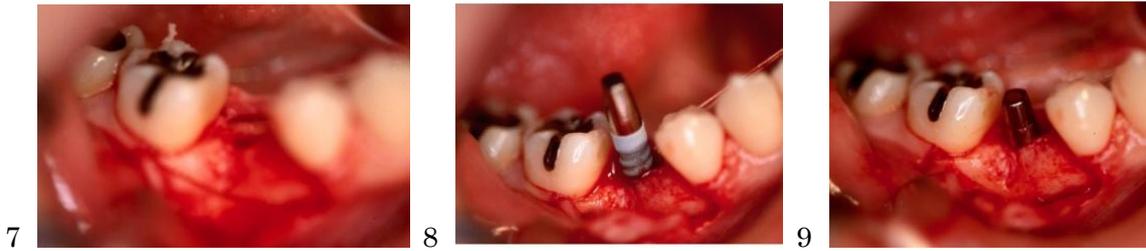
Image 7,8,9: The depth of the implant cavity was adequate, although some bone cleavage on the buccal side could be observed. The implant body could be inserted fairly deep into the cavity, therefore avoiding the exposure of the HA coating layer.

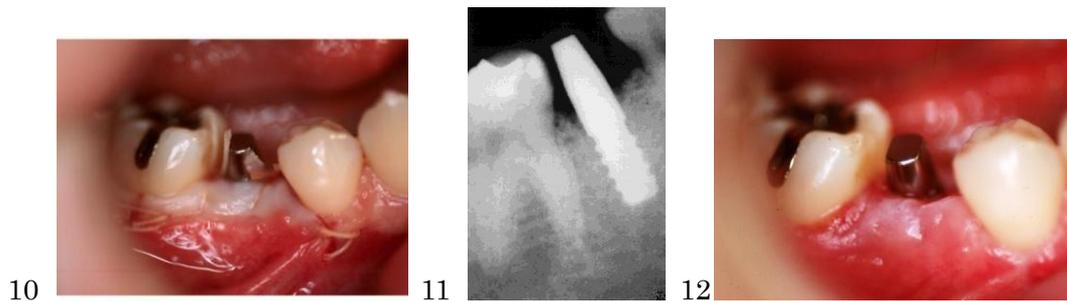
Image 10: With the aim to fully restore the original state, suturing was conducted carefully to avoid exerting excess tension to the mucosal flap.

Image 12: The view of the oral cavity at suture. Wound healing had shown good progress, but the mucosal membrane around the implant resulted in gingival bleeding with a slight probing.

Exertion of excess tension could be avoided by limiting the use of the circular knife to a crescentric motion on the gingivae periosteal flap on the buccal side. The radiograph taken after the installation confirmed that the implant body had been inserted with sufficient depth, and that it was inserted in a suitable orientation. The stitches were removed 7 days after the surgery, where the wound healing process of the mucosa to have been satisfactory (Image-10 to12).

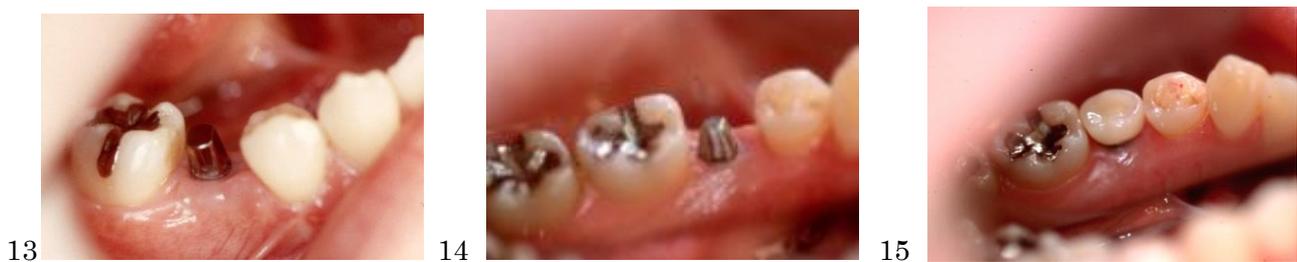
Image 13: Photograph of the oral cavity after 8 weeks. Probing into the soft tissues surrounding the implant showed the tissues to have hardened, with only allowing the probe to enter 1 to 2 mm in. The periodontal susceptibility test result indicated -3.

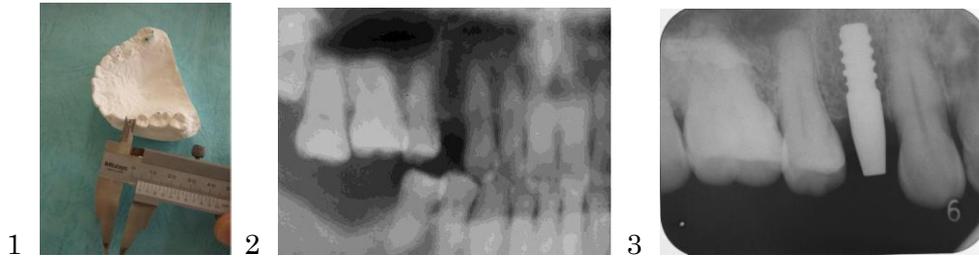
Image-1: Taking study model measurements

Image-3: The dental X-ray radiograph after implant body installation

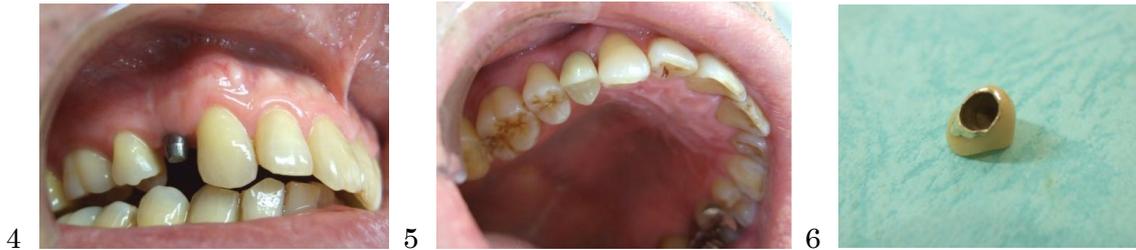
Image-4, -5: The neighboring teeth were left intact by using implant

Image-6: Esthethia with the cavity PGA lining.

Platinum added gold alloy (PGA) based hybrid ceramics (Esthenia) was applied as the replacement of the molar teeth. In order to prevent it from fracturing, clearance space was established to accommodate Esthenia of 2 mm thickness (Image-6). It was then treated with a primer (Image-7) and sand-blasted (Image-8) before its placement with super-bond adhesive.

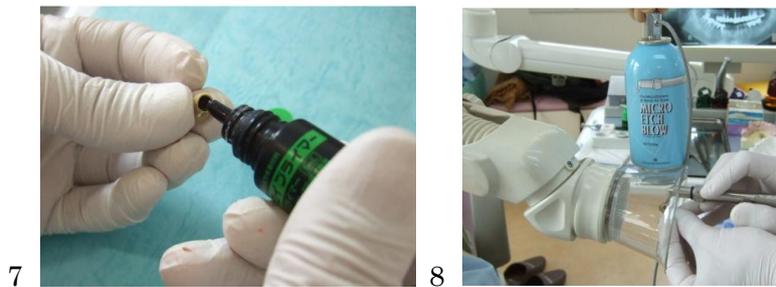
Image-7: Treated with primer, then adhered with super-bond

Image-8: Sand blast treatment

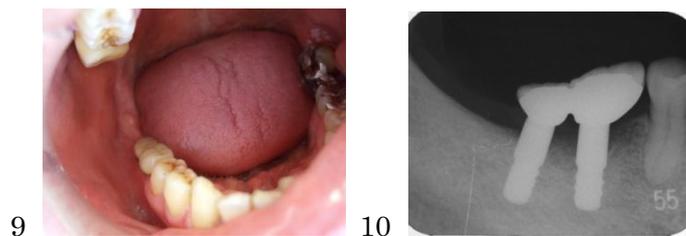
Image-9,-10: Implant prosthesis placed on the right mandible.

The missing teeth on the right mandibular was also installed with implant prosthesis (Image-9,-10).

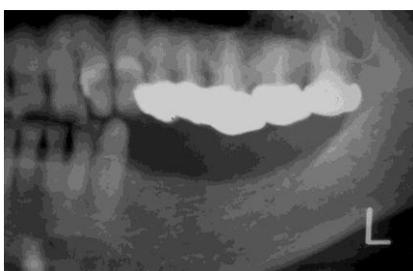
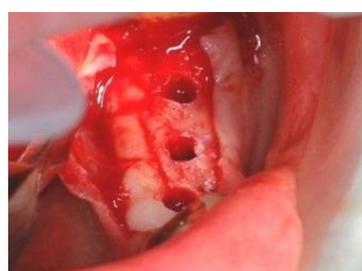
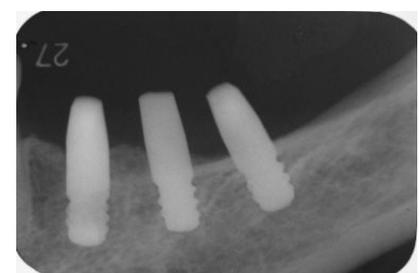
Image-1: The presence of elongated maxillary teeth was evident from the pre-surgical panorama radiograph.

Image-2: The constructed implant cavity

Image-3: Dental radiograph after implantation

A lower extension partial denture had been fitted onto the left mandible however, the sense of discomfort was never relieved even though this was replaced five times within the 25 years. There were periods in which the denture was not worn by the patient, therefore the condition also presented with elongation of the maxillary molars (Image-1).

In the implant surgery, the alveolar crest incision was applied to the left mandible, and the mucoperiosteal flap was elevated (Image-2), followed by 4SM, 4SS, 4SS installation, in this order starting from the anterior region. Defects to the No.1 tooth were also evident but the installment at this position was decided against to retain the sufficient level of oral hygiene (Image-3).

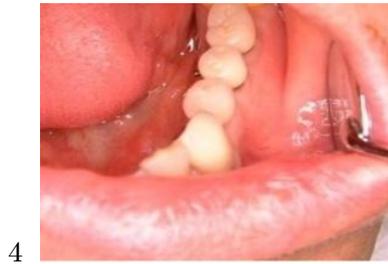
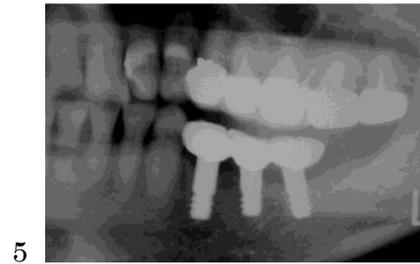
Image-4: The prosthesis was attached six weeks after the installation

The occlusal plane was adjusted by grinding the elongated maxillary teeth in preparation for the dental prosthesis. Even though the patient was in the seventies, the post-surgical progress was smooth and a rapid osseointegration could be achieved rapidly, and the impression was able to be taken four weeks later. This was followed by trials with metal connected crown, and the final superstructure was fitted six weeks after the implantation (Image-4, -5).

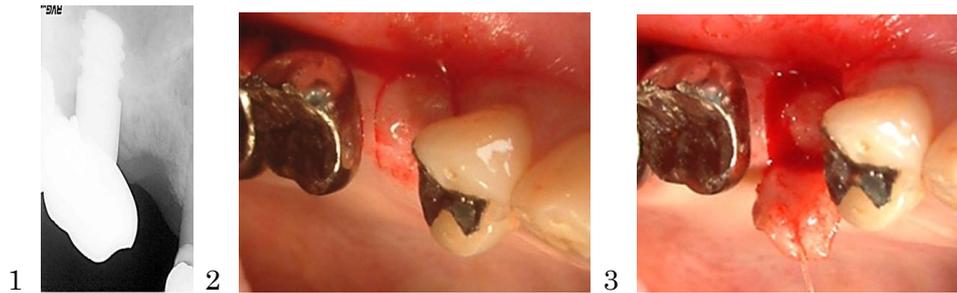
Image-1: No. 6 position had been placed with one-piece type roughly three years ago. Two-piece type was selected for No. 5 position.

Image-3: Flap elevation

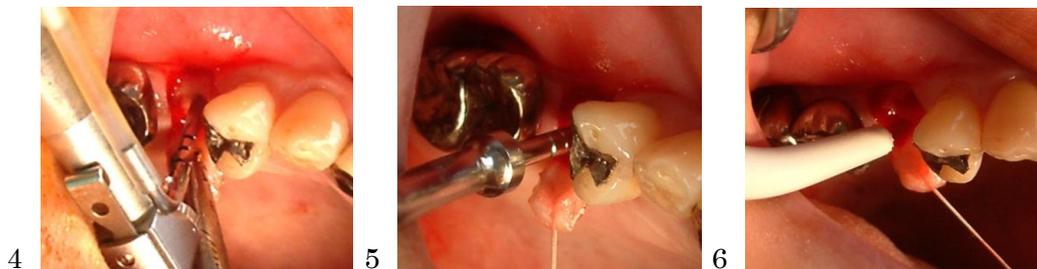
Image-4: Drill with a drilling guide

Image-5: Performing socket-lift procedure using osteotome. The damages and fissures to the mucosal membrane of the maxillary sinus can be avoided by a gradual elevation of the maxilla and filling the space with grafting agents.

Image-6: Boneject (Koken Co., Ltd.) as the HA granules, was injected, using the plastic syringe made specifically for bone grafting.

The best position for the application of the incision line usually is thought to be on the alveolar crest. However, since the width of the alveolar crest was found to be relatively wide, indicating that a stabilized surgical procedure was possible, the mucoperiosteal flap was formed carefully from the incision line that extended in the buccal direction instead (Image-2, -3). The implant cavity was drilled using the standard procedure to the point just below the maxillary sinus, and AQB osteotome was then used to perform socket preservation technique (Image-4,-5).

At the time of insertion of size 4102 AQB two-piece type, the pressing force was restricted to a minimum to avoid causing any damages to the mucous membrane of the maxillary sinus. The insertion procedure was done carefully, relying solely on the rotational force of the ratchet movement (Image-6).

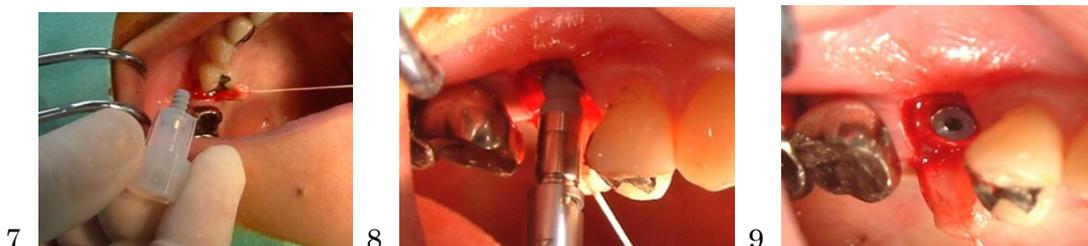
Image-7: The AQB two-piece type implant was removed from its case for it to be inserted.

Image-9: Placement of the healing abutment

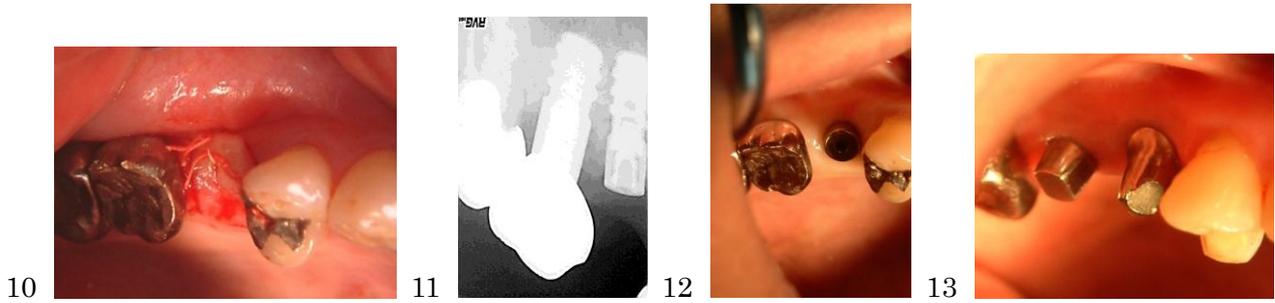
Image-10: Oral cavity, post-suture

Image-13: The state of the oral cavity, after the placement of the abutment.

The healing abutment was placed, ten weeks after the initial installation, as a secondary procedure. The periodontal susceptibility test was -3 (Image-12). The hybrid crown was fitted onto the straight abutment after adjusting its orientation. Concurrently, the superstructure of the No. 14 was also replaced (Image-13 to -15).

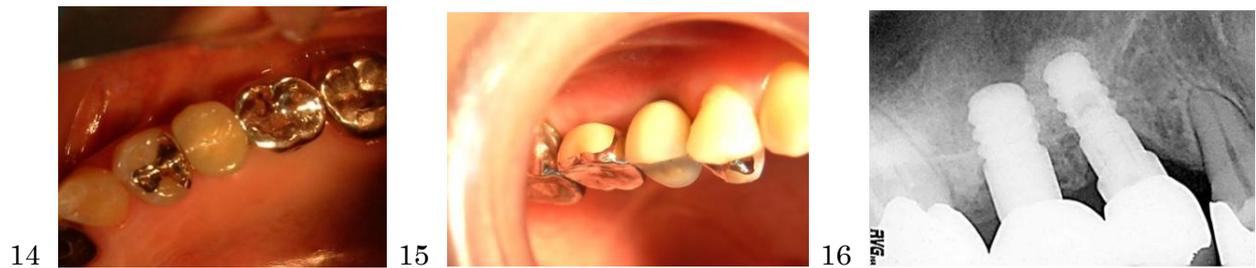
Image-14: Provisional crown attached

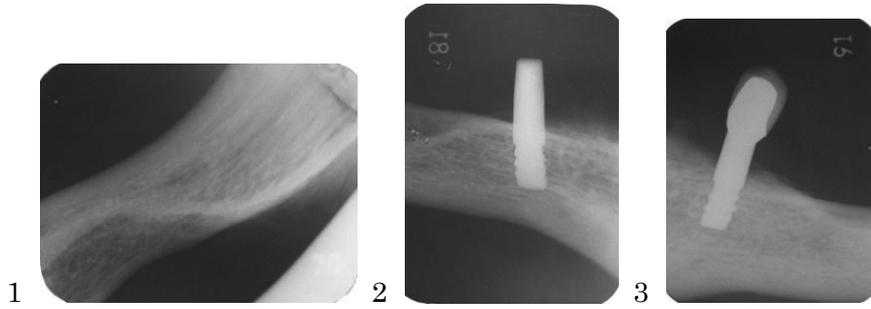
Image-1: A significant bone resorption of the mandible was evident.

Image-2,-3: Dental radiograph after the implant installation, and the placement of the superstructure.

The patient came to the clinic complaining of difficulty to chew due to the instability of the partial denture. The No. 18 tooth was the only tooth remaining, and was acting as an anchor with wiring, but the overall resorption of the alveolar ridge (Image-1) had caused the partial denture to become unstable.

AQB one-piece implant, 4MS was installed into No. 27 and 28 positions (Image-2), and waited for the bone integration to be achieved with the application of a denture by drilling a hole at the positions that corresponded to the implant abutment. The metal-base denture that had been worn on the mandible had been constructed by another dentist a year earlier. The drilling into the metal denture was so hard that the time and effort that it took to drill through the metal, was more than the implant insertion.

Impression for fabrication of the superstructure prosthesis was taken six weeks after the implantation (Image-3), and concurrently, the hook wire was prepared for the anchoring tooth.

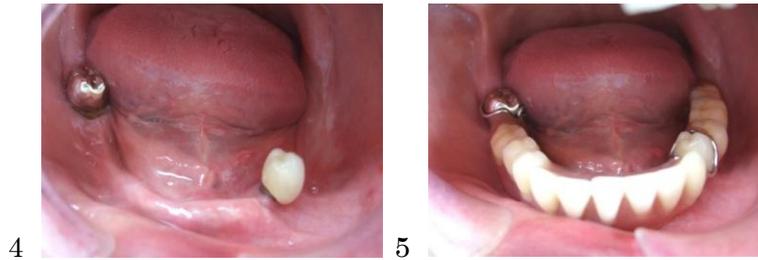
Image-4: Preoperative image of the oral cavity

Image-5: Image of the oral cavity after the placement of the superstructure.

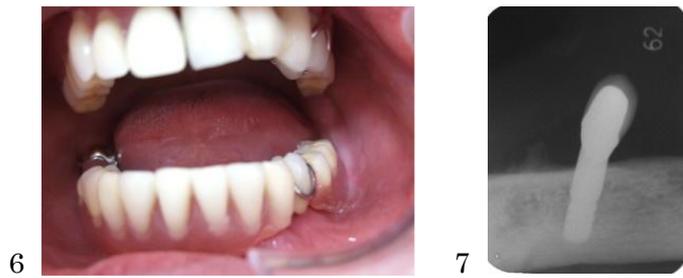
Image-6: The state two years after the implant installation.

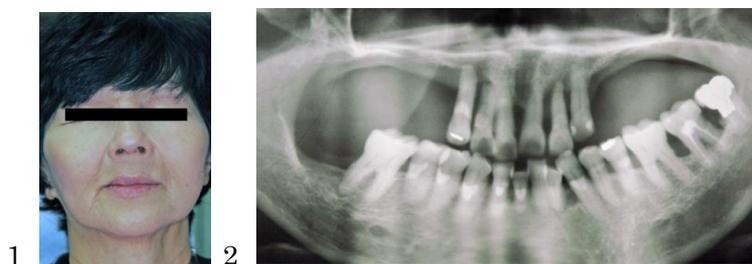
Image-1: The preoperative profile. The cheeks are sunk in, with a low vertical occlusal height.

Image-2: Preoperative radiograph. The vertical distance of the bone is non-existent, at the No. 11 position.

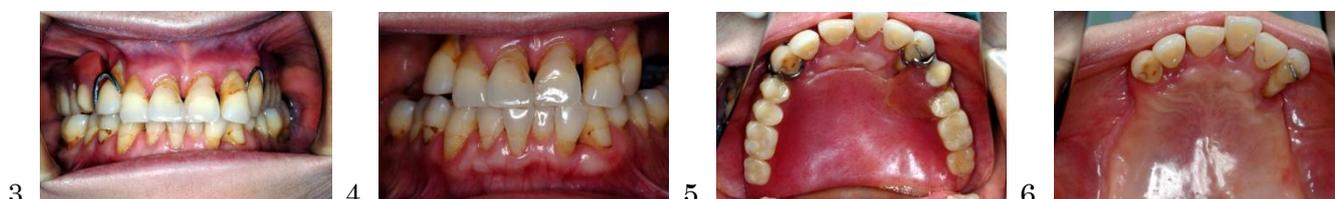
Image-3,-4,-5,-6: The oral cavity interior featuring an extremely destabilized denture, along with the maxilla that is significantly resorbed. Chewing is evidently difficult with this condition.

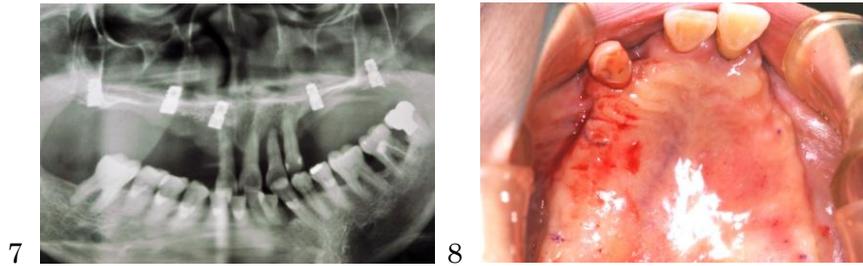
Image-7: Postoperative radiograph. After GBR and the sinus-lift procedures, the two-piece type implant was sufficiently installed.

Image-8: Image of the maxillary ridge before the secondary surgery.

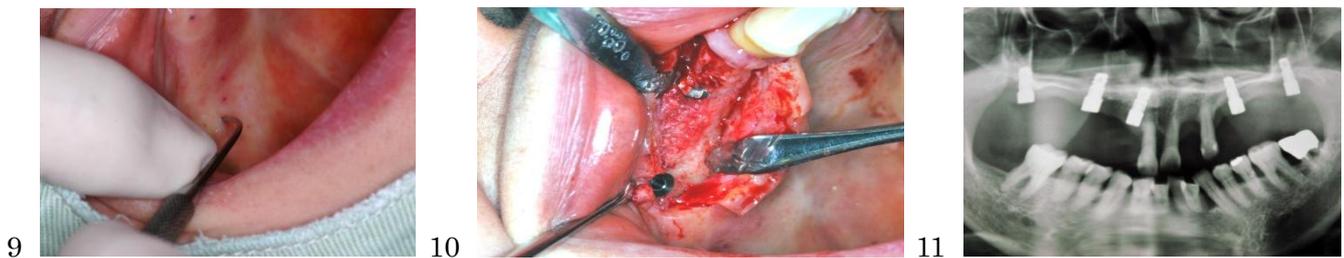
Image-9: The position check of the implant with probing.

Image-11: It is necessary to confirm the condition of the healing abutment with X-ray radiography.

The secondary surgery was conducted roughly 20 weeks later (Image-8 to 11), with the abutment installed once gingivae had stabilized (Image-12) and then the impression was taken with the Dolder-bar. The placement of artificial denture was completed with the standard procedure (Image-13,-14). The dental profile was significantly improved from its preoperative state (Image-15), and the patient was satisfied with the treatment outcome.

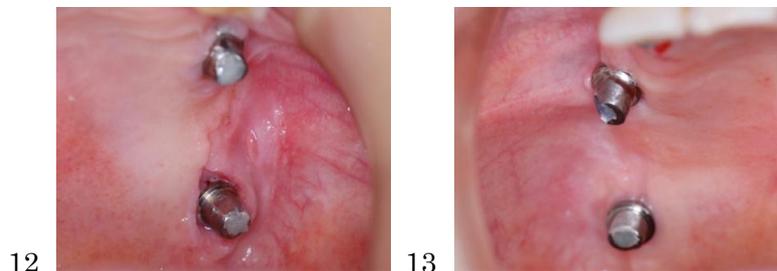
Image-12,-13: The abutment was placed two week after the secondary surgery. Even though there were traces of gingival inflammation, the placement was still possible as the Dolder-bar margin was set over the ridge.

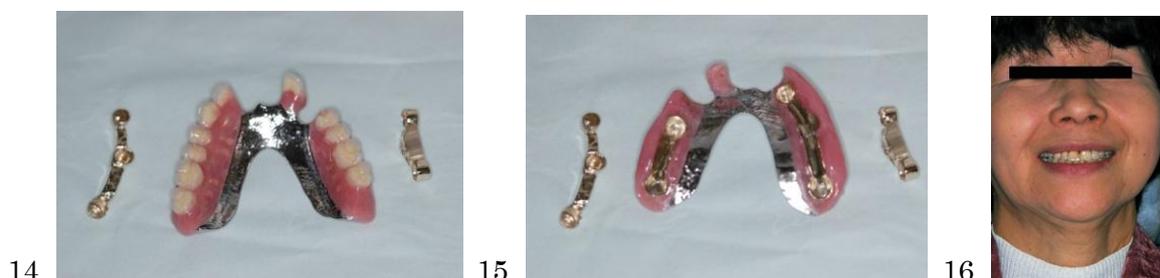
Image-14, -15: The completed Dolder-bar supported partial denture. The palate is left uncovered since firm support can be established (Collaborator: Mr Takahashi, Takahashi Dental Clinic, Oogaki, Gifu-prefecture).

Image-16: Improved dental profile. A significant modification in the facial structures can be observed in comparison to the state before the surgery. It probably feels like the denture has been restored to its original state.

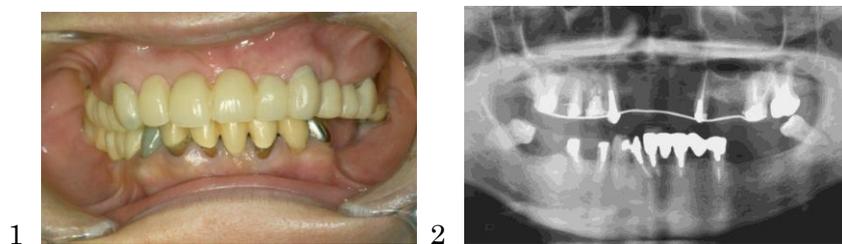
Image-1, -2: Panoramic radiograph at the time of first medical examination (09.18.2004)

A temporary crown that is close to a full bridge has been placed on the maxilla. A bridge that is anchoring only on natural teeth carries an extremely high risk, therefore, there was a request to place implant prosthesis to the positions of No. 7 to 10 and No. 29 to 30.

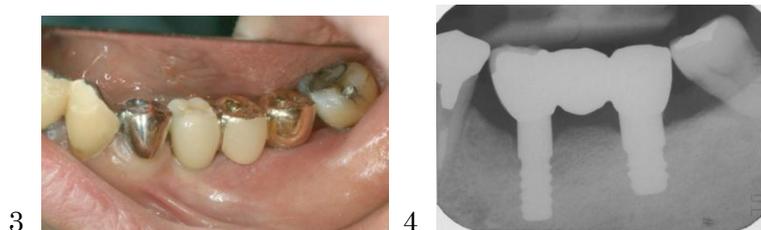
Image-3,-4: 4MM and 5SS were installed (10.22.2004) followed by bridge placement (01.29.2005). Image of the oral cavity, and a radiograph shown at the time of gaining occlusal support on the left mandible.

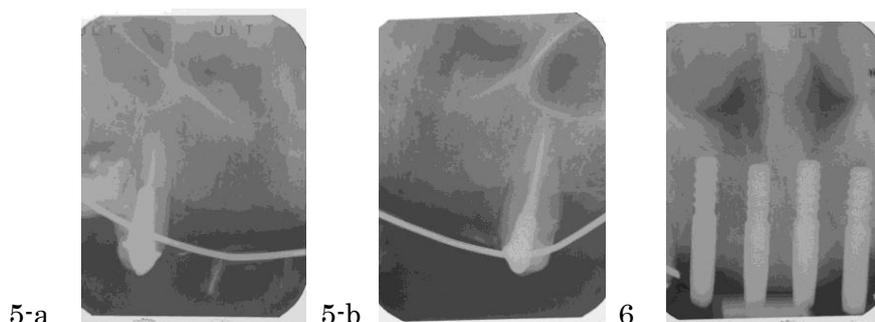
Image-5-a,b: Dental radiograph taken right before excision of the pontic from the temporal bridge (03.11.2005).

7 to 10, having excised pontic of the temporal bridge.

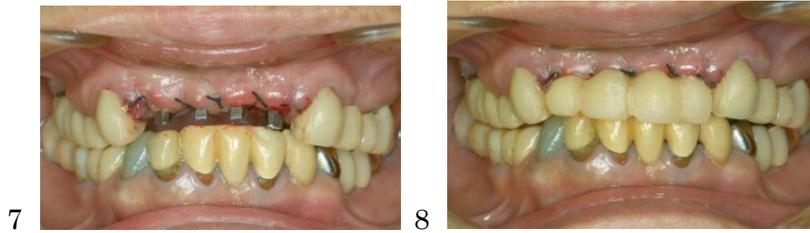
Image-7: Image of the oral cavity at the time of antiseptic wash, the next day (03.12.2005). To secure sufficient amount of occlusal clearance, some parts were milled down, for provisional attachment of the connected temporal crown which had been matted with diamond point. Neodyne was used as the adhesive.

Image-8: Image of the oral cavity at the time of attachment of connected temporal crown.

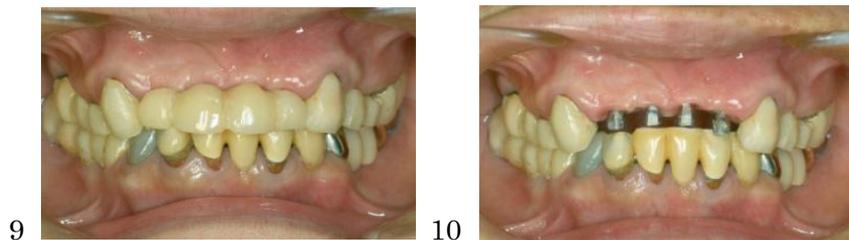
Image-9,-10: Image of the oral cavity, before and after the removal of temporal crown. The connected temporal crown was removed 2.5 months after the installation (05.27.2005). The impression was taken for the connective crown.

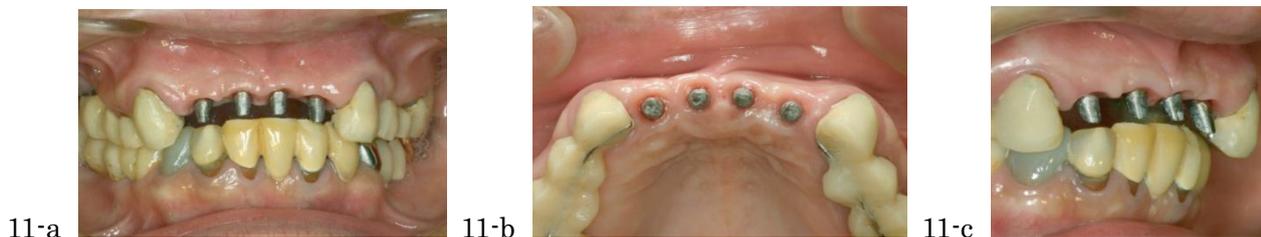
Image-11-a,b,c: Image before the placement of chrome plated connective crown (06.10.2005). As the implant of 3 mm diameter is very narrow, it does not have much lenience for various abutment orientations. Therefore it is necessary to prioritize its parallelism at the time of installation.

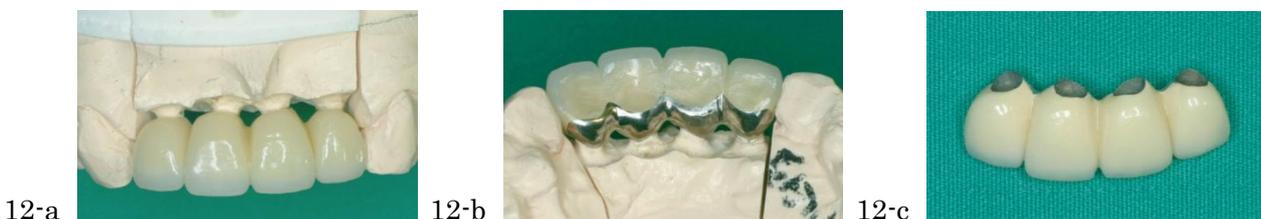
Image-12-a,b,c: The superstructure that was removable, non-separating die type was fabricated with epoxy resin. To achieve a good emergence profile, it is designed so that the crown emerges from directly off the margin, and also taking into account of the need for the brush tips to reach the peri-implant pockets to maintain a sufficient level of hygiene.

taking for natural teeth. It should be noted here that the abutment is positioned lower than that of the natural tooth therefore there is no need for the formation of heavy chamfer or shoulders to form a boundary between the abutment and the gingival epithelium. On 10th June, the connected metal-bonded crown was placed (Image-11-a,b,c). Due to the fragile nature of 3 mm AQB implant, as it carried a risk of fracturing, the silicon mold was taken directly to the technical workshop for filling with epoxy-resin to fabricate a working model (Image- 12-1,b,c). A general cause for concern on the technical aspects is that in the typical removable separated die-type working model, fixed with dowel pin, the prosthesis cannot completely sink in due to a slight freedom in movement of the dowel-pin. For this reason, it was essential to ask for a removable non-separable-dye-type working model.

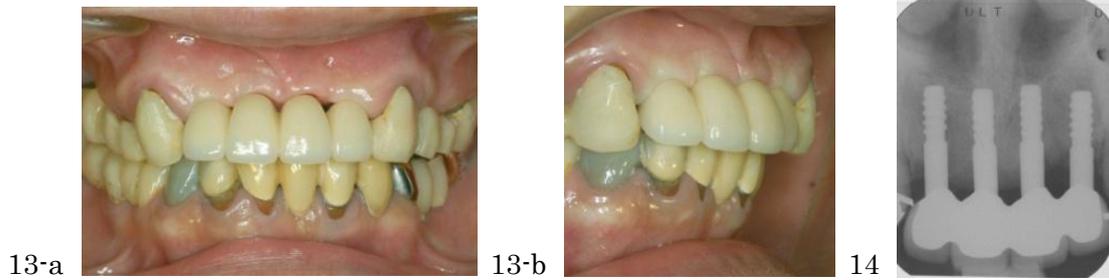
Image-13-a,b: Image of oral cavity interior at the placement of connective crown.

Image-14: Dental radiograph at the placement of the connected crown. At the placement of the crown, occasionally, gingivae are known to become temporary ischemic due to exclusion with pressure application, but in general, the peri-mucosal membranes adapt to the change in crown placement, and can resume the blood circulation in 15 to 20 minutes.

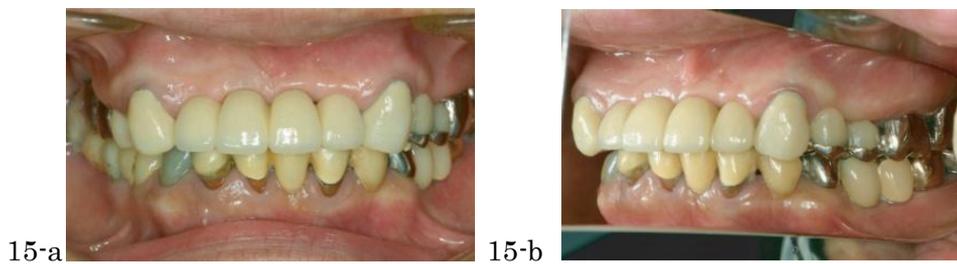
Image-15-a,b: Images of the oral cavity from the front and at an angle, eight months from the time of implantation, and five months from prosthesis placement (11.15.2005).

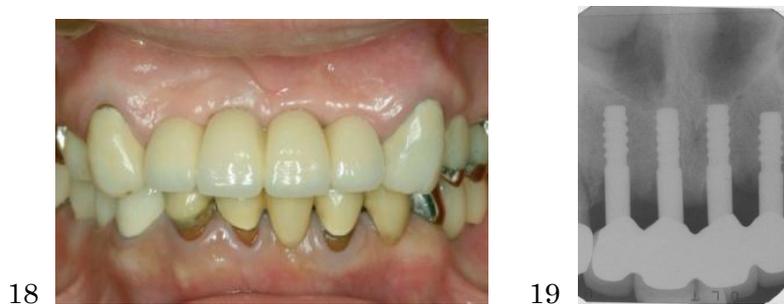
Image-18,-19: Dental radiograph of the oral cavity, two years after the implantation (03.26.2007), showed satisfactory progress.

At the time of checkup on the November 15th of the same year, the absence of any abnormal symptoms was confirmed with the dental X-ray radiography and with gentle probing 8 months after the implant installation, and 5 months after the prosthesis placement. The subsequent follow up a year and a month later, on April 19th 2006, since implantation (Image-16,-17), or two years on, on the March 26th 2007 (Image-18, 19) both confirmed its satisfactory progress.

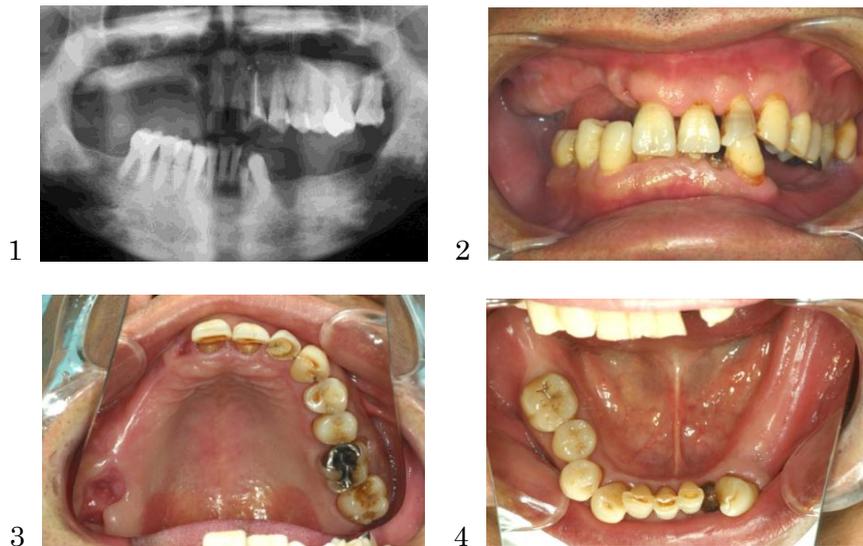
Image-1, -2, -3, -4: Panoramic radiograph at the time of primary medical examination and images of in the oral cavity. The No. 10 and No.28 teeth were extracted 6 months ago in the previous clinic that the patient was referred from (04.19.2005).

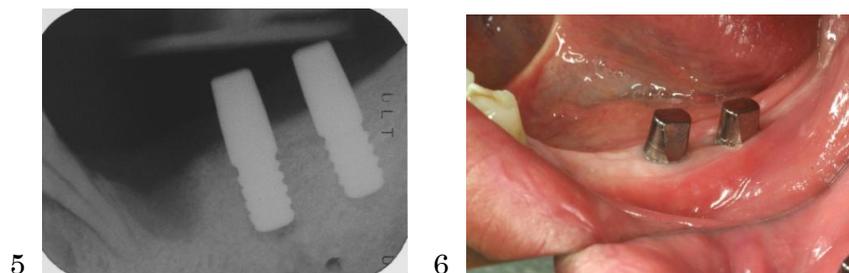
Image-5: Dental radiograph appearance at the time when placing 5MS implants to the No. 29 and 30 positions (05.25.2005). A partial denture was fitted onto the No. 10 to 15 implants after sufficient elevation of the bone.

Image-6: The state of the oral cavity, two weeks after the implantation to positions No. 29 and 30 (07.27.2005).

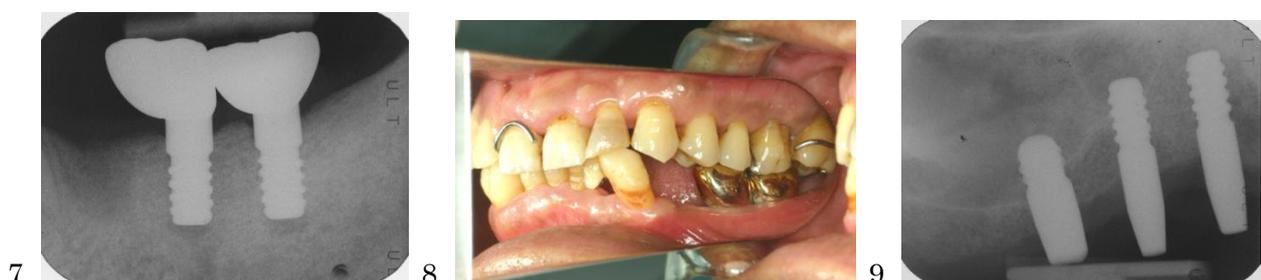
Image-7, -8: Dental and Panoramic radiograph appearances after the placement of gold-alloy crown to the positions No. 29 and 30. The left molar occlusal support was able to be achieved. Simultaneously, the elevation of occlusion was conducted by applying composite resin fillings to the frontal teeth of the maxilla to adjust it to the height of occlusion (08.17.2005).

Image-9: Dental radiograph after implantation of types 5SS, 4MM, 4MM to positions No. 11, 12 and 13.

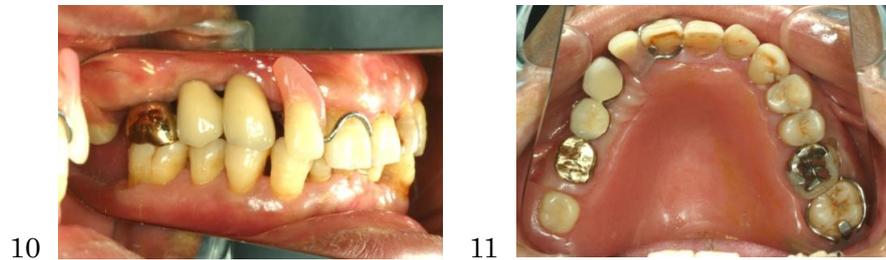
Image-10, -11: Image of the oral cavity, after the placement of gold-alloy crown to the position No. 14, and connected metal bonded crown to No. 12 and 13. The No.2 structure is secured with the artificial tooth of the plated partial denture (12.26.2005).

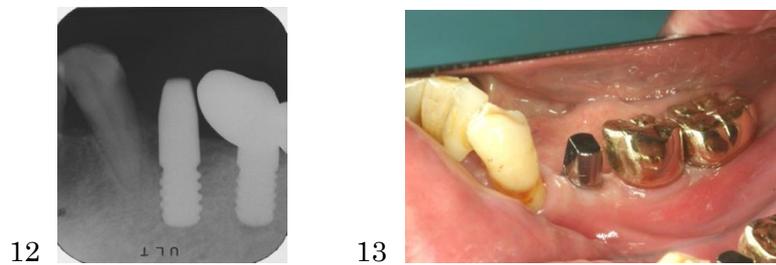
Image-12: Dental radiograph after the 5MM implant was installed with a delay, onto position No. 28.

Image-13: Image inside the oral cavity after two and a half months since installation at position No.28.

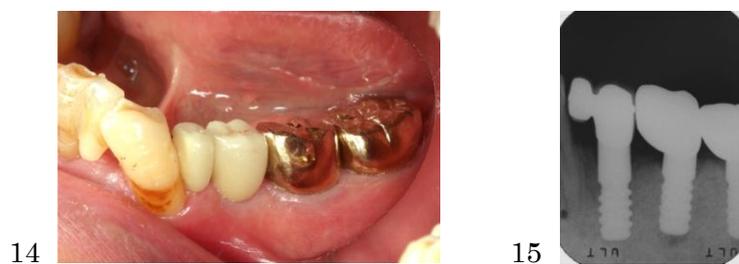
Image-14, -15: Image of the oral cavity, and dental radiograph featuring the placement of metal-bonded crown attached with pontic on the mesial side, to No.28 position (05.30.2005). The neighboring tooth on the mesial side of the implant was slanted in the mesial direction. If the crown is installed that is in contact with the neighboring tooth, it would result in a crown that has an unnatural over contouring profile that is difficult to maintain a sufficient level of hygiene. This issue was solved by the placement of the crown with pontic. Advice to the patient to not only brush the area, but also to thread the dental floss through the pontic, to clean the pocket that is present close to the tooth root, in the area around the implant.

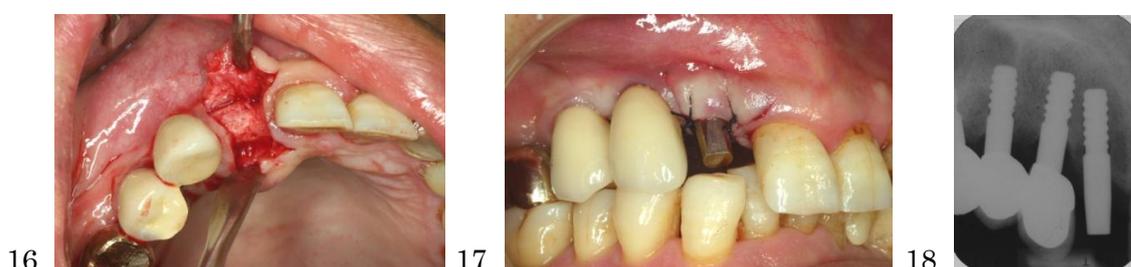
Image -16, -17,-18: Image and dental radiograph of the oral cavity at the time of delayed installation of 4LM implant to the position No.10. As AQB metal-bonded crown had been placed onto position No.11, the mucosal membrane on the front and back of the alveolar crest (gingivae) were incised in a Y-shape to preserve the gingival structure (07.19.2006).

structures on both front and back of the alveolar crest from being affected. As a matter of fact, the author has been applying this Y-shaped incision not only to the parts that are affected by the aesthetic prosthesis, but as a general incision making method for 6 to 7 years.

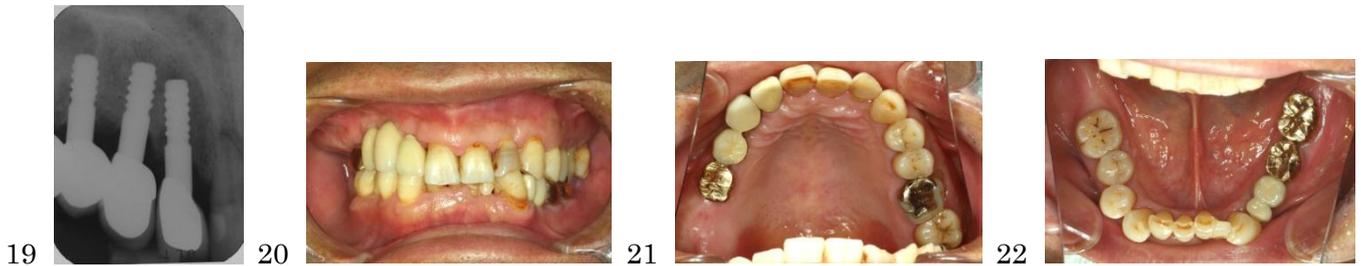
Image-19,-20,-21,-22: Dental radiograph and Image of the oral cavity at the time of metal bonded crown placement to the No.10 position. Delayed implantation was conducted to allow the extraction pocket for it to be set, and resulted in establishing strong occlusal support (10.16.2006).

The metal bonded crown was placed to the No. 10, on October 16th (Image-19, 20, 21, 22). The unstable occlusal contact just on the frontal teeth section, was corrected early on in the procedure by primarily restoring the occlusal support at the No. 11 to 13 and No. 29 to 30. As the bone loss after the tooth extraction of No. 10 and No. 28 was large, the implants were installed using the treatment method for the delayed installation once the bone of the extracted socket had set sufficiently. This achieved a strong occlusal support in the molar sections of the jaw.

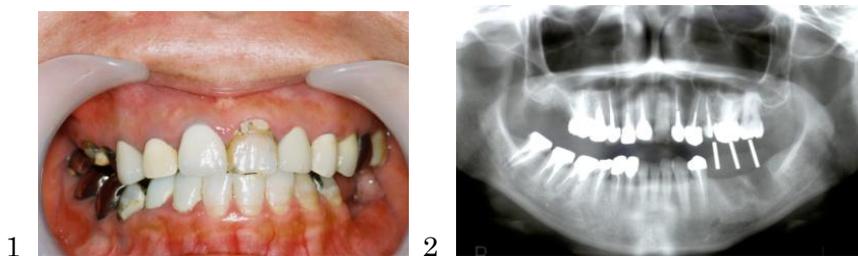
Image-1: Image of the oral cavity at the time of primary medical examination.

Image-2: Panoramic radiograph at the time of primary medical examination.

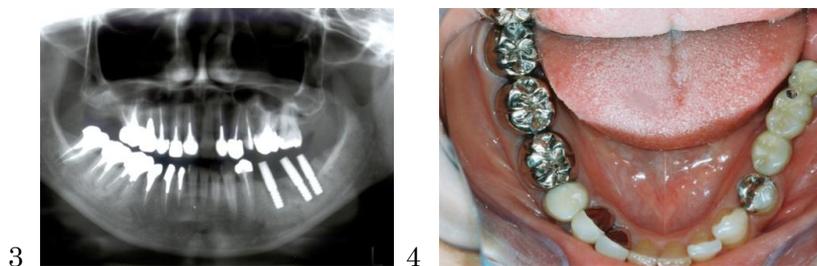
Image-3: Panoramic radiograph after the implant body installation

Image-4: Image of the oral cavity after the placement of superstructure.

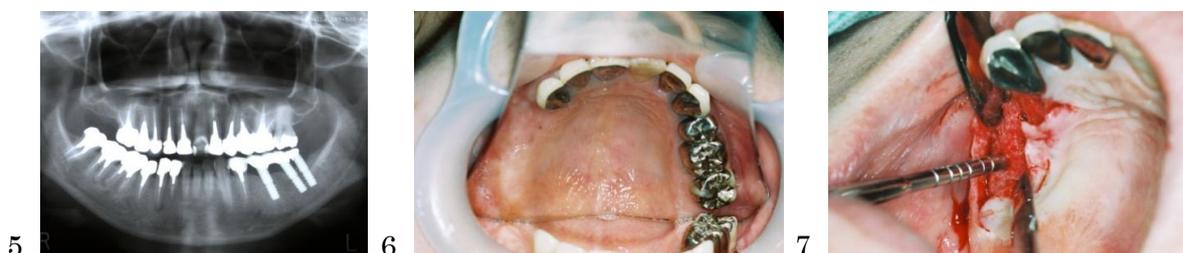
Image-5: Panoramic radiograph after the placement of superstructure.

Image-7: Image of the right maxilla during surgery.

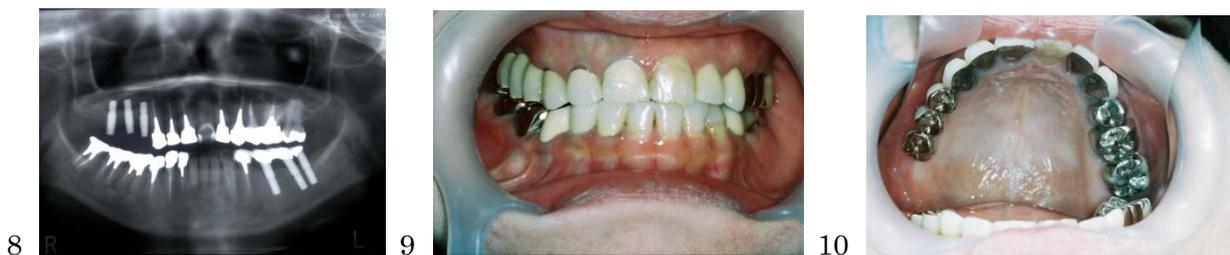
Image-8: Panoramic radiograph after implantation.

Image-10: Image of the oral cavity after the placement of the superstructure.

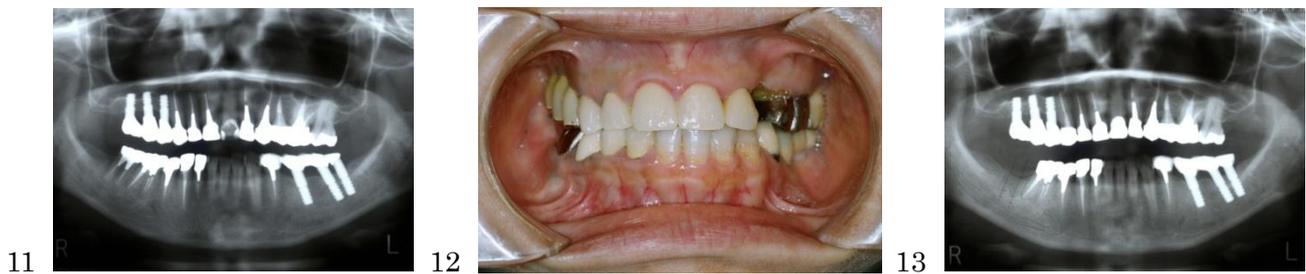
Image-11: Panoramic radiograph after the placement of the superstructure.

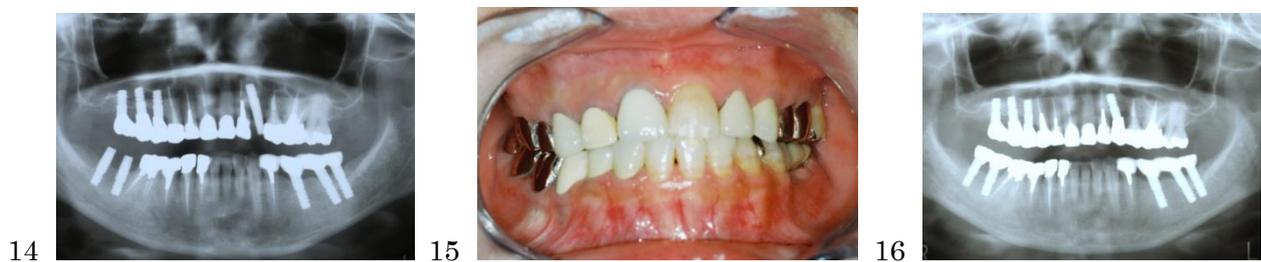
Image-14: Panoramic radiograph after implanting into No. 18 and No. 6 positions.
