## Chapter 2- Cases of edentulous jaw – Cases involving whole of the jaw

1. A case study that achieved occlusal recovery in whole of the jaw after an accident by replacing the lost teeth with implants and prosthesis placement to the natural remaining teeth.

## 2. A case where occlusal recovery was achieved with whole jaw implants to the upper and lower jaws

### 3. A case of implant installation to whole of the maxilla, in unison

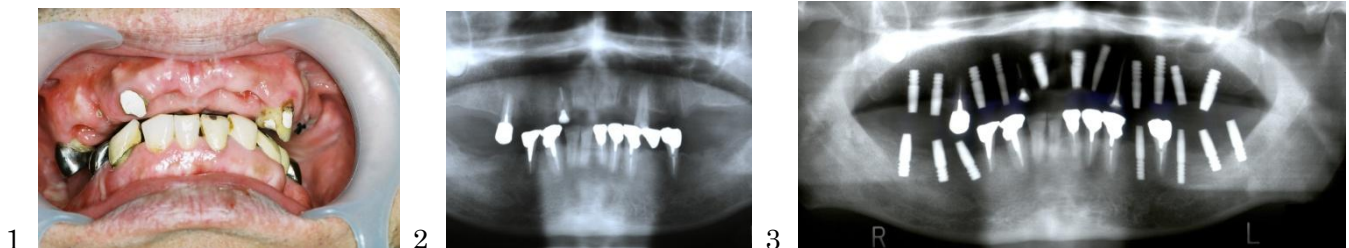
Image-1: Image of the oral cavity at the time of primary medical examination.

Image-2: Panoramic radiograph at the time of primary medical examination.

Image-3: Panoramic radiograph after the implant body installation

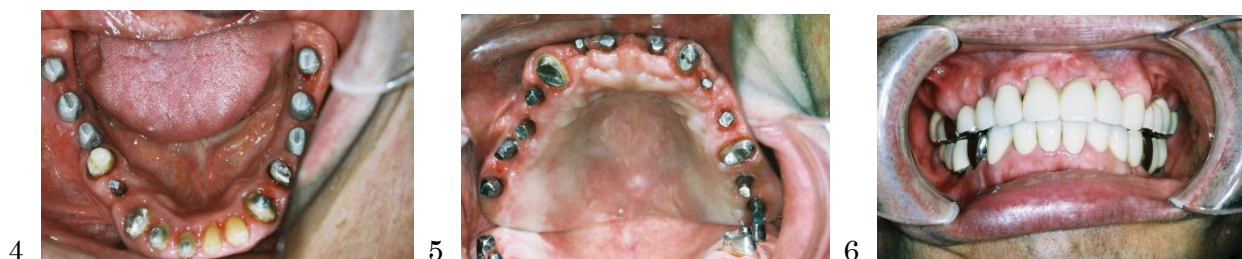
Image-4: Image of the mandible at the time of impression taking.

Image-5: Image of the maxilla at the time of impression taking.

Image-6: Image of the oral cavity after the placement of superstructure.

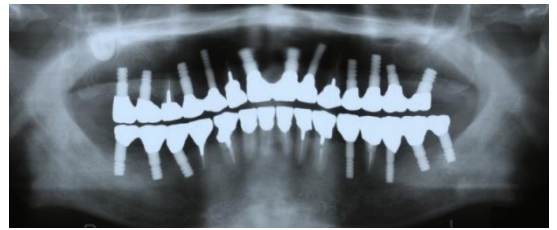
9

Image-9: Panoramic radiograph after the placement of the superstructure.

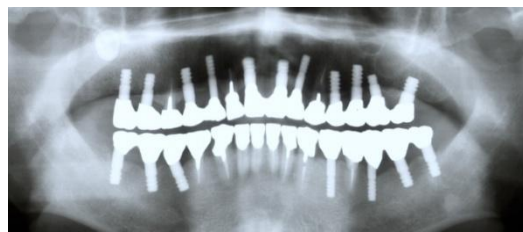
13

Image-13: Panoramic radiograph four years later.

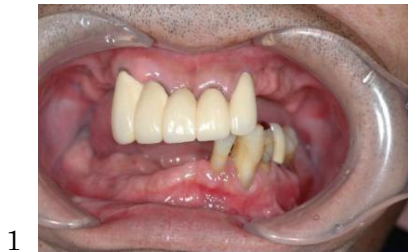
Image-1: Image of the oral cavity before surgery

Image-1 shows the state of intraoral cavity. Image-2 shows the panoramic radiograph of the state before surgical intervention.

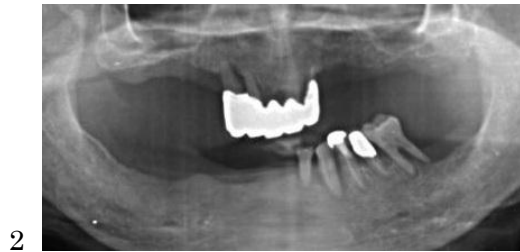
Image-2: Panoramic radiograph before surgery

The insufficient vertical bone quantity, as short as 1 mm, found in the maxilla molar regions on both sides suggested that the usual implantation method would not be suitable. The examination of the maxillary sinus manifested no signs of congestion and showed a clear baseline of the maxillary sinus, confirming an absence of any pathological conditions.

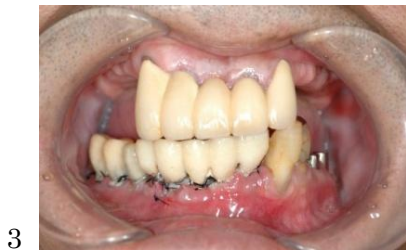
Image-3: Crown structures were placed immediately after the installation of implant bodies.

On day one of the implant treatment, ten AQB implants were installed into the mandible, under local anesthesia. Although No. 27 and No. 28 teeth were required to be extracted, these were left intact for the time being with the aim of protecting the implants, and to restore vertical occlusion. Image-3 features the oral cavity after AQB one-piece implant was installed, and immediately loaded with crown structure. The patient was directed to be on liquid diet. Image-4 features the panoramic radiograph after the implantation procedure.

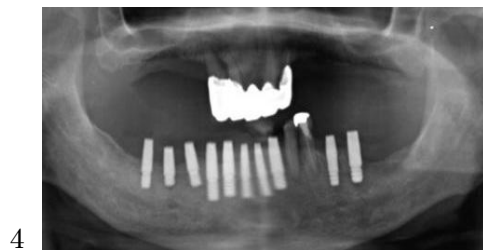
Image-4: Panoramic radiograph after the installation on the mandibles

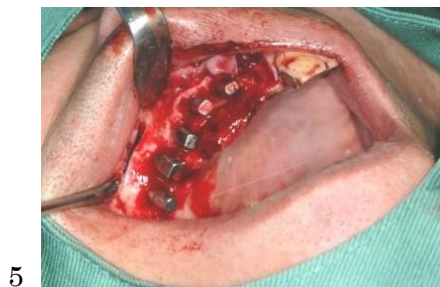
Image-5: Image of the oral cavity at the time of installation of AQB T-type implants to the right maxilla, having undergone sinus-lift procedures.

Image-5 features the sinus lift procedure and installation of T-type implant to the right side of the maxilla. Image-6 features the left side of the maxilla during the surgical procedure. The temporal crown was placed immediately after implant installation (Image-7).

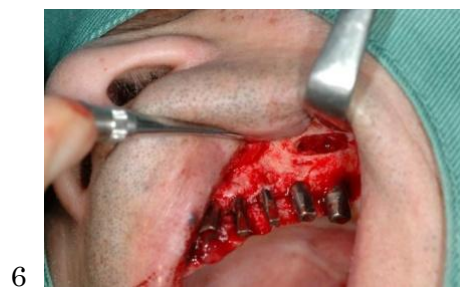
Image-6: Image of the oral cavity during surgery

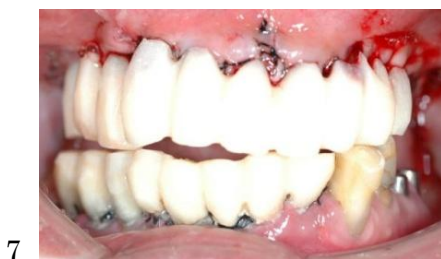
Image-7: Image of the oral cavity at the time of placement of superstructure, immediately following implantation into the maxilla.

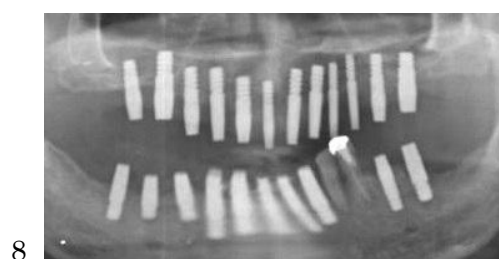
Image-8: Panoramic radiograph post-surgery.

implants to complete all the implantation procedures (Image-8). Image-9 features the oral cavity after the final superstructures were placed.

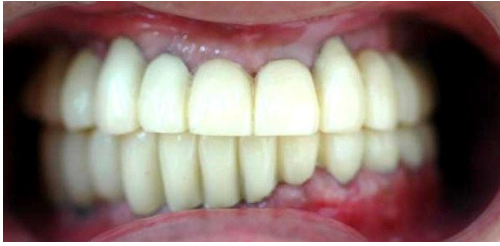
9

Image-9: Image of the oral cavity after the placement of the superstructure.

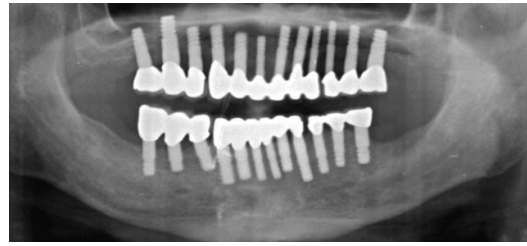
10

Image-10: Panoramic radiograph after a year since surgical procedure

Image-10 shows the panoramic radiograph after a year since the implantations. In the area surrounding implants on the maxillary molar region, opaque smears can be observed, indicating the regeneration of bone. Bone resorption cannot be seen in the area surrounding the implants, and a satisfactory progress thus far can be observed.

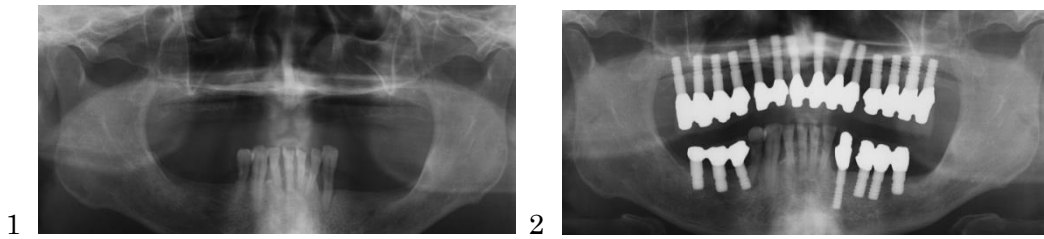
Image-1: Panoramic radiograph at the time of primary medical examination.

Image-2: Panoramic radiograph, 5 years later

The panoramic radiograph before implant installation is shown (Image-1).

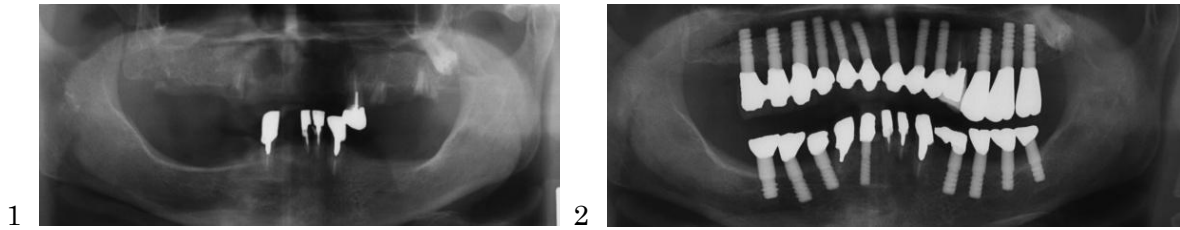
Image-1: Panoramic radiograph before implant installation

Image-2: Panoramic radiograph, 4 years later

The panoramic radiograph before implantation is featured (Image-1). An artificial denture was fixed on top of remaining tooth root therefore the patient could not chew without feeling the pain.

three months after the implant body installation, timing of which was determined with careful clinical observation of the conditions. Image-2 features the panoramic radiograph of the oral cavity 4 years later. With no signs of bone resorption, the patient has been satisfied with the substantial improvement in the masticatory function, and with the ability to eat whatever she likes.

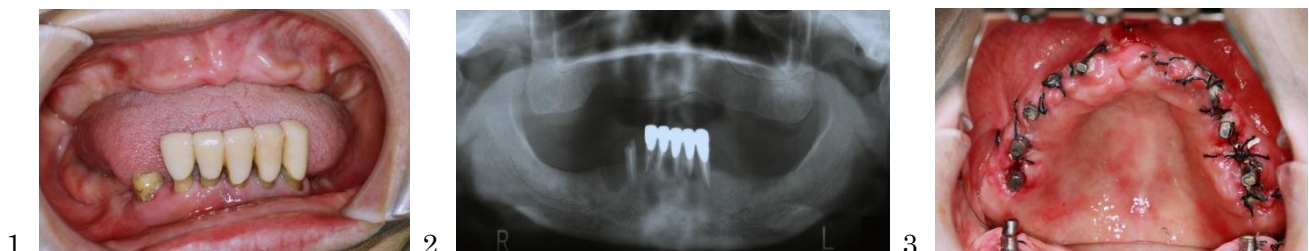
Image-1: Image of the oral cavity at the time of primary medical examination.

Image-2: Panoramic radiograph at the time of primary medical examination.

Image-3: Image of the maxilla after the implantation.

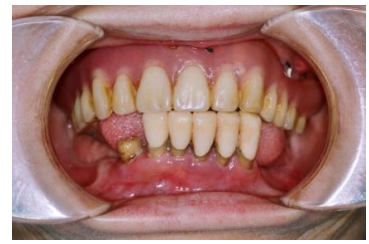
6

Image-6: Image of the oral cavity from the front once the provisional has been set.

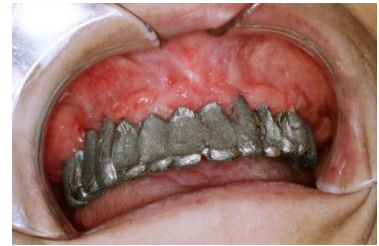
9

Image-9: Trial insertion of the metal frame

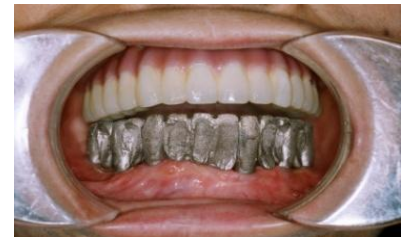
15

Image-15: Trial insertion of the metal frame.
