Chapter 3- Cases where bone augmentation technique was applied.

1. A case where the fixed prosthesis was set after implantation with GBR.

Chief Director of Niwa Dental Office

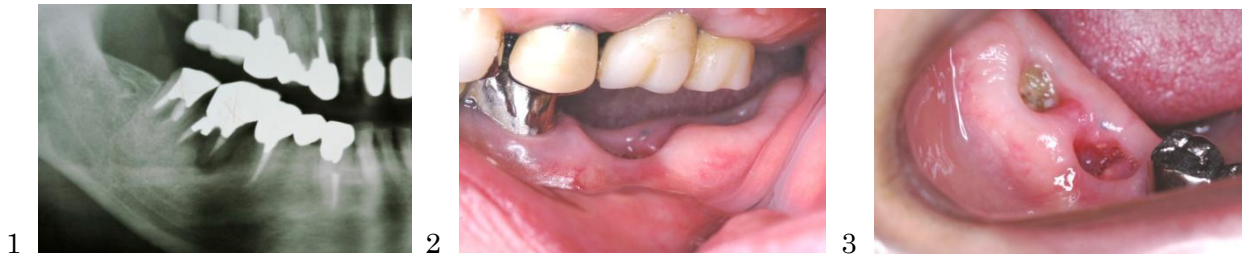
Image-1: Panoramic radiograph before tooth extraction. The lack of bone is particularly noticeable at No. 19 position.

Image-2,-3: The images of the occlusal plane and the lingual side after tooth extraction are shown. Low bone quantity can be predicted from the reduced height of the gingivae.

No. 18 and 19 teeth were judged to be unsustainable (Image-1) therefore were extracted (Image-2,-3). The height of the bone was examined by radiography. Due to the large size of the extracted cavity, the distance to the mandibular canal was short (Image-4) therefore was concluded that the bone quantity was inadequate to achieve primary stability.

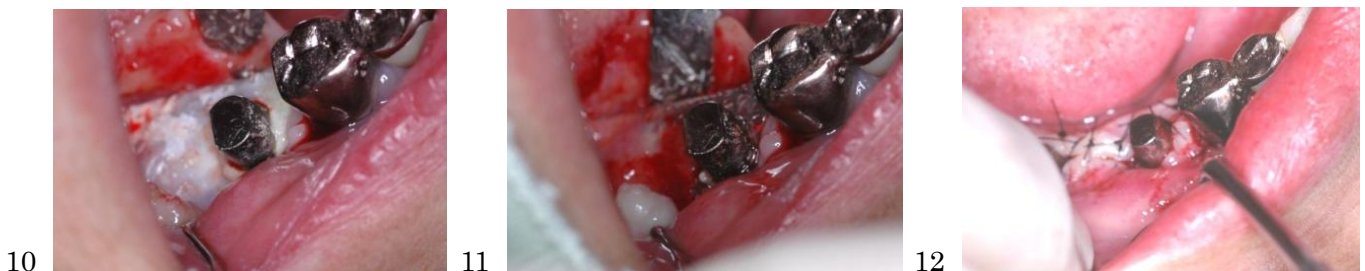
Image-10,-11,-12: Image taken during the secondary surgery, performed 16 weeks after the primary surgery.

First a suitable sized implant was planted, and bone filling agent, that is a mixture of demineralized freeze-dried bone allograft (DFDBA) and hydroxyapatite (HA), were applied to the surroundings. Then, the Ti mesh and non-absorbable barrier-membrane were placed and were fixed using Bone Tack kit. Finally, a release incision to the lingual side mucosal membrane was added, which was stitched up for the completion of the surgery (Image-10). The secondary surgery to remove the titanium mesh and the barrier membrane were conducted 16 weeks later (Image-11 to 15).

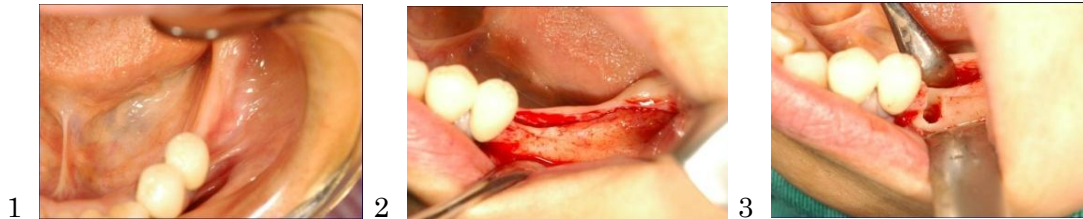
Image-1: Image of the left mandibular molars.

Image-2: Mucoperiosteal flap was constructed to expose the alveolar bone.

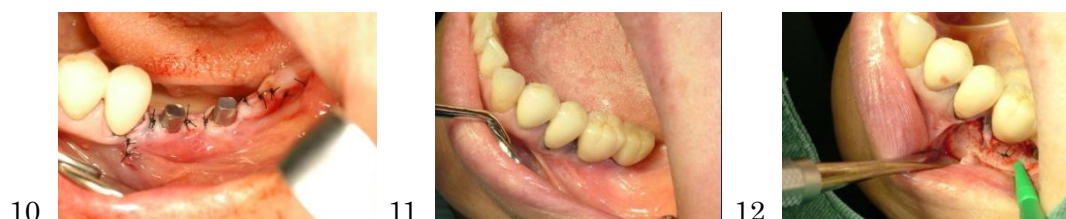
Image-10: Without application of the membrane, the transplanted bone was covered with the periosteum, and stitched up by the usual method of suture.

Image-11: Image of the oral cavity at the time of metal-bonded crown placement, 6 months after implantation.

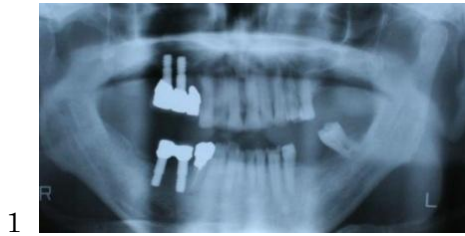
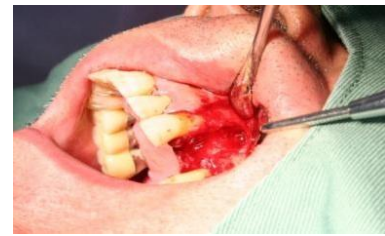
Image-1: Panoramic radiograph before surgery

Image-2: Image of the oral cavity after tooth extraction. The alveolar bone on the buccal side shows complete resorption.

Image-3: Insertion of AQB one-piece implant, 5 mm diameter. The implant body is exposed on the buccal side to its base. The primary stability could be established with the three other sides.

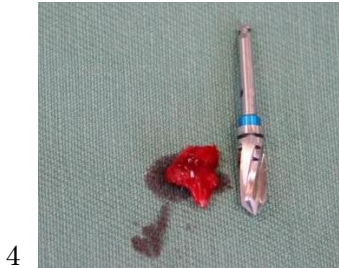
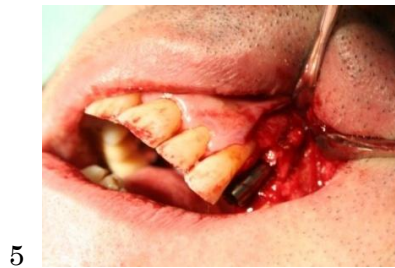
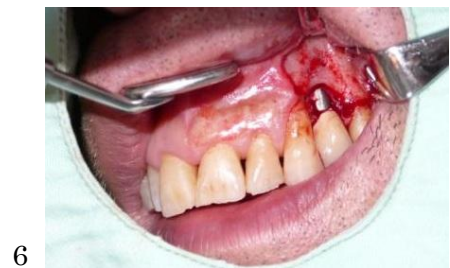
Image-4: The bone, extracted from the left maxillary tuberosity.

Image-5: Bone transplant to the recrystallized HA coating layer.

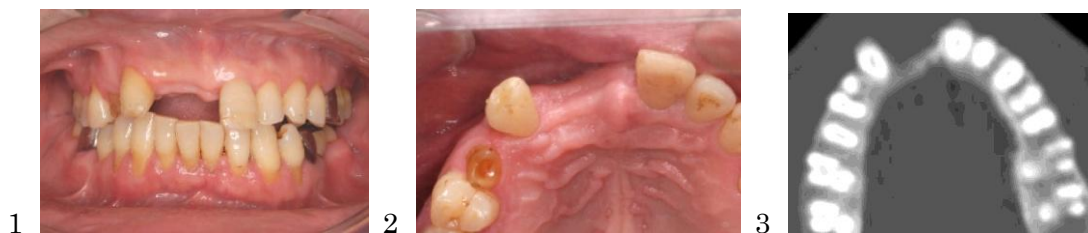
Image-1,-2: Image of the state before the bone augmentation therapy. Bone resorption, labiolingually to the alveolar ridge is evident.

Image-3: CT scan before surgery (Horizontal cross-section) showing a significant bone resorption in the area of No. 9 and 10 teeth.

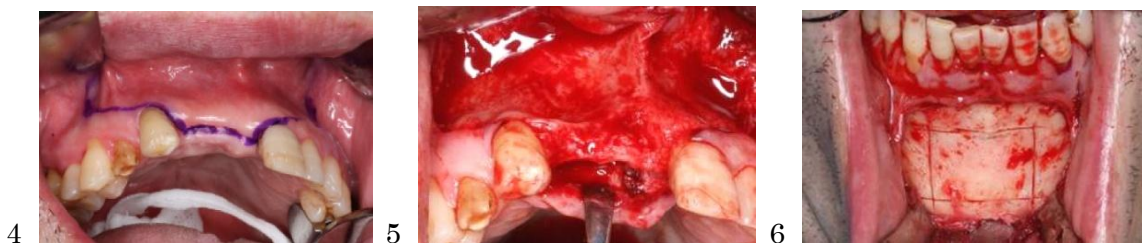
Image-4: Image of the oral cavity during bone augmentation procedure, with the incision line.

Image-5: Image of the state with periosteum detached. A significant bone resorption of the labial alveolar bone can be seen.

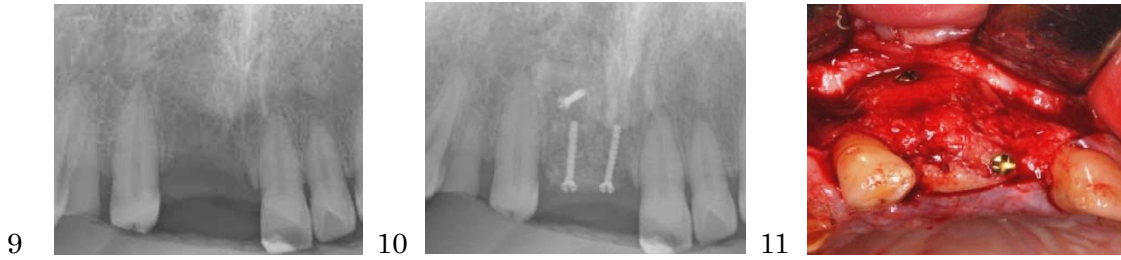
Image-9, -10: Dental radiograph, pre- and post-surgery. The transplanted bone shows satisfactory condition.

Image-11: Image during the implant installation. The bone regeneration was confirmed upon periosteal detachment.

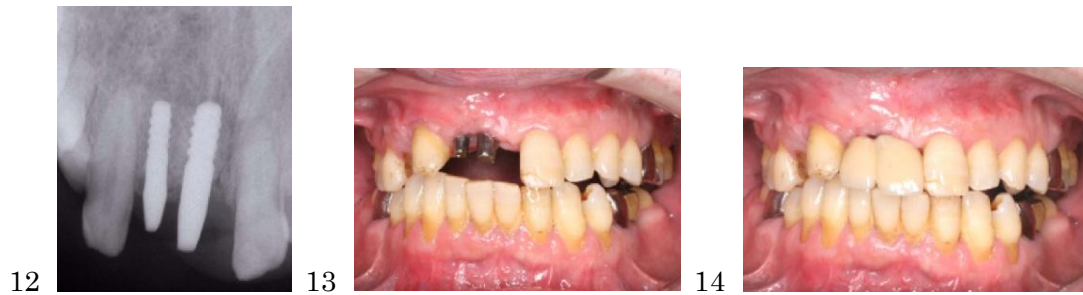
Image-12: Dental radiograph after implant installation.

Image-13: Image of the oral cavity, three months later

Three months after implantation (Image-13), porcelain-bonded-to-metal crown was set after undergoing provisional restoration (Image-13).

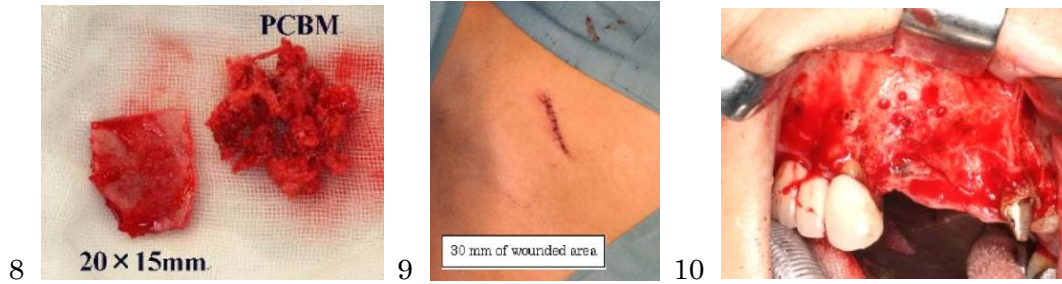
Image-8: Cortical bone with an area of: 20×15 mm was extracted.

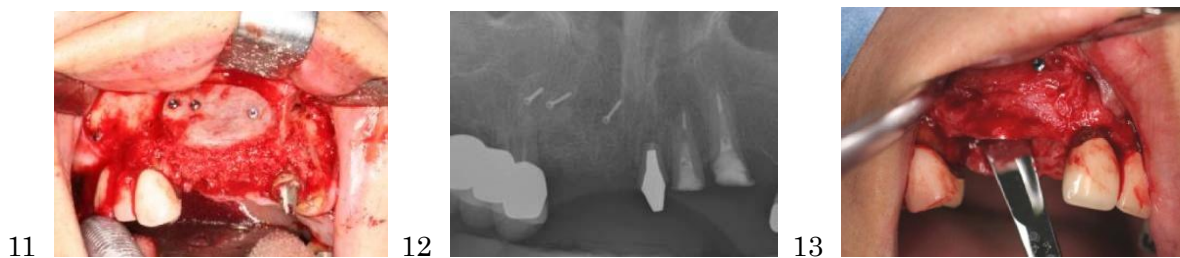
Image-11: The cortical bone was transplanted on the buccal side. Cancellous bone was compacted to the remove the edges between the surfaces of the natural and grafted bone and to the area in which apicotomy was conducted.

The natural bone was pierced through to induce blood supply (Image-10). The block of cortical bone extracted was reshaped to fit the deficient space on the buccal side, and was finally fixed with microscrews. The ridges generated between the grafted and the natural bone, as well as the area to which

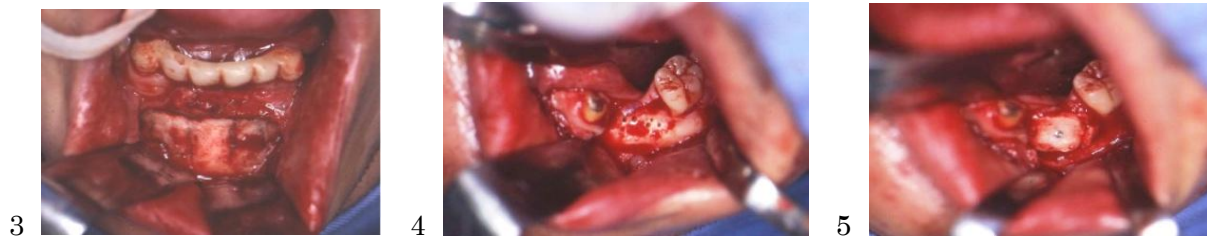
Image-3: Image featuring the extraction of the bone from the chin region

Image-4: Image featuring the formation of the pores to the portion of the alveolar bone. The blood flow in this region was confirmed, and showed a satisfactory flow.

This autogenous bone graft was conducted under general anesthetic conditions. After forming pores to the grafting region with a fissure bur (Image-4), the block of cortical bone that was extracted from the chin region was placed on the buccal side of the thinned alveolar bone in a way that fitted with the state of the bone that lacked teeth (Image-3). The cortical bone block was fitted on the buccal side, fixed with microscrews, and the spaces between the bones were compacted with cancellous bone and cortical bone to smooth out its form.

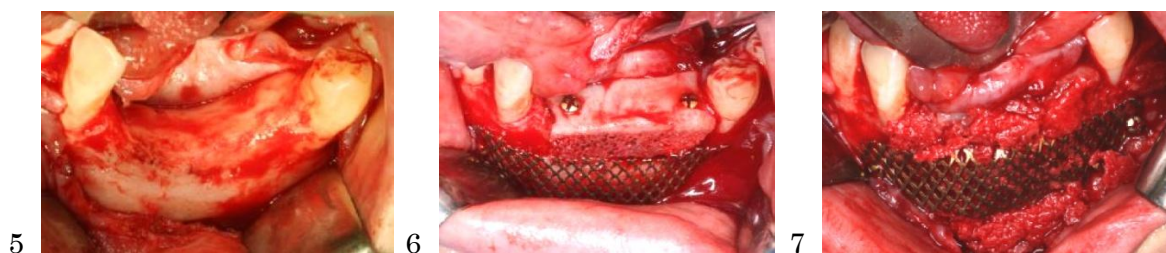
Image-5: Image during the bone augmentation therapy. Detachment of the periosteum revealed a significant vertical bone resorption.

Image-6: Image during the bone augmentation therapy. Extracted bone block was grafted onto the alveolar ridge and the titanium mesh plate to the labial side.

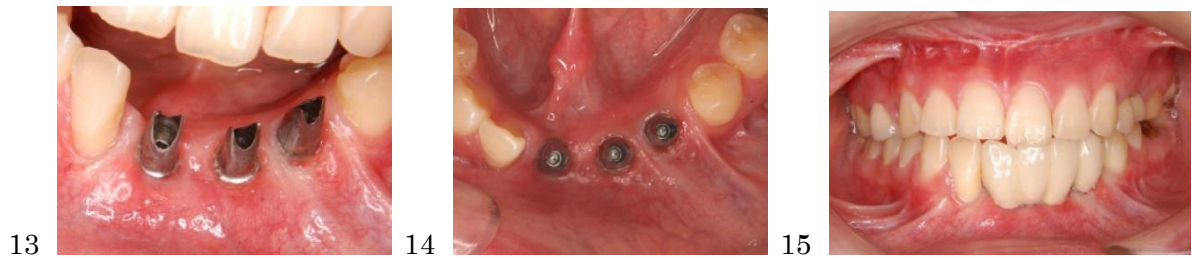
Image-13, 14: Image of the oral cavity after the placement of the custom-made abutment.

Image-15: Image of the porcelain bonded metal crown fitted.

Secondary surgery was performed seven weeks later. Custom-made abutment was fabricated (Image-13, -14) and was fitted with porcelain bonded crown (Image-15). Reduction in the area of the oral vestibules was observed, but favorable state of hygiene, and peri-gingival conditions were found.

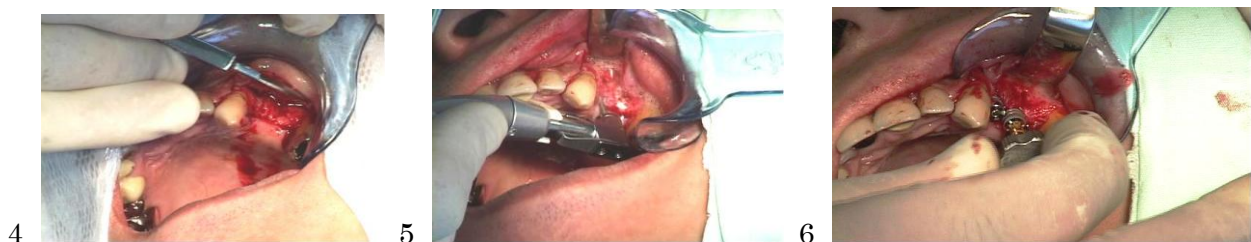
Image-4: Image of the state during surgery. The suture was applied in line with the tooth cervix, to allow sufficient view of the bone.

Image-5: The implant cavity was constructed and expanded with the usual means.

Image-6: The implants were placed to avoid exposure of the HA coating but could not prevent a portion from being uncovered.

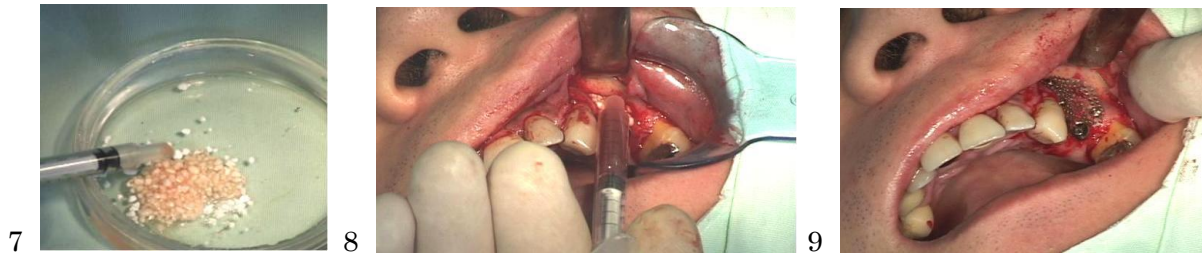
Image-7: Gel-like mixture of bone filling agent immersed with PRP.

Image-8: Further application of PRP.

Image-9: Fix with the titanium bone tack.

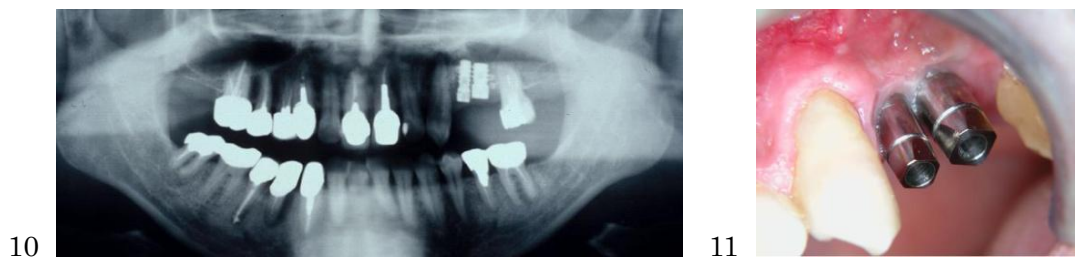
Image-10: Panoramic X-ray after the placement of two-piece implant.

Image-11: Placement of the abutment at the secondary surgery

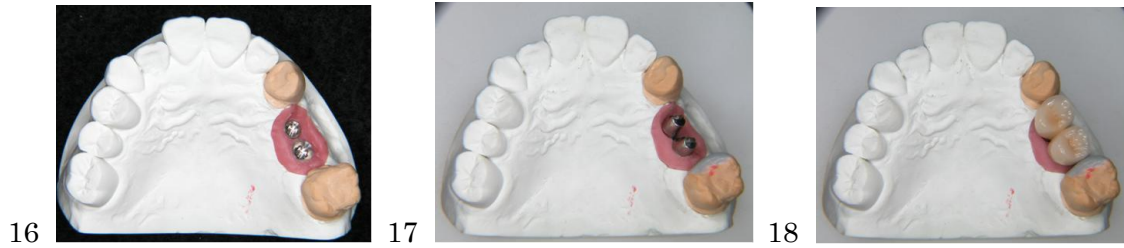
Image-16: Pour the impression agent up to the level of interdigitation, and upon its settlement, pour plaster to complete the model.

Silicon impression agent was pasted onto the inner and outer surfaces of the pick-up impression coping, and impression was taken with the personalized tray that had been previously prepared (Image-13). Once the impression agent had set, and the tray had been removed, the pick-up impression coping was found remaining in the impression material (Image-14). Multi-abutment was removed from inside the oral cavity, to which an implant analogue was firmly fitted. This was restored into the pick-up impression coping that was present within the impression agent (Image-15). In an attempt to duplicate the gingivae structure, the gum impression agent was added to the level of interdigitation. The model was completed by finally pouring in the plaster after the agent had set (Image-16).

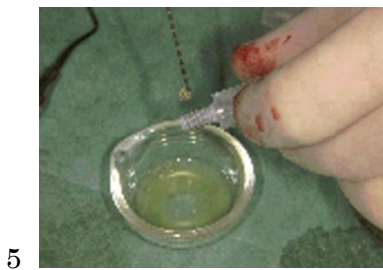
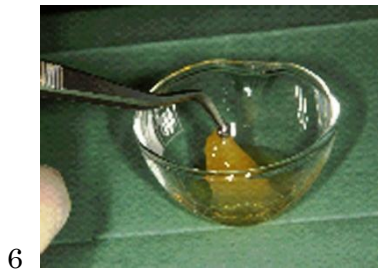
Image-5: Fraction 3 was applied onto the implant.

First the venous blood of the patient was collected, and was subjected to centrifugation under the PRGF system (Image-3). Then the third fraction of the supernatant was collected to be applied onto the implant body (Image-4), and to the drilled implant cavity. The first and second fractions were hardened with heat treatment and were placed as an adjuvant form to the bone surrounding the implant before closing the wound (Image-5,-6,-7).

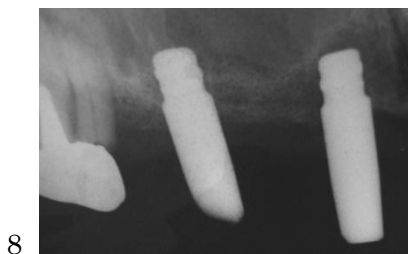
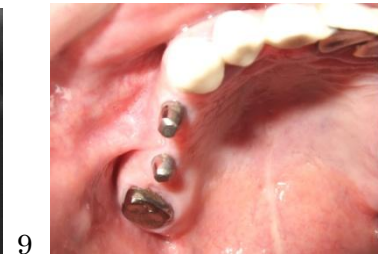
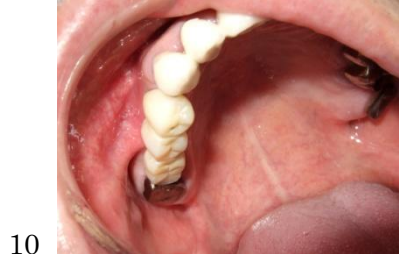
Image-8: Dental radiograph straight after the implant.

Image-9: Image of the oral cavity, six weeks after surgery.

Image-10: Placement of the superstructure.

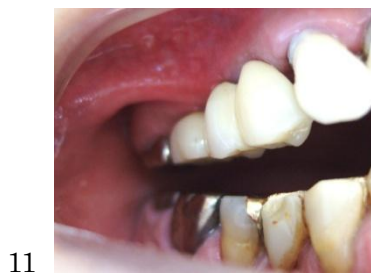
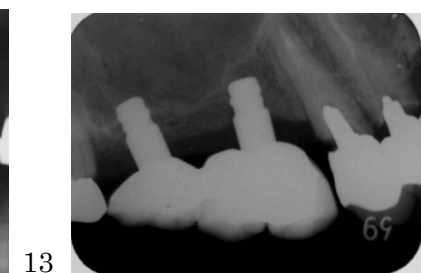
Image-11: Bridge was placed onto the implant installed at the positions No. 12 and 14.

Image-12: Panoramic radiograph after the placement of the superstructure.

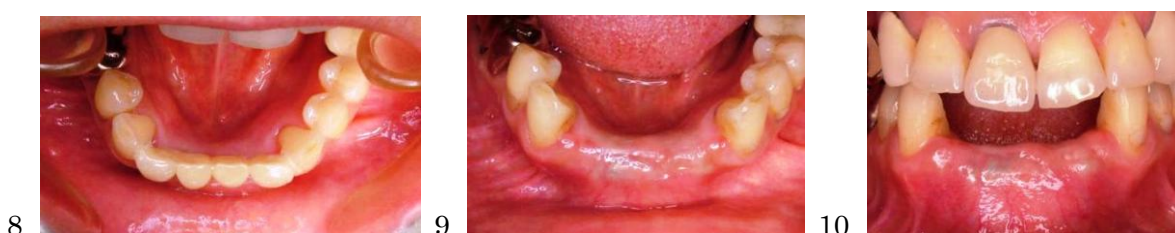
Image-8: Temporary crown was fitted for four months.

Image-9,-10: Image of the oral cavity after 4 months.

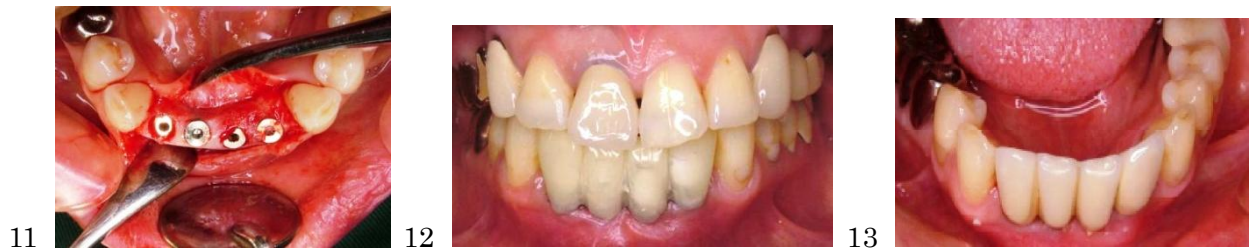
Image-11: Upon removal of the membrane, implant body was seen to be covered with neonatal bone.

Image-12: Abutment was mounted, and monitored the healing process for six months, protected by the placement of temporal crown. A satisfactory progress without any bone resorption was observed. Metal bonded crown was placed as the final prosthetics.

Image-1,-2 show the state of the anterior mandible. The narrowing in terms of the labiolingual width and vertical bone resorption can be observed. Image-3 features where the mucoperiosteal flap is curved out for the exposure of the alveolar bone. The lingual portion of the alveolar bone shows some remaining while the labial portion shows complete resorption. Inserted AQB two-piece implants, of 4mm diameter, are shown in Image-4. Even though the HA coating on the labial side was left completely exposed, primary stability could be achieved. Release incision was applied to the mucoperiosteal flap on the labial side as shown in Image-5. Next, the membrane (Gore-Tex, TR6) was applied to cover the HA coating completely (Image-6). Bone or artificial bone graft were not performed here. The mucoperiosteal flap was recovered to its original position and sutured with the 4-0 surgical thread, having covered the membrane (Image-7). This was left to heal for 4 months, protected with temporary crown (Image-8). The images of the state during the healing process is shown in Images-9 and -10. The state underneath the membrane, as shown in Image-11, the implant body has been covered with neonatal bone. With the placement of abutment, its stability was monitored for six months, protected with the application of temporary crown. With good progress made, and no apparent bone resorption, metal bonded crown was placed as the final prosthesis (Image-12).

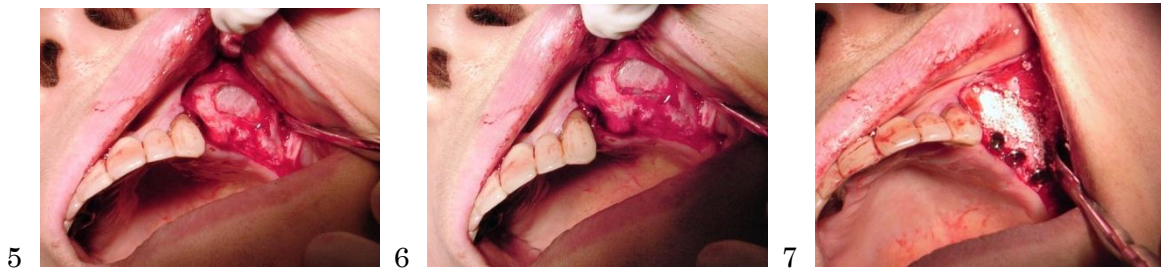
Image-5: Elevation of schneiderian membrane.

Image-6: Verifying the movement of the mucous membrane along with nasal respiration.

Image-7: Implant insertion, and filling the elevated space with the graft material, extracted autogenous bone mixed with β -TCP.

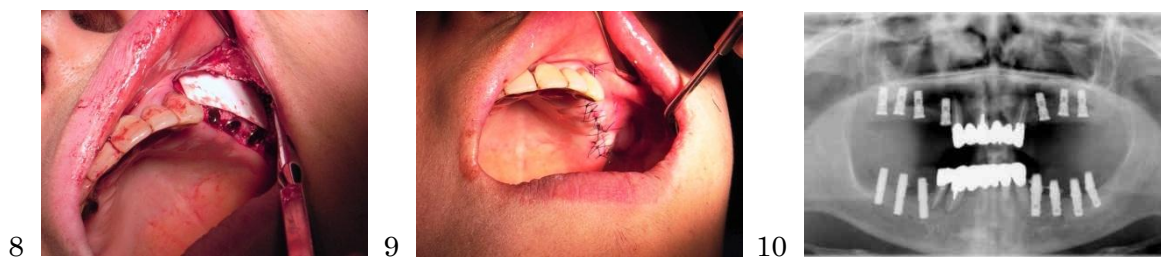
Image-8: Cover the window opening with absorbable membrane.

Image-9: Suture with nylon thread

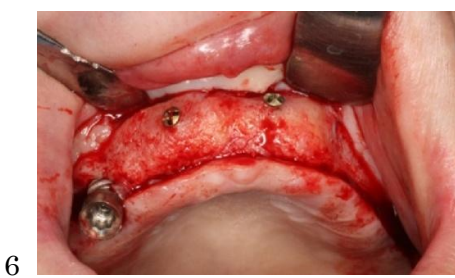
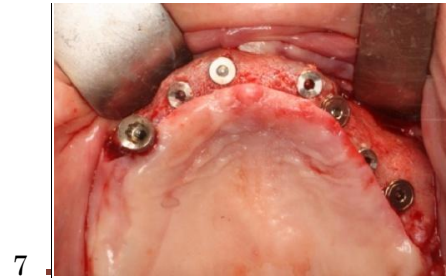
Image-6,-7: Image during the insertion of implants to the left anterior teeth. 6) The grafted bone appeared to be in good condition. 7) Six AQB two-piece implants were inserted.

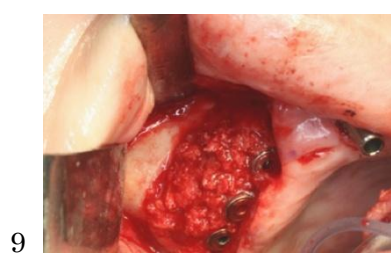
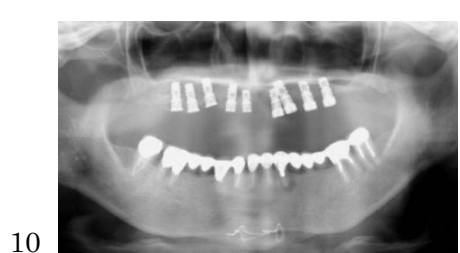
Image-8,9: Images featuring the sinus-lift procedure to the right. 8) Implant cavities were constructed and its depth and its orientations were verified using alarm gauge. 9) The state after the bone graft, having inserted the implants.

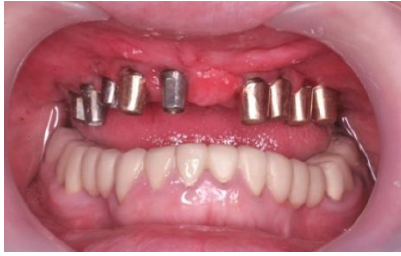
11

Image-11: Implant set with inner crowns.

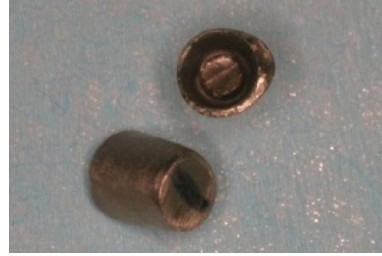
12

Image-12: Inner crowns

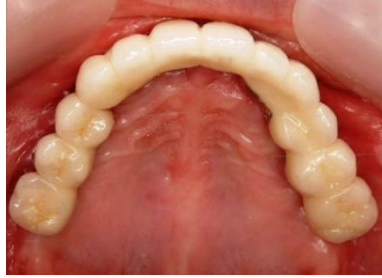
14

Image-13,-14: Image of the oral cavity fitted with final prosthetics.

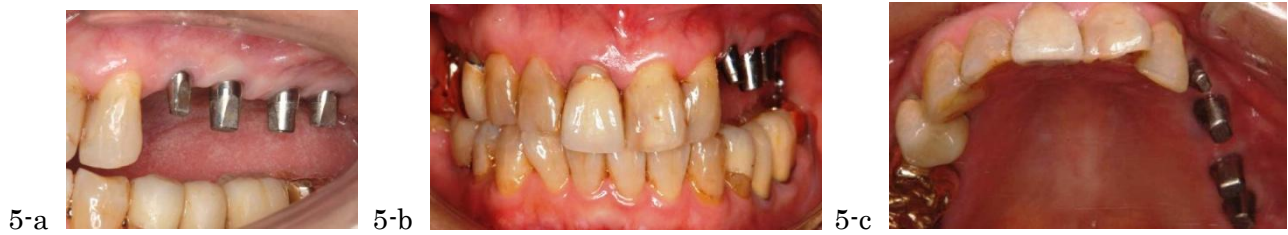
Image-5-a,b,c: Image of the oral cavity interior before the placement of the final prosthesis.

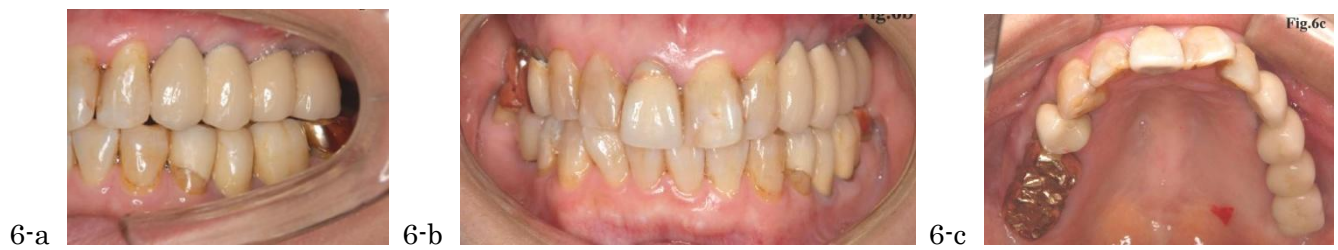
Image-6-a,b,c: Image of the oral cavity interior after the porcelain bonded-metal crown has been mounted.

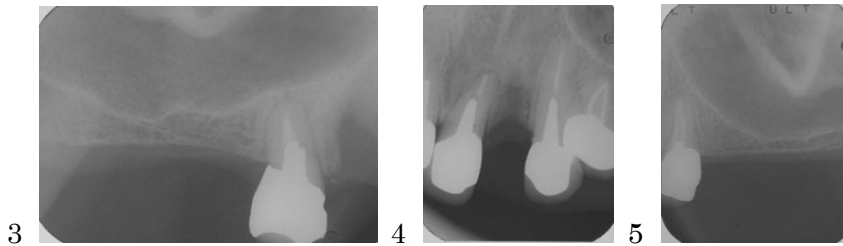
Image-3,-4,-5: Dental radiographs featuring the state four months since No. 7 and 12 extractions (12.11.1998). The alveolar bone height at the positions No. 2-4 and No. 13 -15 are low.

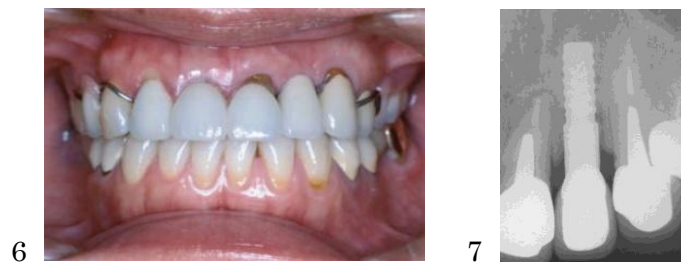
Image-6,-7: Image of the oral cavity and radiograph featuring the 4LM implanted to position No. 7 after the jaw bone had stabilized (06.09.1999), placement of the metal bonded crown (12.27. 1999).

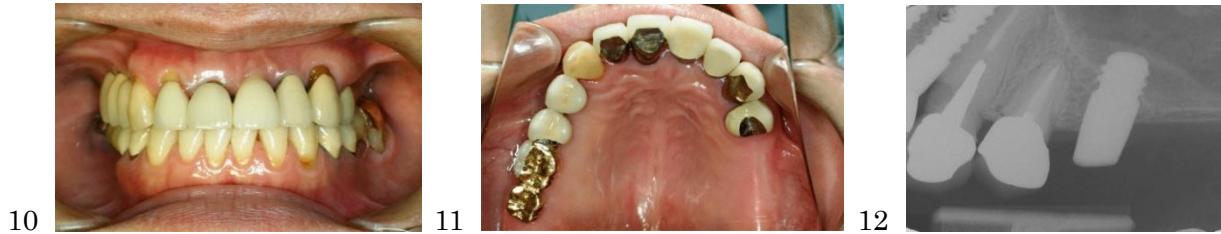
Image-10, 11: Images showing the state at the end of the secondary surgery (06.08.2004).

Image-12: The dental radiograph taken at the time of tertiary surgery. The 5SS implant was installed to No. 12 position with socket-lift procedure. The image displays the state of the blood pooling in the space under the mucosa that has been detached and elevated. Resin crown was placed three months later, and prepared for the case where the primary stability of AQB implant was insufficient at the position No. 2 where the bone was particularly narrow.

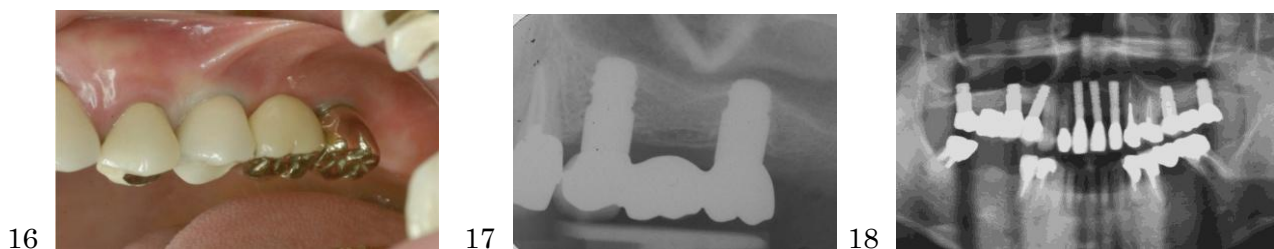
Image-16,-17: Image of the oral cavity as well as the radiograph featuring the state after the final bridge superstructure was mounted. The bridge was placed 11 months after the implant installation to No. 4 position, and 5 months after No. 2 position (12.17.2007).

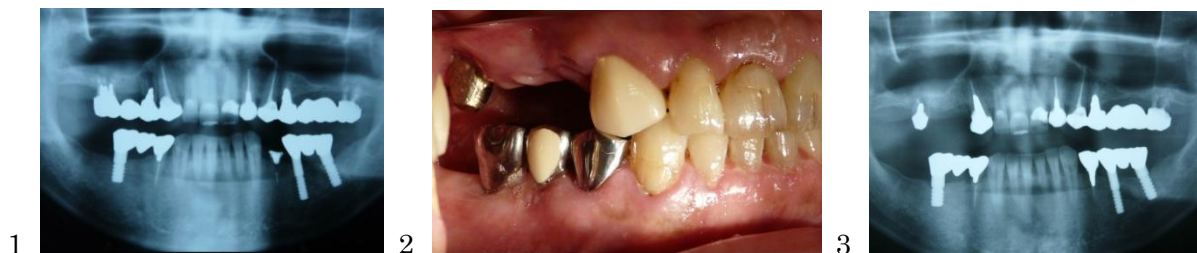
Image-1: Panoramic radiograph that featured the root fracture of No. 12 and 14 teeth that had been used as anchoring teeth for bridge prosthesis.

Image-2: Image of the oral cavity, ten months after the segmental and normal extraction.

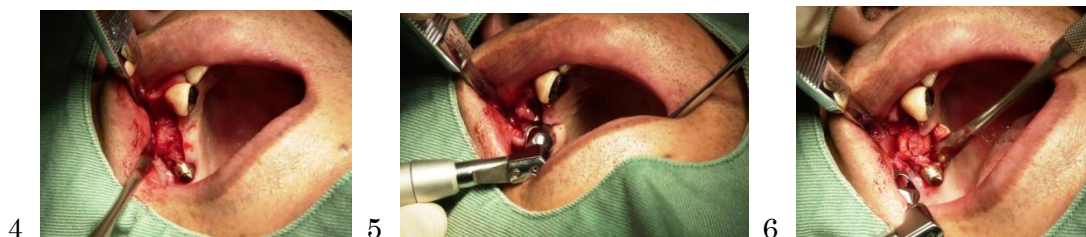
Image-4: The mucoperiosteal flap was incised and then detached under conduction anesthesia.

Image-5,-6: Images taken at the time of drilling to reach the cortical bone of the maxillary sinus with 8 mm diameter trephine bur.

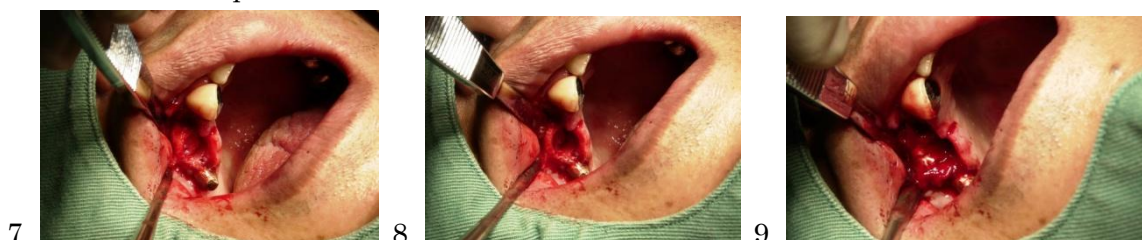
Image-7: Image at the time of elevating the bone fragment that was extracted with trephine bur towards the sinus.

Image-8: Image at the time of further elevation of the bone fragment to roughly 4 mm above what had been originally decided with respect to the extent of blood supply to the bone.

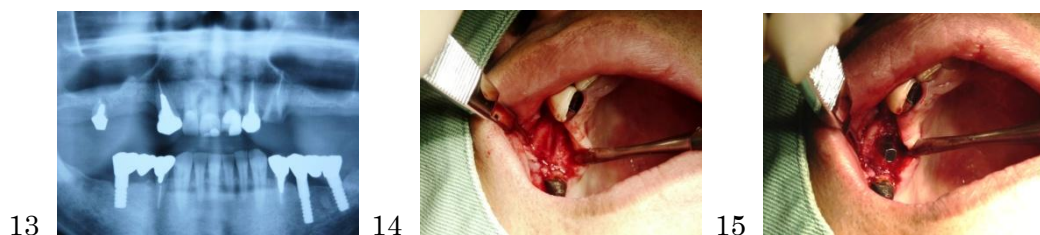
Image-13: Panoramic radiograph six months after surgery.

Image-14: The gingival incision and detachment were conducted, under conduction anesthesia

Image-15: One-piece type implant was installed following standard protocol.

The one-piece implant was then installed after confirming the intactness of the alveolar bone after the usual procedure of gingival incision and its detachment, under conduction anesthesia. 4SS implant was installed, and the flap was sutured up to complete the surgical procedure (Image-15,-16). Image-17 features the radiograph straight after the implant installation. Although it was installed slightly more towards the posterior region than planned, the implant body position was confirmed to be inserted into

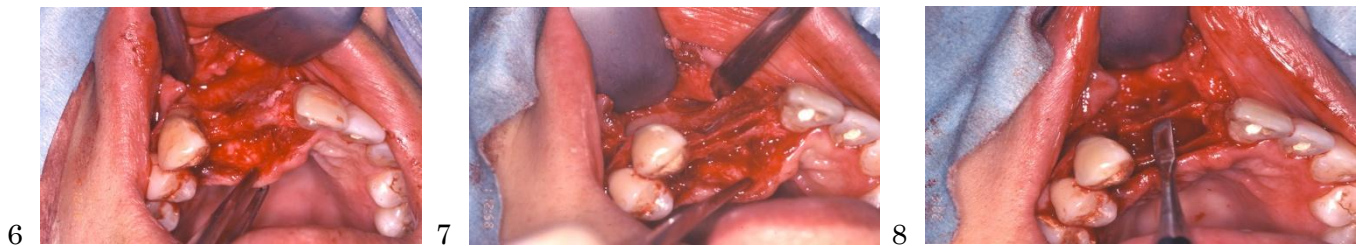
Image-6,-7,-8: Perioperative image of the oral cavity. Horizontal splitting of the alveolar bone is shown.

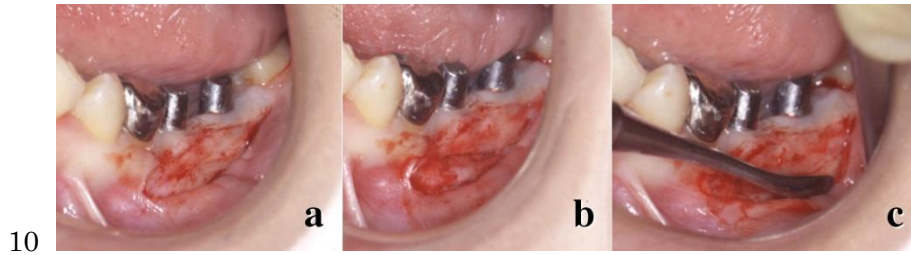
Image-10 a,b,c: Vestibular expansion (full and partial thickness incision)

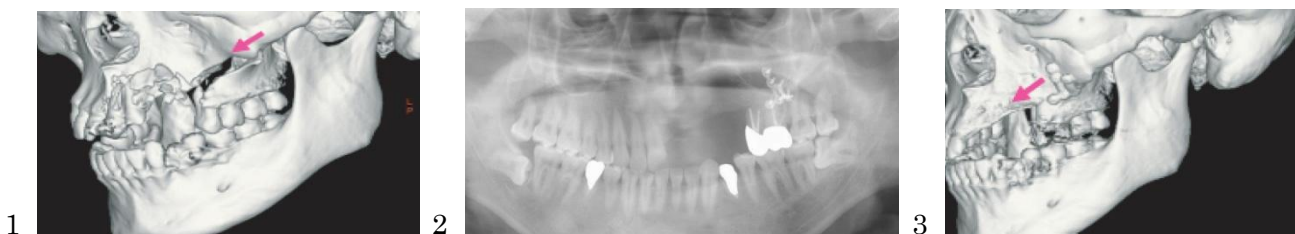
Image-1: 3D-CT at the time of first clinical evaluation. Lack of No. 5 to 8 teeth as well as the splintered fracture of the alveolar crest can be observed.

Image-2: Panoramic radiograph taken 10 months after the ORIF procedure. The mini-plate that was fixed to correct the fracture can be seen

Image-3: 3D-CT taken ten months after the ORIF procedure. Lack of No. 5 to 8 teeth is evident.

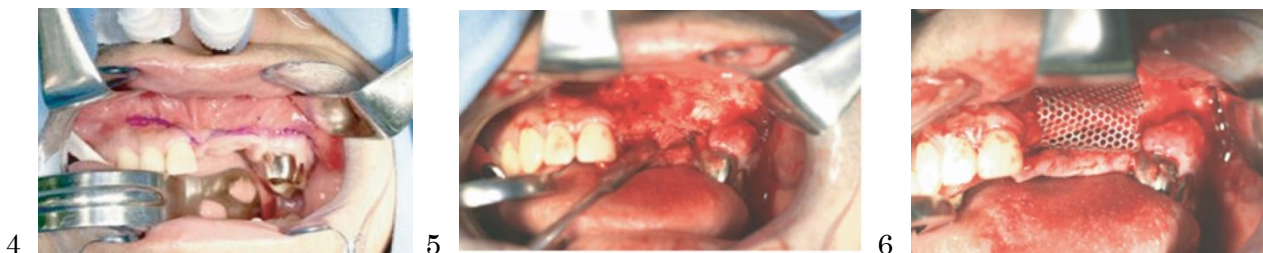
Image-4: Intraoperative image during bone regeneration operation. The mucosal incision was applied on the more labial side than the alveolar ridge.

Image-5: Image of the oral cavity after periosteum detachment.

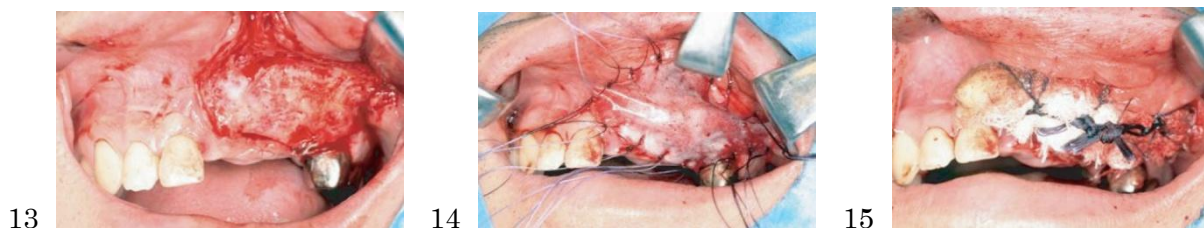
Image-13: The mucosal flap is lifted off the periosteum.

Image-14: Pelnac® was placed on the exposed area of the periosteum.

Image-15: After grafting the artificial dermis, pressure dressing was applied by the means of tie-over dressing technique.

was removed at positions No. 5 to 8, and after the mucoperiosteal flap was transferred to the apical side (Image-12,-13), artificial dermis (Pelnac®, Gunze) were placed to cover the exposed area of periosteum, and pressure dressing was applied by means of tie-over dressing technique (Image-15).

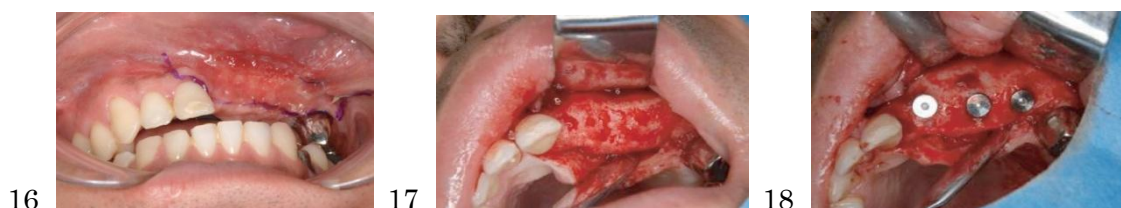
Image-16: Image of the oral cavity before implant installation. A reverse bevel incision line is drawn here.

Image-17: Image after periosteal elevation ready for implant installation.

Image-18: Image of the implant cavity directly after the two-piece type implant installation

The two-piece implant installation was conducted a month after the vestibular expansion (Image-16 to -18). As planned, the 5102 type were installed to No. 6 and 8 positions, and 5122 to No. 5, and completing the surgery. The postoperative radiograph is shown (Image-19).

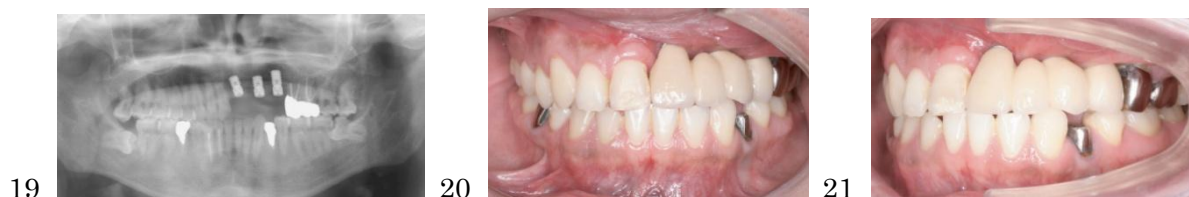
Image-19: Postoperative panoramic radiograph. Implants were able to be inserted as initially planned.

Image-20,-21: Image a month after the placement of porcelain bonded metal crown (from the front and the side). No inflammation of the surrounding structures can be observed.

Two months following implant installation, porcelain bonded metal crowns were placed having finished the secondary surgery (Image-20,-21). The images feature the state three months after undergoing the vestibular extension procedure, where a slight regression of the mucosa can be observed, but since this is at the anterior teeth, it should not significantly affect the level of oral hygiene. Procedures such as free gingival graft and skin grafts are also effective in replacing vestibular extension technique however, since a donor site is required, a thorough deliberation is required.
