Chapter 5- Cases where special attention was paid to the prosthodontics

- Application of CAD/CAM system

1. A case in which the all-ceramics crown fabricated with CAD/CAM system was fitted

2. The method to mount the superstructure fabricated with CAD/CAM system to the AQB implant

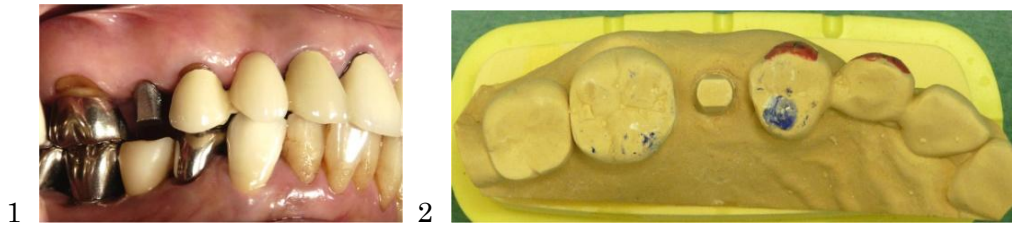
Image-1: Image of the oral cavity, two months after the installation

Image-2: Occlusal plane of the working model

No. 13 tooth was extracted following its root fracture, to which one-piece implant (4SS) was installed in undergoing the standard protocol, after a year and nine months. Two months later, impression and occlusion registrations were conducted (Image-1,-2). Having constructed the model, all-ceramic crown was fabricated using the CAD/CAM system, and the superstructure was mounted (Image-3,-4,-5,-6). With regards to the dimensions of the crown, its occlusal plane was fabricated to be smaller than those of the natural teeth, and as the opposing tooth was also implant prosthesis, the occlusal plane was designed with the size to match its opponent. The occlusal relationship was designed to be 30 μ m below that of the anterior natural dentures, so that it would separate with the lateral movement. The dental radiographs at the time of implant installation as well as the placement of the superstructure are featured in Images-7, -8, -9,-10, where no inflammations in the surrounding structures can be observed. Image-11 and 12 show the state, eight months after the installation, with no breakage of superstructure or presence of any other abnormalities. There are no constrictions or inflammations in the gingiva surrounding the implant prosthesis. The implant installations were conducted nine and a half years previously to the opposing teeth No. 13 to 15, and had been mounted with a metal based hybrid to the No. 13 position, and the metal crown to No. 14 and 15. But there had been neither signs of bone resorption nor gingival constriction, indicating a successful implantation case.

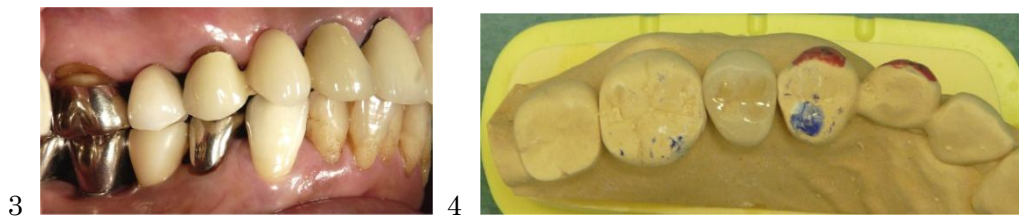
Image-3: Image of the oral cavity at the time of prosthetic placement.

Image-4: Prosthetics on the model.

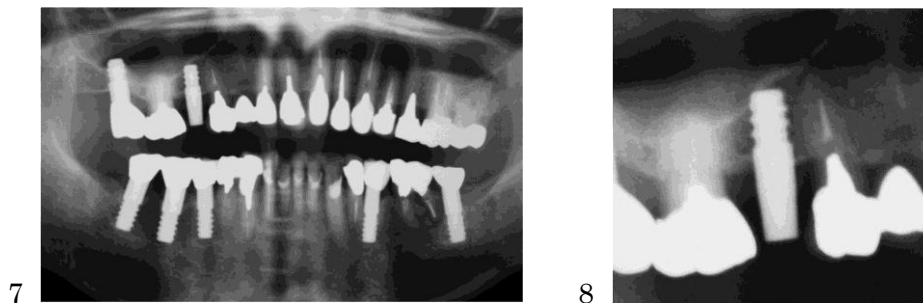
Image-7,-8: Radiograph directly after the implant installation

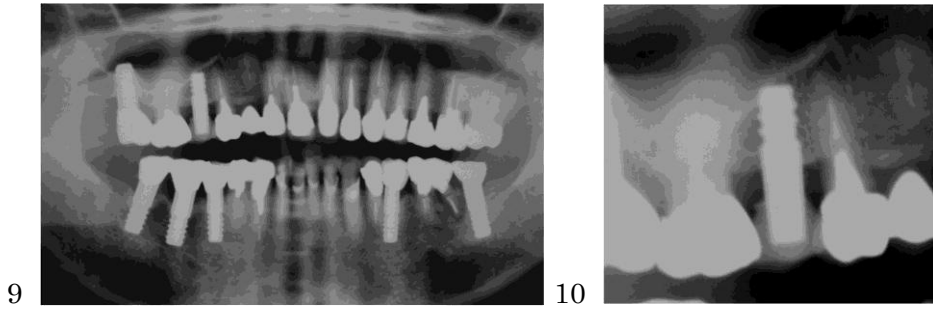
Image-9,-10: Radiograph of prosthetic placement, two months after the implant installation.

All ceramics crowns which were constructed by CAD/CAM system

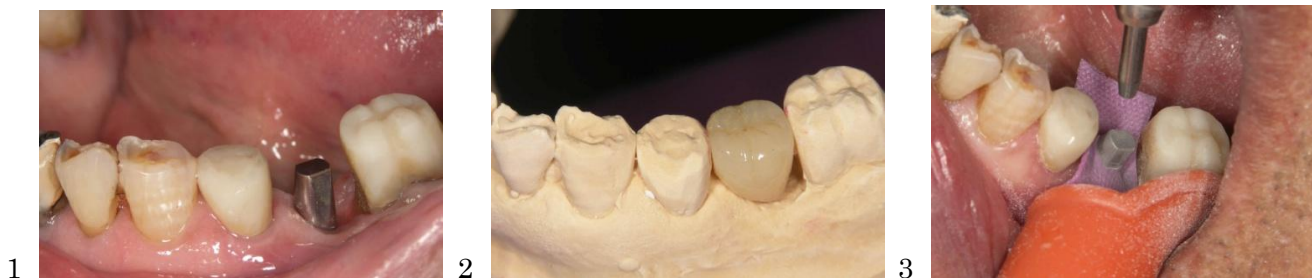
Image-1: It is a single implantation case however, since the wearing of the incisal margin of No. 26 and 27 is significant, sufficient adhesive strength was necessary.

Image-2: The all-ceramics crown was fabricated with Kaguya block using the CAD/CAM system.

Image-3: The polished surface of the implant and the surrounding tissues in the margin were protected by a rubber-dam. The surface was washed with water and then dried after the sandblast treatment. Metal primer treatment was performed, and then dried. After the coating with the bond-force that had been condensed with air-blow, form a bonding resin polymerized layer with photo-irradiation.

The sandblast treatment to the titanium surface acts to increase the surface area of adhesion and is effective for strengthening the mechanical fit. However, it can become the surface for plaque accumulation if applied to the gingival margin. Therefore rubber dam should be adopted to protect the margin, the neighboring teeth as well as the gingiva. The blast treatment to the crown interior should be avoided as it can create a point of fissure, and therefore the surface should be left untreated after cutting with diamond particles.

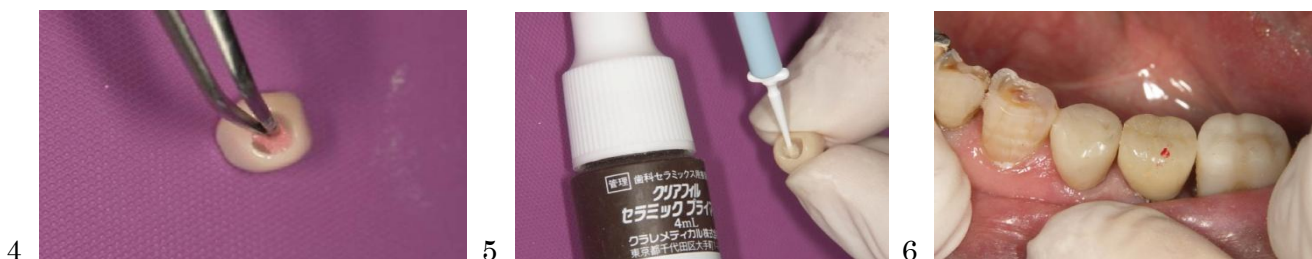
Image-4: Rinse the superstructure interior with water, after a phosphoric acid treatment.

Image-5: After silane coupling treatment, undergone heat treatment with air-blow and dryer.

Image-6: Fill the internal surface with resin cement such as Clear-fill esthetic cement opaque color that can vary the color tone, and then set. Irradiate the crown interior one second at a time from the buccolingual side. After the removal of excess resin, polymerize with an irradiation device with high irradiation strength. Adjust the occlusion, and polish after it has hardened

The aim of the treatment with phosphoric acid is not the etching of the internal structure but solely to clean the interior of the crown. After the silanization, under the clinical practice settings, the drying of the titanium surface should be done with devices such as dryer that would limit the increase in the temperature to reduce the difficulty in lowering the temperature since risks lie in the expansion of the crown or shortening of the working time of cementing with heat.

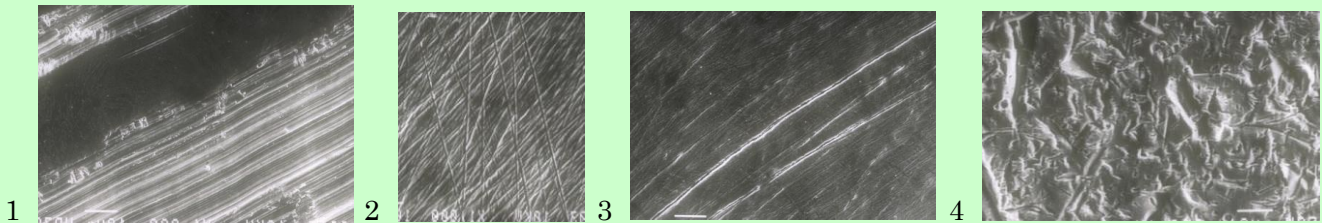
Fig. 1 Scratches made on the titanium surface with scalars (SEM image 1000× magnification)

Fig. 2 Scratches made on the titanium surface with polishing tool (Medium)

Fig. 3 Scratches made on the titanium surface with polishing tool (Fine)

Fig. 4 State of the titanium surface after air-powder polishing (for 30 seconds from 5 mm distance)

The resistance to microorganisms with implant prosthesis is considered to be much lower than that of natural teeth due to the absence of connective tissue attachment, and its exposure to the oral cavity. The maintenance of oral hygiene with cleaning is essential for the long-term survival of the implant. However the problem lies in the relative softness of JIS Class I pure titanium and therefore the low resistance to frictional wear often are scratched with metal scalars (Fig. 1), polishing tools (Fig. 2,-3) or ruined with phosphoric acid etching or acidic sodium fluoride solutions. The scratches on these polished surfaces become a great environment for the microorganisms to breed therefore great precaution has to be taken when using phosphate etching when repairing the neighboring teeth; using concentrated acidic sodium fluorides; during professional mechanical cleaning (PMC) with coarse polishing tools; or at the time of air-powder polishing (Fig. 4). The uses of metal scalars should be avoided, and be replaced with a plastic scaler specific for implants.

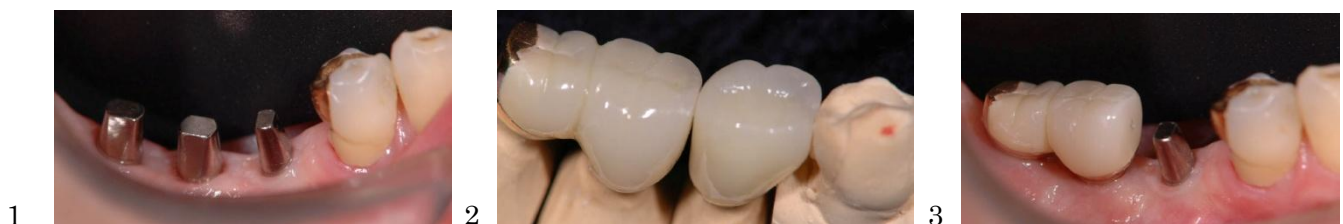
Image-1: Implants were installed in parallel to No. 14 and 15, but No. 13 implants were inclined in the distal direction therefore complicating the superstructure connection.

Image-2: The one-piece implants installed to positions No. 14 and 15 were planned to be mounted with

Esthena veneer connected crown, but No. 13 implant with single Esthena crown. A 300 μ m gap between No. 13 and 14 were left and were treated with sandblast treatment.

Image-3: First the connected crown was fitted onto No. 14 and 15.

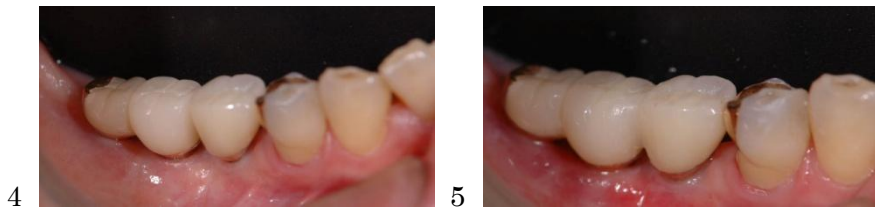
Image-4: Next the single crown to No. 13 implant.

Image-5: The gap between No. 13 and 14 were treated with phosphoric acid silanaization, and bonding application, followed by polishing after the Estelite flow quick attachment (Tokuyama Dental America Inc.).

The method of superstructure attachment in the oral cavity utilizes the fact that periosteum layer is absent with implant, and the adhesion is a secure fixation technique. In other words, as the pressure to the adhesive area is small in an undisturbed implant, the connection with adhesion can be a treatment that can be guaranteed for a long time. Furthermore, the advances in the recent composite resin have enabled recovery with high stability of color tones and polish that also encompassed high tensile strength. The ease in the superstructure fabrication as well as the clinical operations of intra-oral adhesion method has advantages not only in reducing technical errors and mistakes, or in reducing patient expenditure, but also with regards to the repair of the superstructure.
