Chapter 6 – Aesthetical improvement – Use of one-piece type implants

1. Improving esthetics with one-piece implant

Director of Kinebuchi Dental Clinic

Takao Kinebuchi

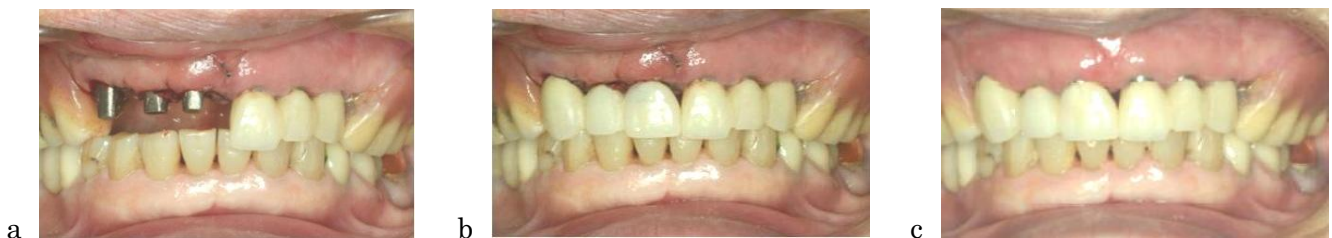
Image-6a,b: The day after the implant installation, during the placement of the provisional crown after disinfectant cleansing. Prepare the abutment tooth before its placement in the oral cavity in accordance with the color markings. Inform the patient that the temporal crown is placed solely for the sake of achieving minimal amount of estheticism, and designed to prevent any form of

occlusal contact made between the opposing tooth at the time of occlusion as well as preventing the sliding motion towards the anterior teeth.

Image-6c: Image of the oral cavity a week after the suture removal.

Inform the patient that the aim of the provisional crown is solely for the sake of esthetic appearance before adjusting the occlusion in a way that there is no occlusal contact with the opposing teeth both at the time of mastication and gliding motion to the anterior region. An EZ type temporary cement should be used so that it can easily fall out upon exertion of strong occlusal pressure, thus preventing any damage caused to the implant itself. It is usual to remove the stitches 5 to 7 days after the implant installation, and start the brushing few days later using super-soft brush, but it can be delayed depending on the conditions of the wound. In the first and second month, accelerate the constriction of the peri-implant mucosa with thorough brushing, and take impression imaging two months or so later before fabricating the prosthesis. Constriction of the mucosa surrounding the temporary crown exposing the titanium is a common occurrence. If sufficient mucosal constriction is not achieved during this period and has to constrict after the superstructure placement, the area of titanium abutment exposure increases with the subsequent gingival constriction, therefore estheticism is lost with aging of the prosthetics.

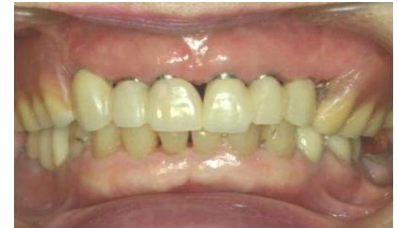
Image-6d: A few days after the stitch removal, start brushing with super-soft brushes designed specifically for postoperative use. Use of normal brushes can be initiated 3 to 4 weeks after surgery.

Image-6e,f: In the first and second month post surgery, constrict the gingivae with thorough brushing for a month, followed by impression taking after 2 months for fabrication of prosthetics.

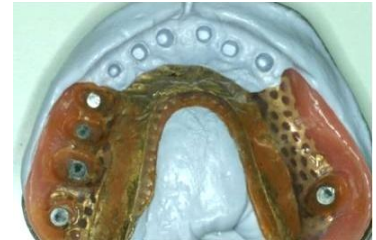
Image-6g,h,i: Take impression imaging 2 months later, after the removal of the temporal crown, and after the preparation of the abutment tooth.

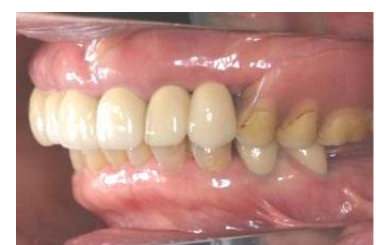
Image-6m,n,o: Ten months after the installation to the positions No. 9, 10, 11, a year after the installation to the positions No. 6, 7, 8, and 7 months since the crown placement to all of these implants installed.

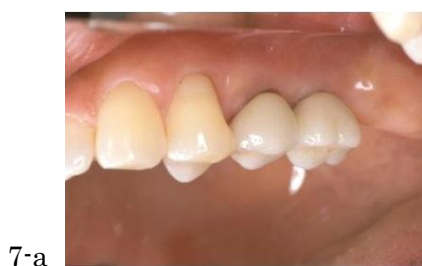
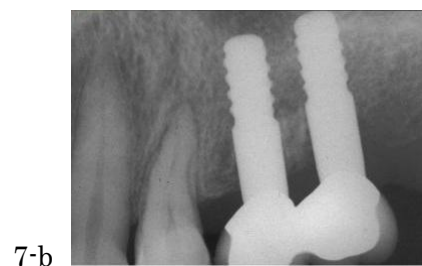
Image-7a,b: Image taken at the time of connected crown placement to No. 3 and 4 positions (09.01.2000).

The crown margins of one-piece type tend to be less in depth than with the two-piece types. This does make the cleaning much easier, and the shallowness can prevent the issues encountered with the difficulty in the complete removal of temporary cement with those with deep pockets. The temporary cement remnant can cause chronic peri-implantitis, causing bone resorption therefore this factor must be handled cautiously (Image-7). As a preventative measure, the confirmation of the absence of cement remaining with dental radiograph after the coronal placement, with dental X-ray radiography and peri-implant pocket examination should be conducted six months later. With the presentation of progressive bone resorption and lengthening of the pocket depth from the radiograph, and can also be suspected from probing, the dental practitioner should have the courage to verify this by more invasive means such as opening the flap for cement curettage. It should be noted that the changes with regards to any modification to the bone on the mesiodistal sides of the implants can be evident on the dental radiograph, but the initial bone resorption on the labiopalatal sides are not clear.

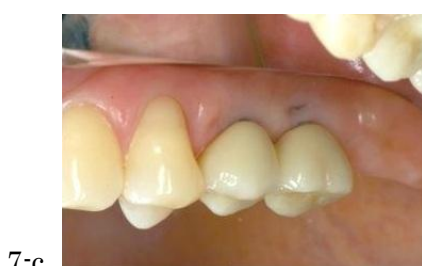
Image-7c,d: The temporal cement remnant causing decubital ulcer with perforation in the mucosa. Bone resorption was not observed in the dental radiograph. A perforation window remained for a period after the cement was removed with the probe.

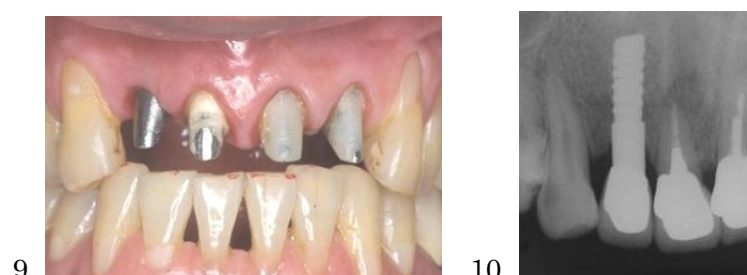
Image-9,10: Right before the placement of the metal bonded crown. Only one out of the four anterior teeth is the AQB implant (10.31.2001).

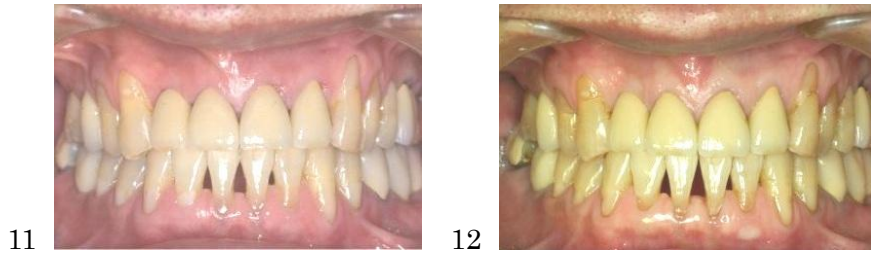
Image-11: Occlusal adjustment a week after the superstructure placement to No. 10 position
Image-12: The state of the prosthetics placed 5 years and 1 month after the implant installation. The prosthesis to the No. 10 position shows no significant differences with the other natural teeth, No. 2-9 (08.23.2006).

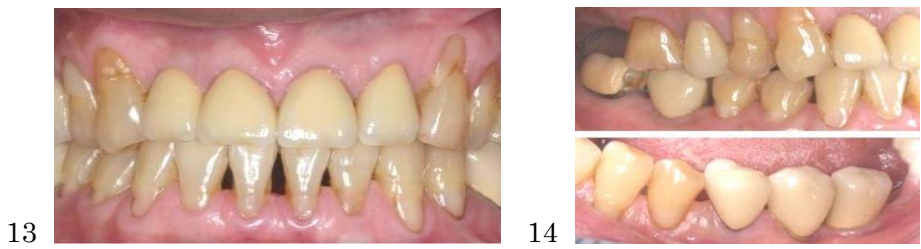
Image-13 to 17: The states of the implant prosthesis eight years after the placement to No. 10 and 19 positions, and 9 years and 7 months for 30 and 31. It is difficult to differentiate that only No. 10 position is an implant (05.13.2009).

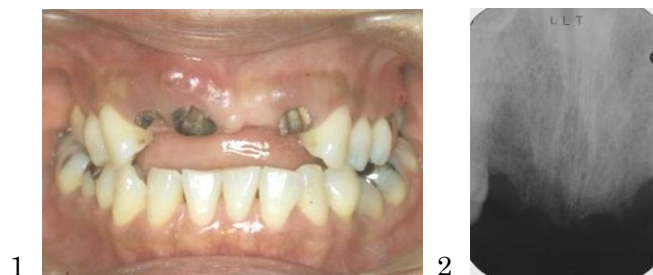
Image-1: Image of the oral cavity at the time of initial medical examination.

Image-2: The dental radiograph 5 months after the root extractions.

The bridge that had been placed 22 years ago to No. 7, 9 and 10 positions first fell out 4 years ago and has continuously been replaced since. At the time of primary clinical evaluation in November 25th 2003 (Image-1,2), the dental radiograph showed softened interior of the root canals of these teeth, therefore were deemed unsuitable for preservation, therefore was decided to be placed with immediate denture. No. 7, 9 and 10 teeth were extracted, and were placed with immediate dentures with No. 7 to 10 implants as the anchors (12.05.2003). Since this region is usually limited in the space available, it is usually installed with four 3 mm diameter AQB implants to for a narrow ridge. However, as the ridge width in this case was shown to be sufficient for 4 mm implants, 2 implants were installed to this space, for subsequent placement of the bridge prosthesis.

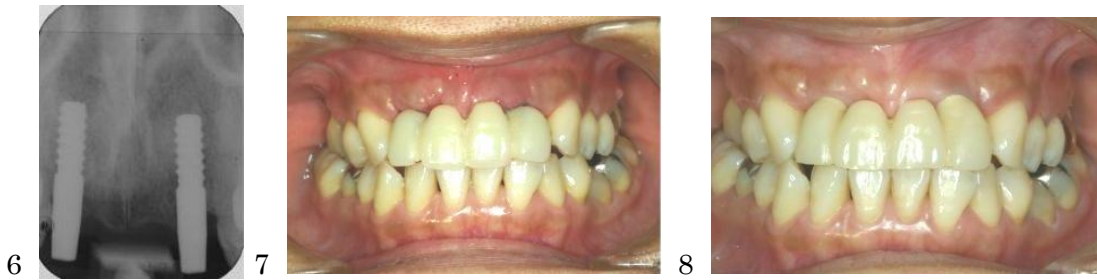
Image-6: Dental radiograph straight after the implant installation.

Image-7: The placement of the temporal bridge, a week after the stitch removal.

Image-8: The temporal crown margin was stretched in preparation to the gingival constriction after the brushing.

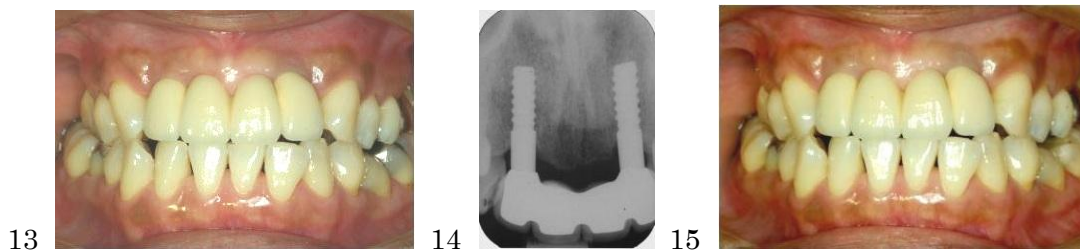
Image-13,14: Image and dental radiograph featuring the state 3 years after the implant installation. The esthetic outcome has been retained since the initial installation (05.09.2007).

Image-15: Image of the oral cavity 4 years after the implantation (06.03.2008).

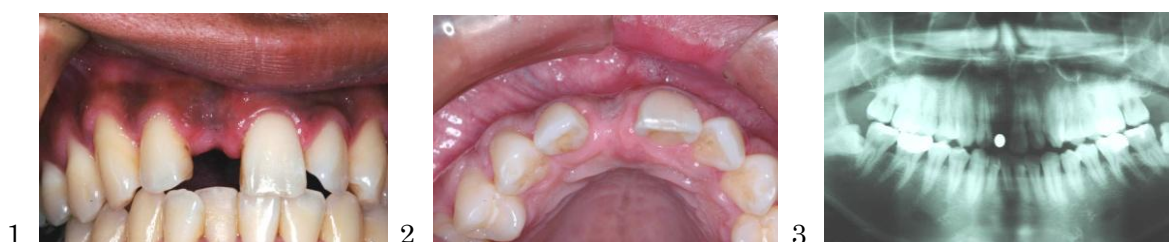
Image-1,2: Maxilla with a deep indentation on the labial side of position No. 9.

Image-3: Panoramic radiography, where a sufficient alveolar height can be seen, with the presence of cortical bone on the palatal side that is equivalent of the level of margin.

The labial side of the alveolar bone in this patient had significantly been indented (Image-1,2), and estheticism was not likely to be achieved even with implant treatment. Consequently, bone augmentation by means of GBR method was necessary to facilitate the implant procedure. The idea of utilizing one-piece type implant had to be abandoned. Fortunately, with the presence of remaining bone on the palatal side confirmed with dental radiography, the applicability of GBR to this case was verified (Image-3).

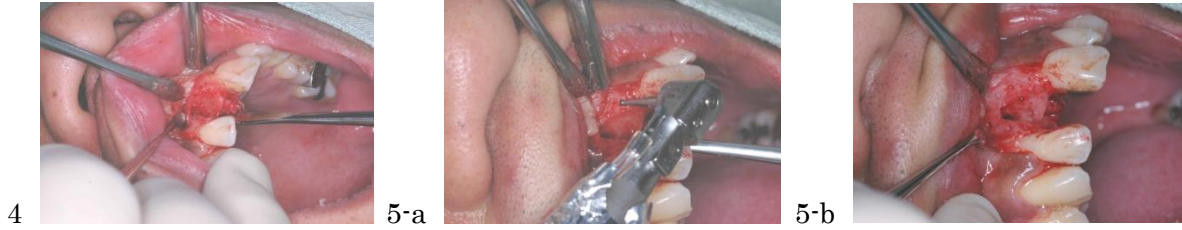
Image-4: Image featuring the state upon detachment of periosteal mucosa. A significant bone deficiency can be observed.

Image-5a,b: Showing decortication of the jaw bone. The bone regeneration requires blood supply from the surrounding bone, and not just those of the implant cavity.

A significant loss of the bone on the labial side was presented upon incisional detachment of the implanting region (Image-4). After the construction of the implant cavity with the standard protocol, the bone was decorticated to induce blood supply to the area (Image-5a,b). After the installation of two-piece type implant, 4122, (Image-6), demineralized freeze-dried bone allograft (DFDBA) and hydroxyapatite (HA) were added. This area was then covered with titanium mesh, 0.1 mm thickness, to retain its structure (Image-7), before preventing the connective tissue invasion with the application of resorbable membrane. A release incision was applied to the periosteum once confirming its stability, ready for the subsequent suturing (Image-8). The postoperative dental radiograph showed the implants to have been placed at ideal locations with favorable equilibrated distances with the adjacent tooth roots (Image-9).

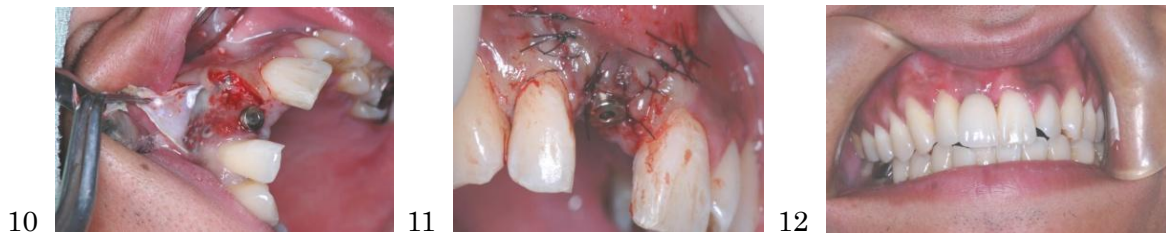
Image-10: 17 weeks post-surgery. The GBR subjected area displays the osteoid tissues to have filled out over the titanium mesh.

Image-11: The state at the end of the secondary surgery. An incision was applied to preserve the dental papillae – an important step that should not be neglected to retain the estheticism of the gingiva.

Image-12: The state after prosthesis placement – estheticism was achieved.

The space created by the GBR membrane was confirmed to have been filled with osteoid tissues 17 weeks after the surgery (Image-10) therefore the secondary surgery was conducted after this to extract and remove the titanium mesh and membrane (Image-11). Impression was taken via the open-tray method, 3 weeks later, and completed the surgery with the placement of the ceramo-metal crown (Image-12). The indentation on the labial side that presented on the primary clinical evaluation was filled, thus fulfilling the patient's request for estheticism.
