# Chapter 7: Treatment to patients with underlined systemic diseases/ disorders

## 1. Human immunodeficiency virus (HIV) patient

## 2. Idiopathic thrombocytopenic purpura (ITP) patient

### 3. Osteoporosis patient

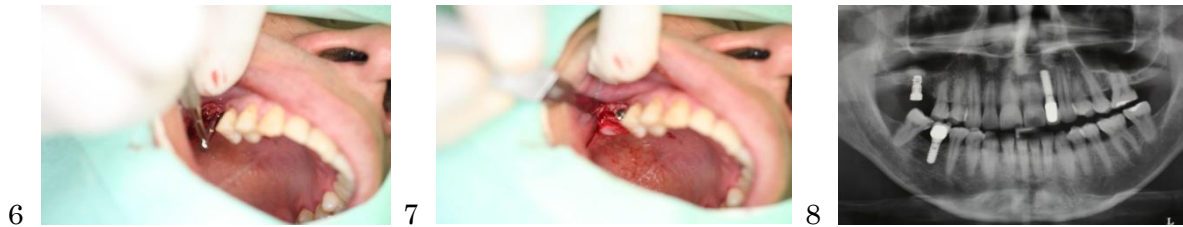
Image-6: Socket-lift procedure was conducted using the sinus-lift kit.

Image-7: Fixture (4082) was installed.

Image-8: Panoramic radiograph confirmed the elevation of the Schneiderian membrane.

The width of the maxillary alveolar bone was shown to be satisfactory but insufficient in terms of height (Image-4,5) therefore two-piece implant (4082) was installed facilitated with socket-lift technique. Under 2% xylocaine (with epinephrine) infiltration anesthesia, the gingival mucosa and the periosteum was incised up to No. 15 posterior position, and elevated before performing socket-lift procedure using Dr Cosci sinus-lift kit (Hakuho Corporation). Maxillary bone was extracted from the position relative to No. 15 position using the  $\phi$  3.5 trephine bur. This was then combined with 1g of bone filling agent, Boneject® (derived from bovine bone with atelocollagen, Koken Co., Ltd.) (Image-6,7) and then applied to the area.

The radiograph confirmed the elevation of the schneiderian membrane (Image-8). The secondary surgery was conducted 4 months later upon confirming that adequate healing process had taken place. The progress after the secondary surgery was also satisfactory (image-9,10,11), therefore the straight abutment S size was installed, impression imaging taken, and was finally placed with the final superstructure (Image-12).

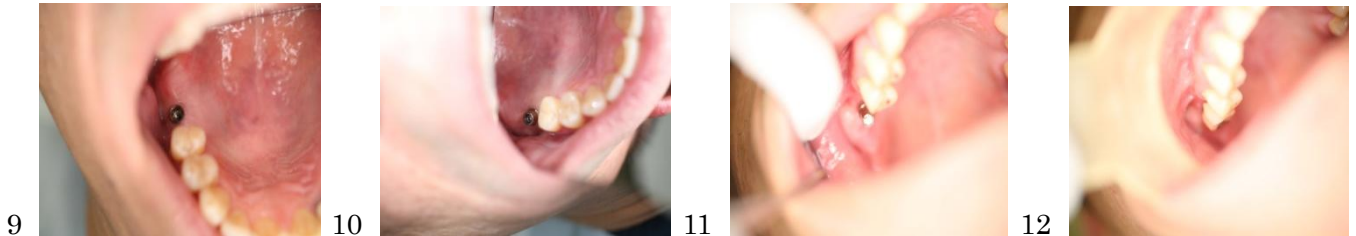
Image-9: Before the placement of straight abutment. No abnormal symptoms were found in the surrounding mucosa.

Image-10, 11: The state after the placement of the straight abutment.

Image-12: Placement of superstructure.

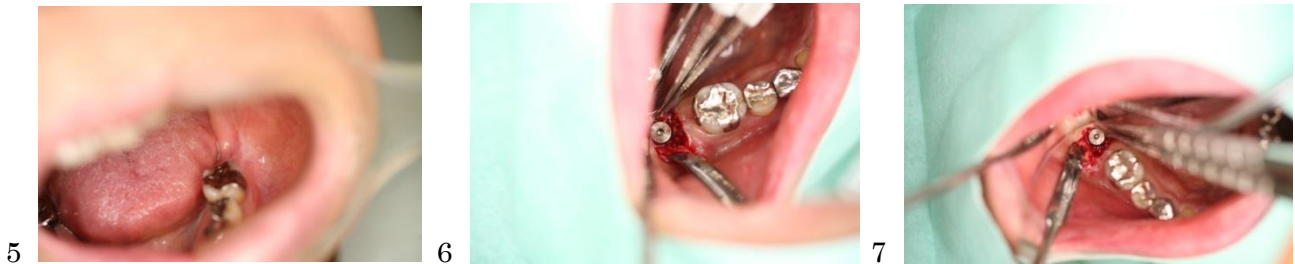
Image-5: The state of the wound 3 months after the primary surgery.

Image-6,7: The state during secondary surgery, where the incision was applied to the alveolar bone in order to check the conditions of the fixture (mirror-image).

The postoperative progress was found to be satisfactory (Image-4,5), and the secondary surgery was conducted 4 months later. Upon exposing the bone surface with alveolar incision, the implant fixture appeared to be rooted firmly with no loose motions, but a slight indentation at the mesial bone grafted site was found and exposing a portion of Boneject particles to be present (Image-6,7,8). The secondary surgery was complete with the placement of healing abutment (L) and closing with suture (Image-9,10). The stitches were removed a week later (Image-11), and a straight abutment (L) was mounted (Image-12) before taking impression image. The final prosthesis of metal bonded crown was selected (Image-13,14). It has only been days since the placement of the final superstructure, but a satisfactory progress has been observed.

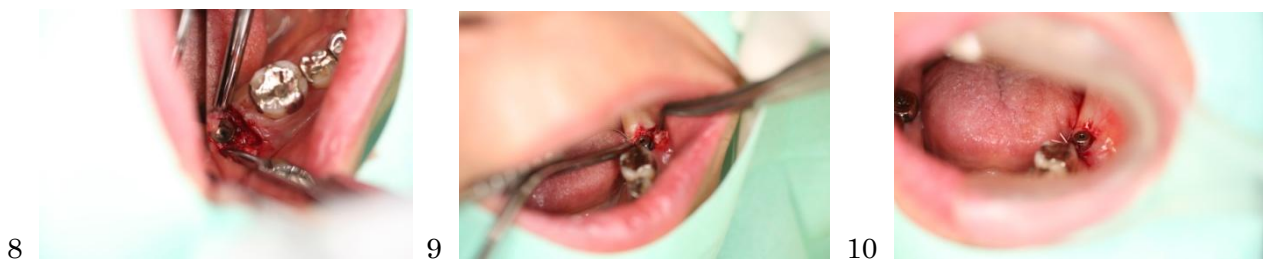
Image-8: Deficiency of the bone on the mesial side and few Boneject particles were found upon healing cap removal (Mirror image).

Image-9,10: The top was replaced with a healing abutment before closing with suturing.

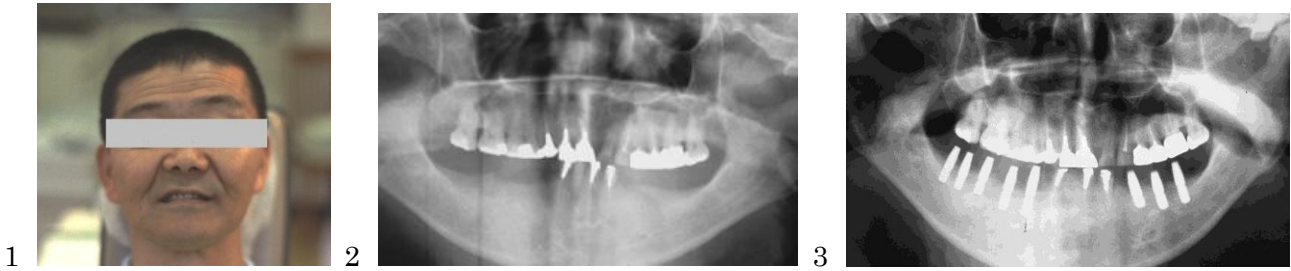
Image-1: The patient presented with losses of No. 18 to 22 on the right, and No. 28 to 31 on the left, and had been previously fitted with a partial denture, but had stopped using it. It was difficult for the patient to hold the mandibular rest position for more than a few seconds. At the first clinical examination, the patient found it difficult to retain the open mouth state due to the involuntary movement of the facial muscles. No abnormal symptoms with respect to the oral mucosa were shown.

Image-2: Panoramic radiograph featuring the lack of teeth and the presence of slight periodontal disease in the remaining teeth in the mandible. No other complications are present.

Image-3: Postoperative panoramic radiograph

The facial structure was asymmetrical (Image-1), muscular constriction was evident when attempting to open and close the mouth, and muscles were not able to move.

Intraoral observation: Presented with lack of No. 18 to 22 teeth on the right, and No. 28 to 31 on the left, but was not using the partial denture (Image-2). The states of remaining teeth were P1, P2 levels. No abnormal symptoms to the oral mucosa were seen.

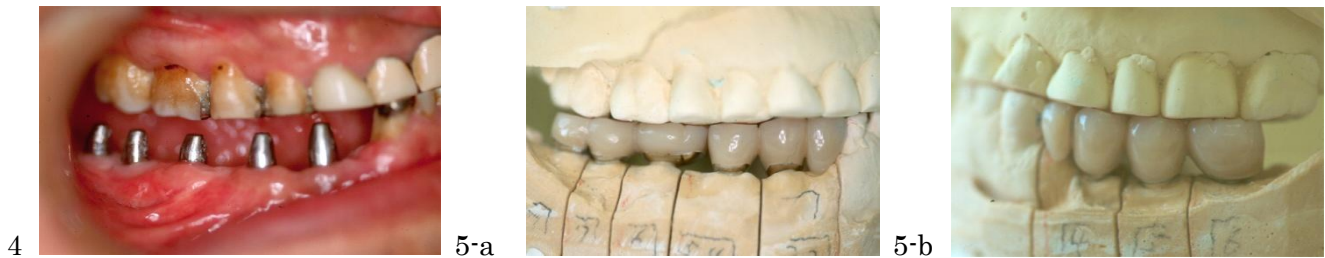
Image-4: Six weeks after surgery, abutment preparation. A through plaque control measures were conducted once a week. Estenia crown was fabricated paying particular attention to the maintenance of hygiene in designing the margin, and was set 1 mm above the gingival margin. The inclination plane of the dental cusp was designed to be  $0^{\circ}$  to avoid the resultant lateral force.

Image-5a,b: Prosthetics (on the working model)

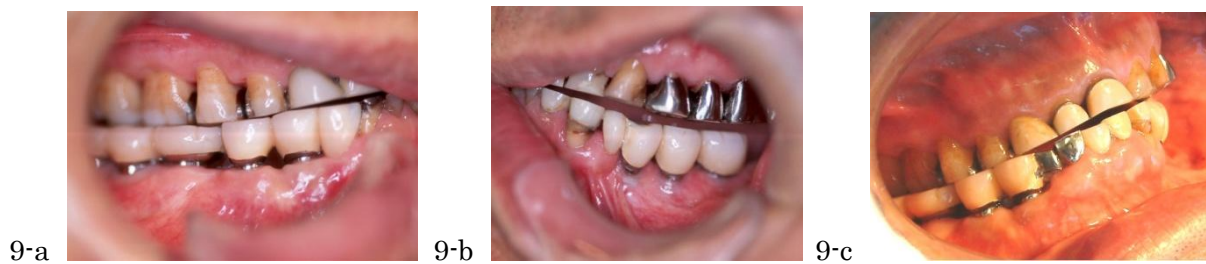
Image-9 a,b,c: Image 5 years and 7 months since the surgery. Plaque control was conducted for the first 6 months from the time of primary operation, and a regular follow-up, once a month, has been continues up till now. A cooperative and proactive oral cleaning has been directed by the patient's mother, and a good oral hygiene level has been maintained till now.
