Chapter 8: Long-term observations of implant treatments

1. Five case examples of AQB implants that were installed more than ten years ago

Director of Tokyo Kagawa Dental Clinic

Toshiaki Miyazawa

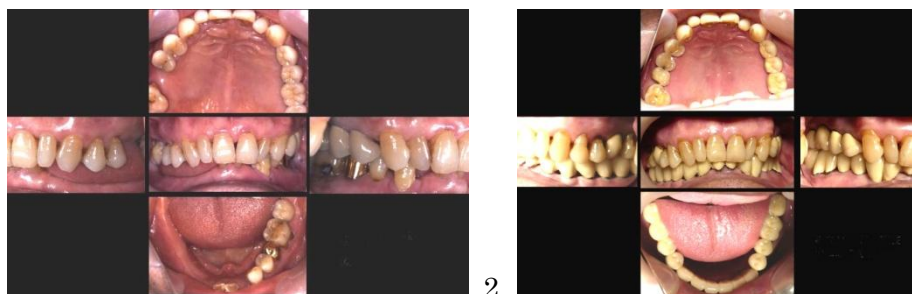
Image-1: The state of oral cavity at the first medical examination

Image-2: The current state (May 2009), 10 years after the installation.

Ten years has passed since the implant installation, but no presences of inflammations in the surrounding mucosa, mobility of implants or alveolar bone resorption have been observed, and satisfactory progress has been made thus far. In addition, the 5 implants placed into the left maxilla and mandible that have been installed for 12 years have also shown stability over the years. The natural teeth No. 8 and 9 that were connected to implants have not yet shown any alveolar bone resorption, ankylosis, or disuse atrophy.

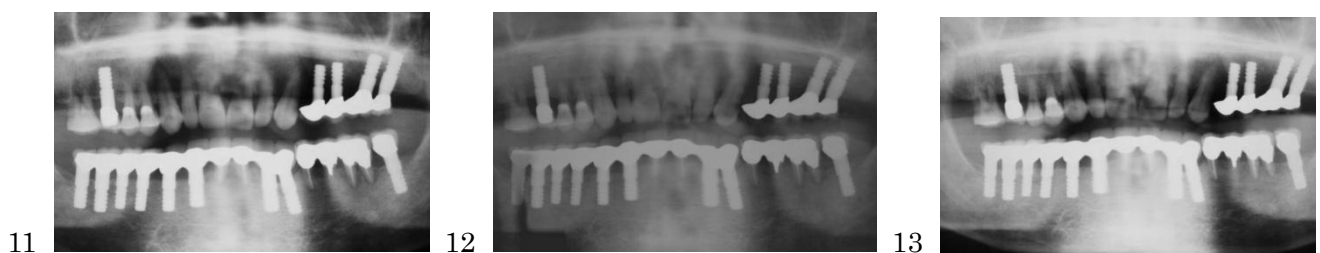
Image-11: Panorama radiograph a year later

Image-12: Panorama radiograph 3 years later

Image-13: Panorama radiograph 5 years later

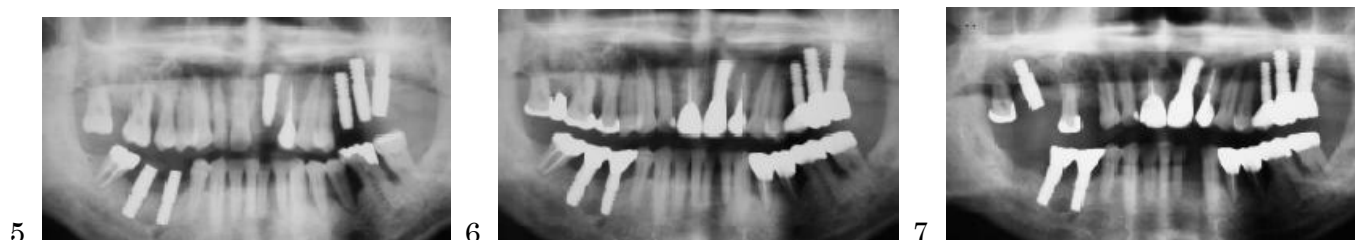
Image-5: Installed 4MM, 5MS, 4MS to positions No. 8, 19, 20.

Image-6: Panorama radiograph 3 years later.

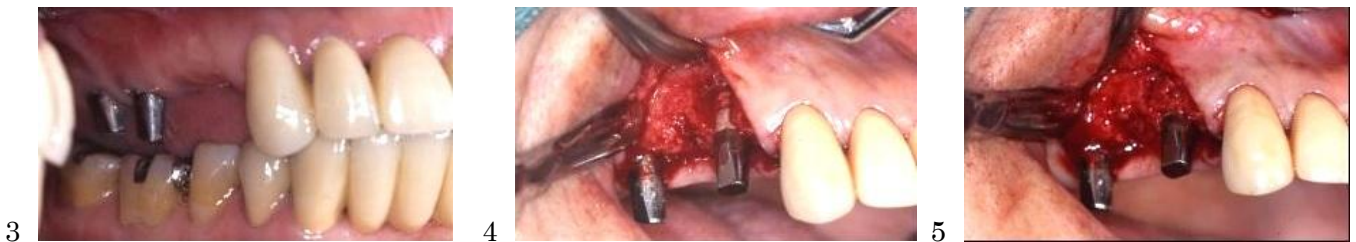
Image-3: No. 12 and 13 were extracted. To allow these positions to heal, the implants were installed primarily to No. 18 and 19 positions

Image-4: The implant body was exposed on the buccal side due to the narrowness of alveolar bone width at No. 12 position.

Image-5: Applied the bone fragments derived from the drilling to the exposed area.

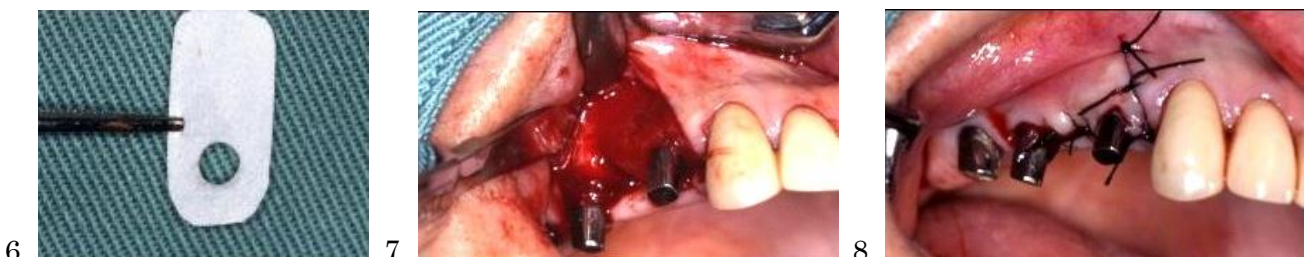
Image-6,7: The resorbable membrane was cut out with a circular knife, and covered the implant and the bone grafted area on the buccal side.

Image-8: The state after suture.

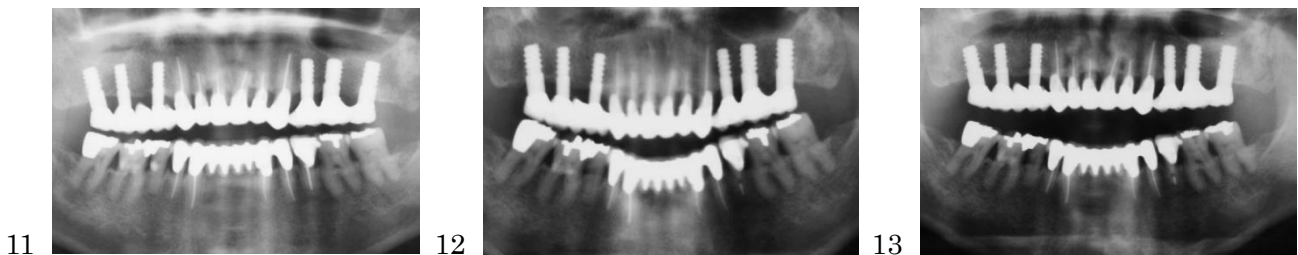
Image-11: Panorama radiograph a year after installation.

Image-12: Panorama radiograph 3 years after installation.

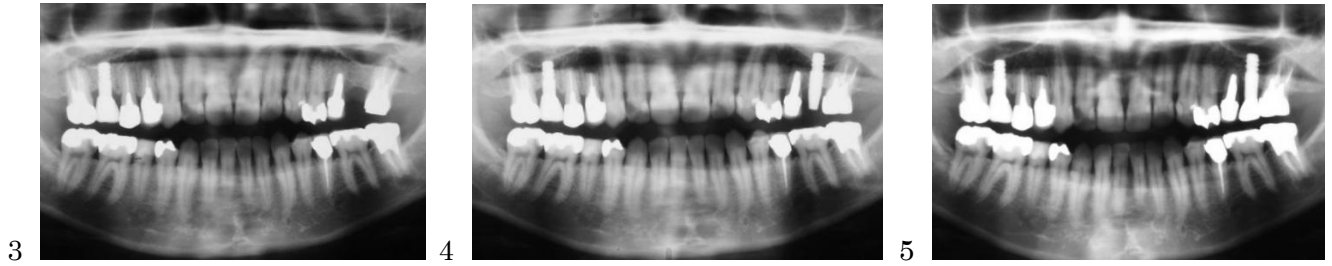
Image-3: Panorama radiograph a year later (No. 3 extracted).

Image-4: Panorama radiograph 2 years later (No. 3 extracted).

The state 12 years since the implantation shows a satisfactory outcome with no inflammation surrounding the implant structure. The implant to No. 3 position was conducted in conjunction with socket-lift technique, 10 years ago. The radiographic image confirms the bone augmentation around the implant body, even though bone filling agents were not applied after the elevation of maxillary sinus floor. Such observation can be shown in the cases where a sufficient primary stability has been achieved, with no damages done to the schneiderian membrane.

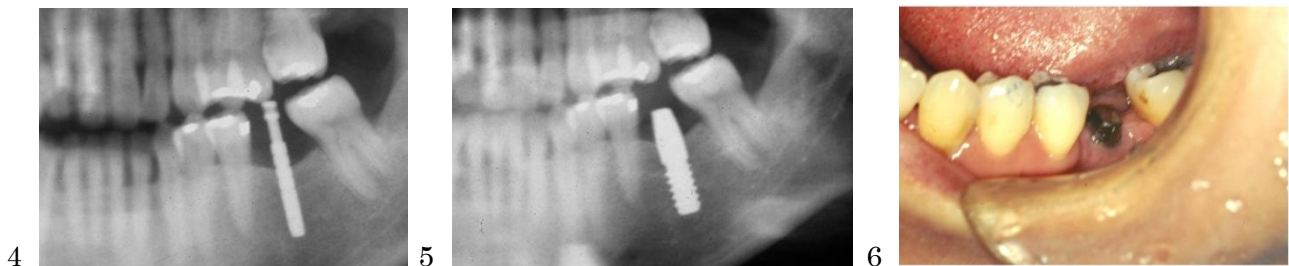
Image-4: Panorama radiograph taken to evaluate whether the depth of the implant cavity could be increased with the alarm gauge.

Image-5: Panorama radiograph at the time of implant installation.

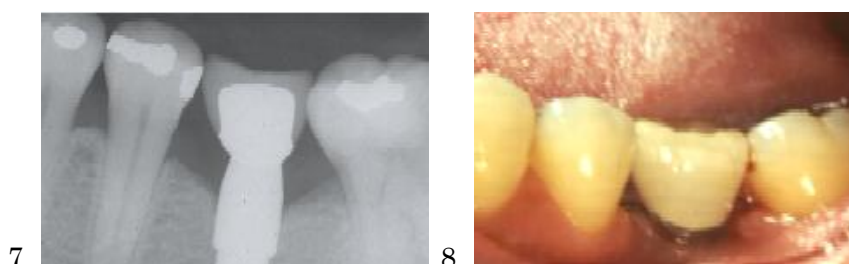
Image-7: Dental radiograph after the placement of the superstructure

Image-8: Image after the placement of the superstructure.

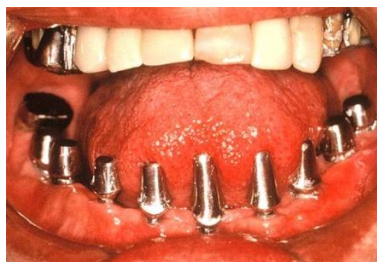
Image-5: Placement of abutments

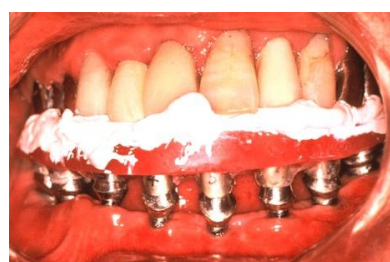
Image-6: Bite check

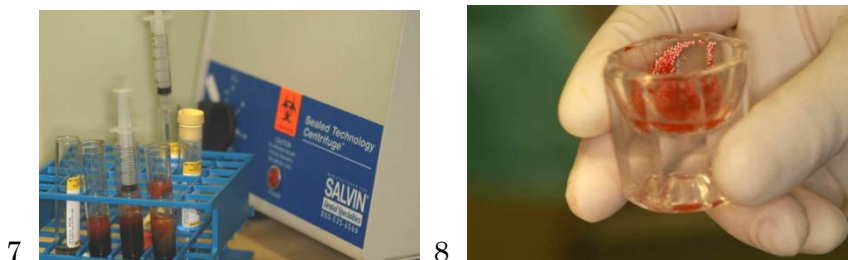
Image-7: Fractionation of blood plasma with a specialized centrifuge machine specific for PRP.

Image-8: A combined preparation of PRP, allograft bone, and β -TCP, (will be referred to as PRP filling agents)

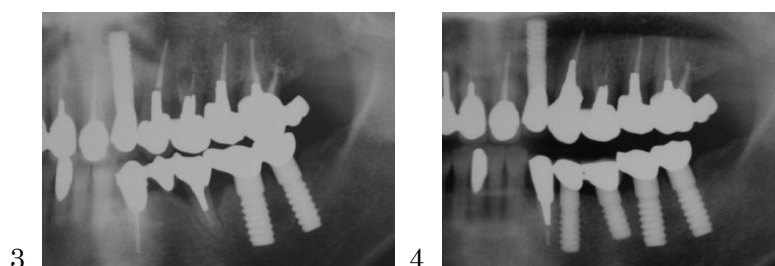
Image-3: Panorama radiograph after a course of 8 years. 4ML implant was placed at the position No. 7 after it was extracted as it was deemed not able to be preserved due to fracture in the root.

Image-4: Radiograph taken 14 years later. No. 29 tooth was extracted due to its root fracture, and was replaced with 4MS AQB one-piece type implant.

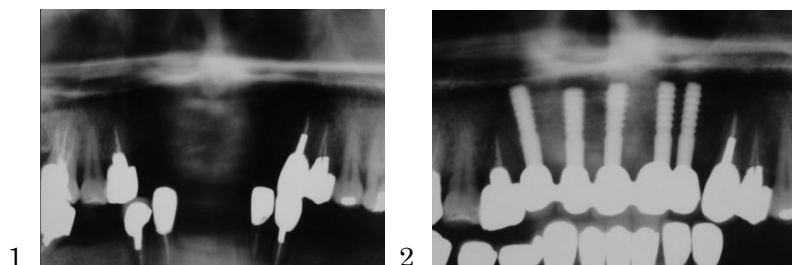
Image-1: Panorama radiograph before surgery. Five 3LL AQB one-piece types were installed to positions No. 6 to 11, January 16th 1992. Subsequently placed with connected metal-bonded crown 4 months later

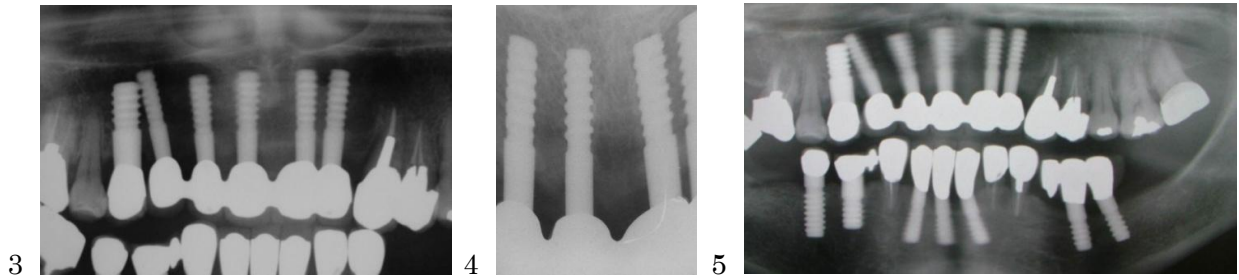
Image-3: Panorama radiograph 14 years after the surgery. No. 12 tooth was extracted due to its root fracture. 5LM AQB one-piece type was placed.

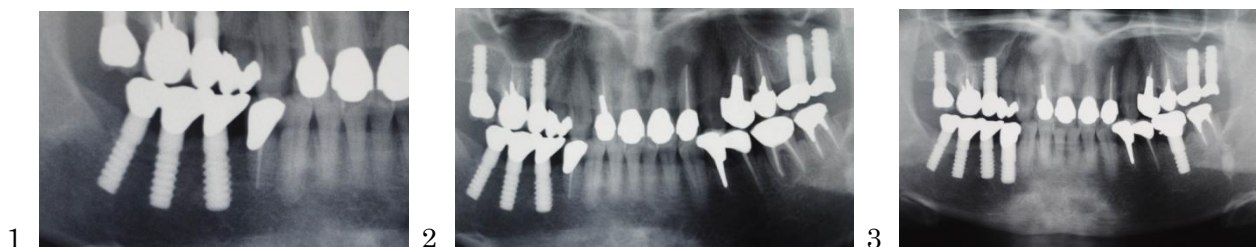
Image-2: Panorama radiograph 9 years after the installation. 5SS AQB one-piece type implant was placed to No. 2 and 3 positions, and completed with the placement of the final prosthesis of metal-bonded crown.

Three 5MS AQB one-piece type implants were installed separately to No. 20, 21 and 22 respectively. The primary stability was shown to be satisfactory, and connected gold alloy crown was placed four months later to complete the prosthetic treatment.

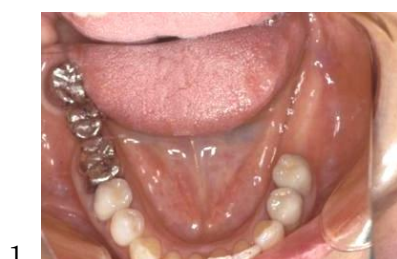
Image-1,2: Image and a radiographic image at the time of a boring check before implant installation (06.07.1989). The patients undergoing implant surgery for the first time should be examined for their bone quality and the distance to the mandibular canal. The use of the boring test can be an effective means to evaluate these.

It was one of the earliest examples of using the trephine bur, and even though the HA coating layer can be expected not to have been completely covered within the bone structure, significant bone resorption cannot be observed. The increased bone density of the implant surroundings after the two, three years period after installation is a fine characteristic of bio-integration.

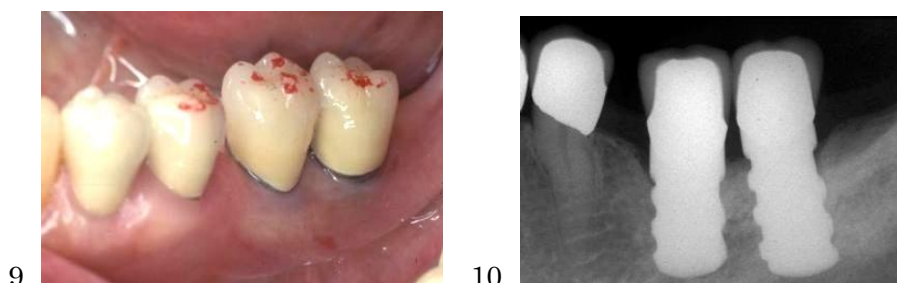
Image-9,10: Photograph and radiograph featuring the state 8 years later (07.28.1997). Generally, an increase in the bone density can be observed but with no modifications to the bone morphology.

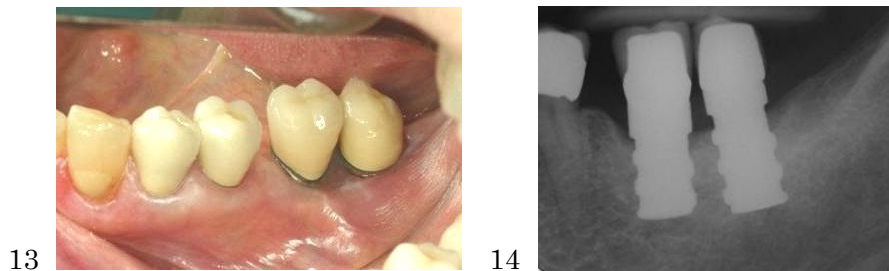
Image-13,14: Photograph and radiograph featuring the state about 19 years later (05.19.2008). The condition of the bone shows a slight deterioration but shows stability.

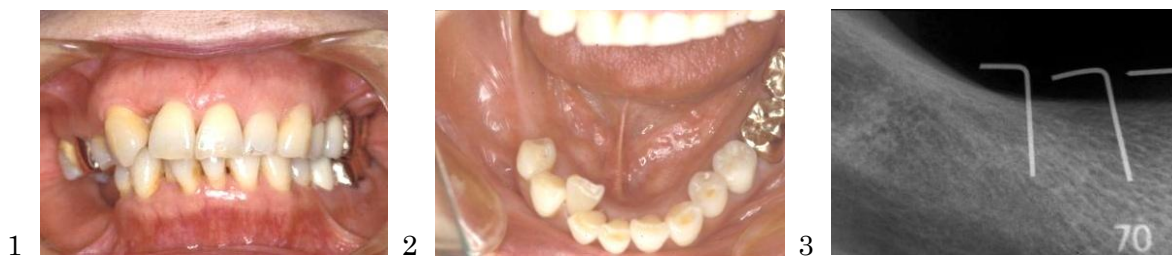
Image-1,2,3: Boring check, before surgery (11.06.1989)

The first clinical trial conducted at the Mitsui Memorial Hospital in Facility 1 where the implant body had been refined with its screw forms becoming close to the market-release version. Bone resorption in an inverted conical shape surrounding the implant structure can be observed for the initial installation period of a few years due to surgical intervention. But the images show the increase in the bone density of the alveolar crest and those surrounding the implants. In the radiographs taken close to the ten years mark, there are images that show bone augmentation to the alveolar crest. With biointegration, implant becomes part of the bone through interactions. Where the force is exerted on the physiological structure via the implant body, it can be thought that the bone structure has prepared itself to withstand this force up to a certain level. In observing the series of radiographs taken over the years, it makes one speculate the presence of biological mechanism that meets this.

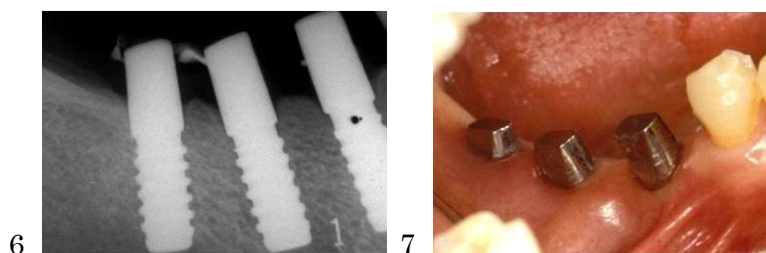
Image-6,7: Photograph and radiographic images 3 months after the installation. The impression was taken after the removal of the temporal crown structure (03.09.1990). A slight cortical bone resorption in the area surrounding the implants can be observed that resulted from the forces of surgical intervention at the time of implant cavity construction. This was not a progressive one.

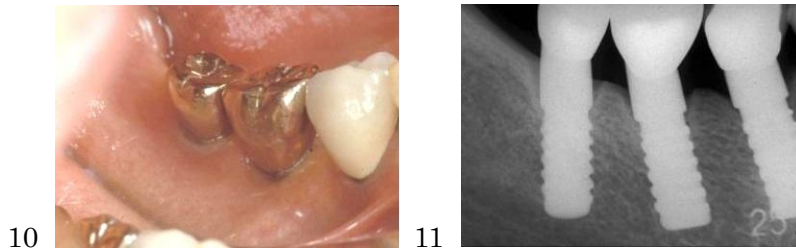
Image-10,11: Photograph and dental radiograph a year after the installation (12.06.1990). The condensation of the alveolar crest bone can be seen from this point.

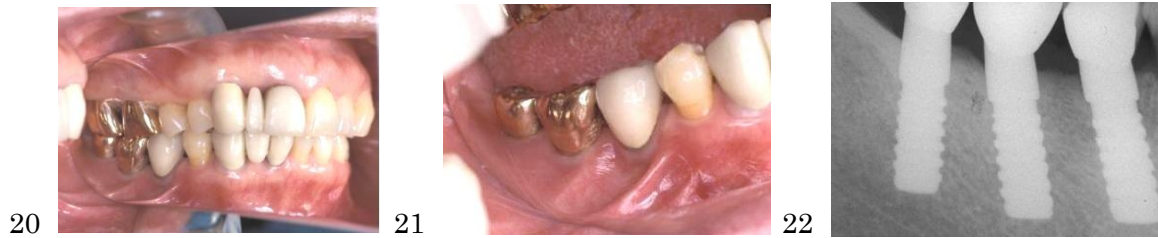
Image-20,21,22: The state ten years later (12.02.1999). Majority of the natural teeth have remained, and strong occlusal force is acted on the implant prosthesis of No. 18 to 20 positions. An additional bone development has shown further progress in the alveolar crest.

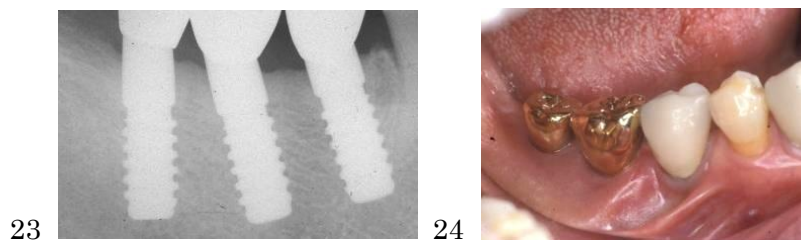
Image-23,24: The state 11 years later (12.28.2000). The alveolar bone region has become even, with the additional bone development, and an increase in the bone density around the implant structure can be evident.

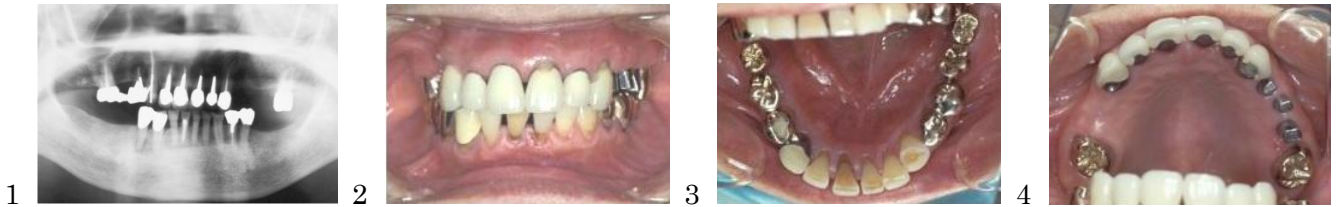
Image-1: Panorama radiograph before starting the implant treatment (12.28.1994).

Image-2,3,4: The state after the patient was transferred to our clinic from Mitsui Memorial hospital, having undergone implant installation and superstructure placement to No. 19, 20, 30,31 and to No. 3, 4, 5 (14.12.1997).

This is a case where the occlusion is formed by the implant prosthesis on molars of both the upper and lower jaws. Since the mandible consists of cortical bone, single crown prosthetics can be fitted provided that 5 mm diameter AQB implant can be inserted, but, implantations to the maxilla needs further considerations as it is made of cancellous bone.

Particularly with example, the occluding teeth in the molar region were both implants on the upper and lower mandible, therefore the prosthesis on the maxilla were be connected. This consideration might have been the key to its long-term success.

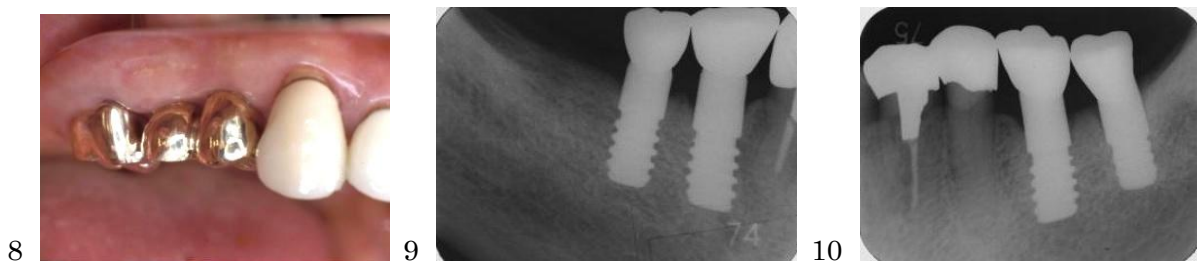
Image-9,10: Dental radiograph 2 years after the installation to the both sides of the mandibular molar region (01.26.1998). Increase in the bone density of those surrounding implant structures and the alveolar crest can be observed.

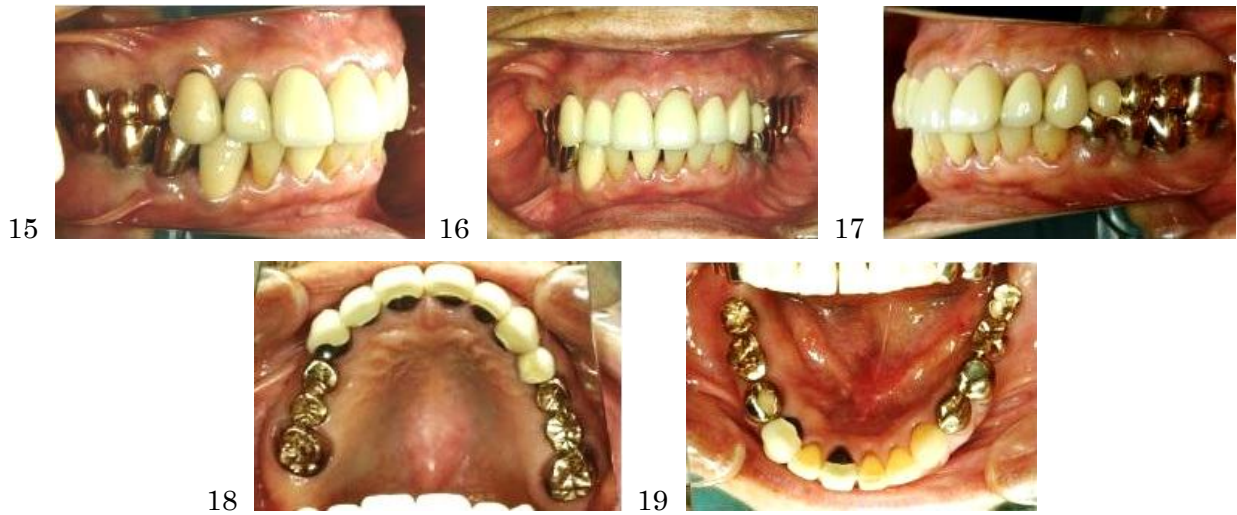
Image-15,16,17,18,19: The state, 10 to 11^{1/2} years after the surgery. Occlusal support at the molar region has been established.

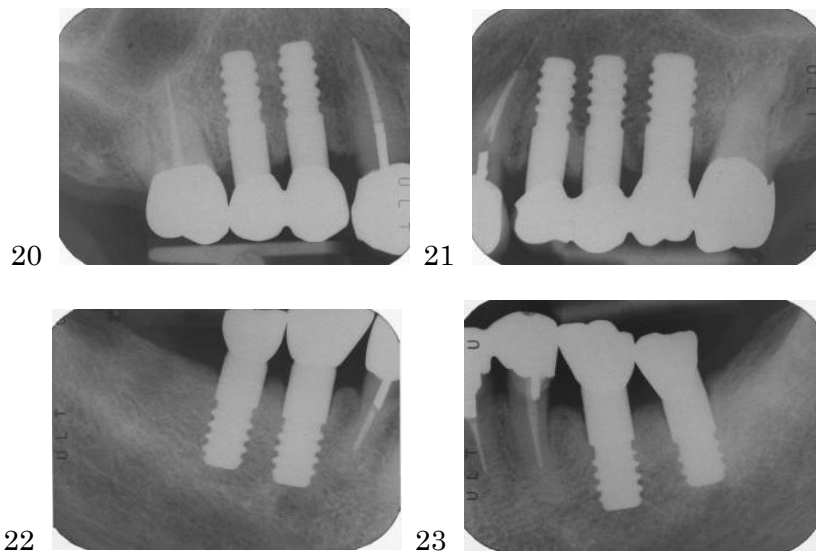
Image-20,21,22,23: Dental radiograph, 10 to 11^{1/2} years after the surgery (08.10.2007). Upon achieving bio-integration, the bone density of the surrounding structures of the implant and the alveolar crest increase. In this case example, a clear increase in the bone density of the structure between the implant bodies can be observed in the maxillary premolar regions.

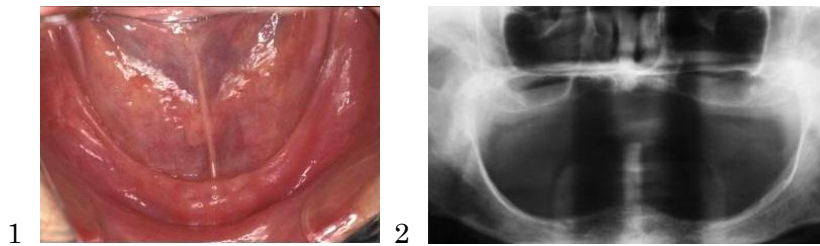
Image-1,2: Image of the edentulous jaw, and a panoramic radiograph before surgery (02.09.1996). The installation to the region distal to the mental foramen was not possible due to the short distance to the mandibular canal. The implant installation to No. 22 and 27 positions were planned.

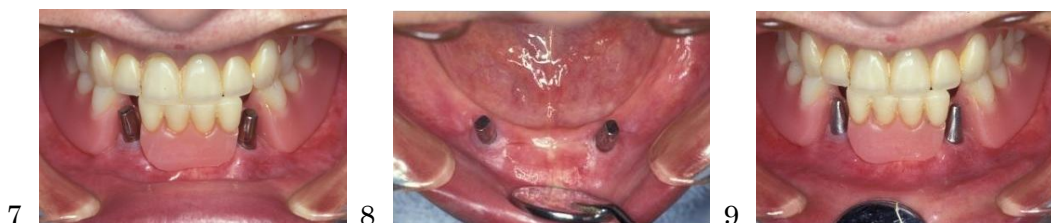
Image-7,8,9: At the time of impression taking, 2 months later (05.31.1996). The placement of prosthesis to edentulous jaw is complicated as there is nothing to mark the orientation of the implant insertion. The implantation to the anterior mandible should be inserted in a more upright position, but a slight adjustment at the time of preparation should be adequate to solve this issue.

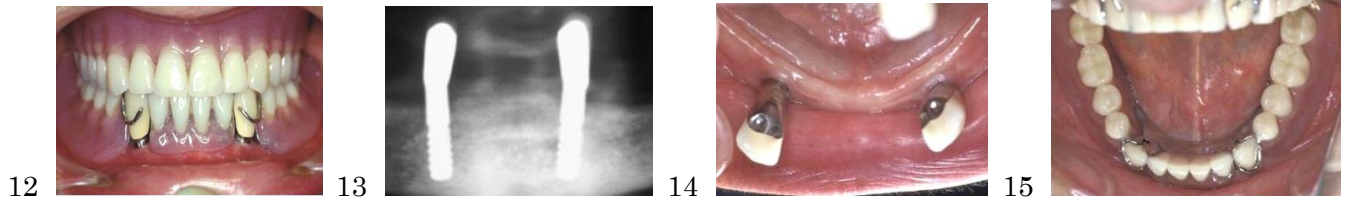
Image-12,13,14,15: Images taken eight months later (02.12.1997), replaced by the metal floor denture to both the maxilla and mandible, with its rigid rest hooked onto No. 22 and 27 implants for the occlusal force to be supported by these two.

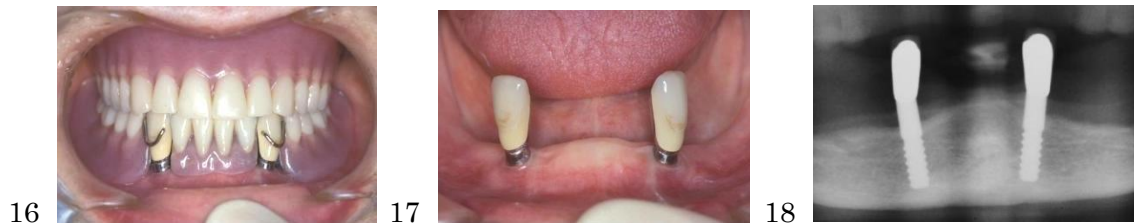
Image-16,17,18: Four years later (02.25.2002), the mucosa surrounding the implants was shown to have constricted in comparison to when the alveolar mucosa was covered with a plate denture. For this reason, the degree of titanium metal exposed appeared to have increased, and it is not a result of bone resorption.

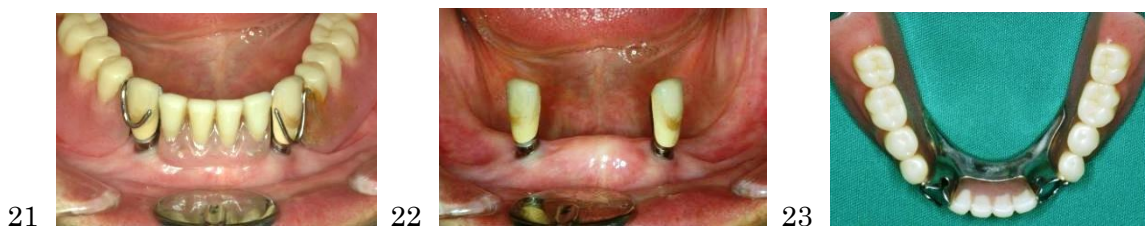
Image-21,22,23: 12 years later (04.30.2008). There have not been any major issues with the prosthesis, apart from the fracturing of the clasp on the labial side, and had been simply repaired. The prosthetics, the dentures to the maxilla and mandible as well as the two implants are shown to be in good condition.

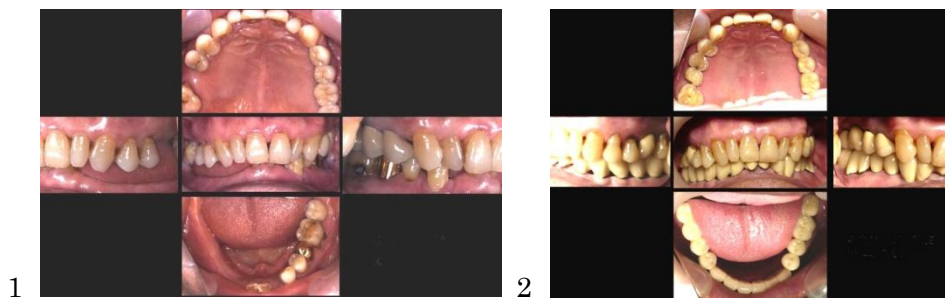
Image-1: The state of oral cavity at the first medical examination

Image-2: The current state (May 2009), 10 years after the installation.

Ten years has passed since the implant installation, but no presences of inflammations in the surrounding mucosa, mobility of implants or alveolar bone resorption have been observed, and satisfactory progress has been made thus far. In addition, the 5 implants placed into the left maxilla and mandible that have been installed for 12 years have also shown stability over the years. The natural teeth No. 8 and 9 that were connected to implants have not yet shown any alveolar bone resorption, ankylosis, or disuse atrophy.

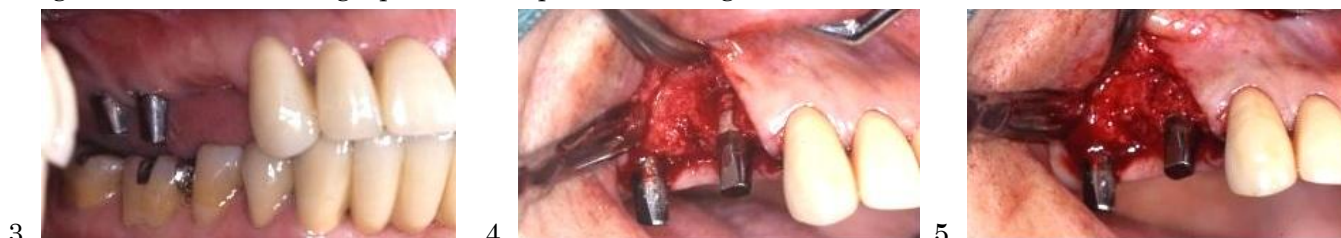
Image-3: No. 12 and 13 were extracted. To allow these positions to heal, the implants were installed primarily to No. 18 and 19 positions

Image-4: The implant body was exposed on the buccal side due to the narrowness of alveolar bone width at No. 12 position.

Image-5: Applied the bone fragments derived from the drilling to the exposed area.

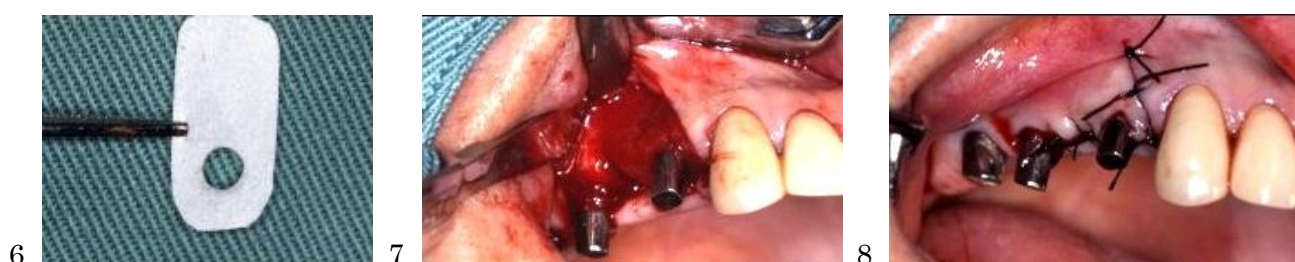
Image-6,7: The resorbable membrane was cut out with a circular knife, and covered the implant and the bone grafted area on the buccal side.

Image-8: The state after suture.

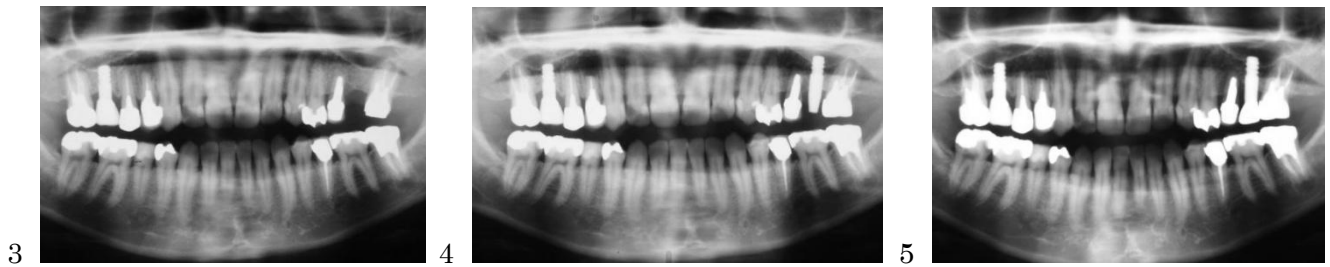
Image-3: Panorama radiograph a year later (No. 3 extracted).

Image-4: Panorama radiograph 2 years later (No. 3 extracted).

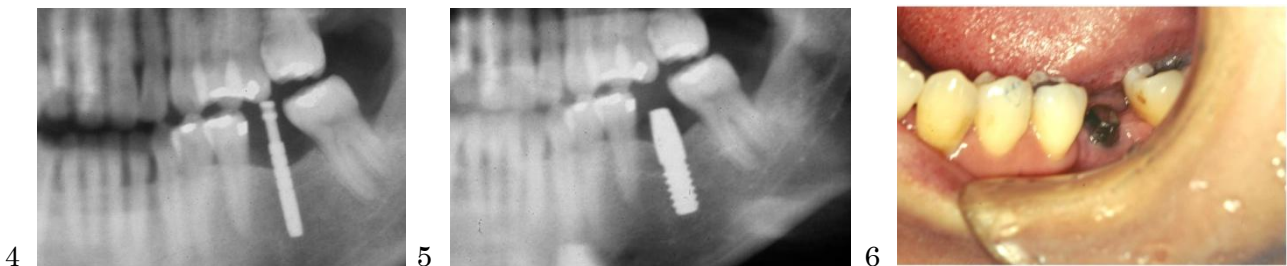
Image-4: Panorama radiograph taken to evaluate whether the depth of the implant cavity could be increased with the alarm gauge.

Image-5: Panorama radiograph at the time of implant installation.

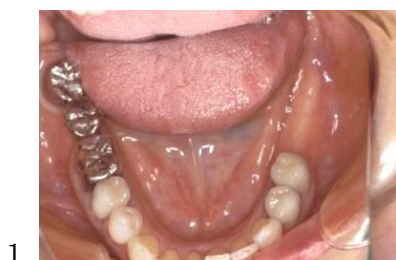
Image-1,2: Image and a radiographic image at the time of a boring check before implant installation (06.07.1989). The patients undergoing implant surgery for the first time should be examined for their bone quality and the distance to the mandibular canal. The use of the boring test can be an effective means to evaluate these.

It was one of the earliest examples of using the trephine bur, and even though the HA coating layer can be expected not to have been completely covered within the bone structure, significant bone resorption cannot be observed. The increased bone density of the implant surroundings after the two, three years period after installation is a fine characteristic of bio-integration.

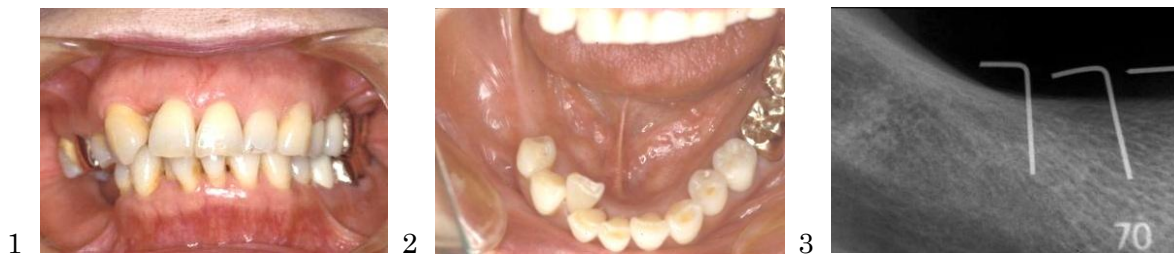
Image-1,2,3: Boring check, before surgery (11.06.1989)

The first clinical trial conducted at the Mitsui Memorial Hospital in Facility 1 where the implant body had been refined with its screw forms becoming close to the market-release version. Bone resorption in an inverted conical shape surrounding the implant structure can be observed for the initial installation period of a few years due to surgical intervention. But the images show the increase in the bone density of the alveolar crest and those surrounding the implants. In the radiographs taken close to the ten years mark, there are images that show bone augmentation to the alveolar crest. With biointegration, implant becomes part of the bone through interactions. Where the force is exerted on the physiological structure via the implant body, it can be thought that the bone structure has prepared itself to withstand this force up to a certain level. In observing the series of radiographs taken over the years, it makes one speculate the presence of biological mechanism that meets this.

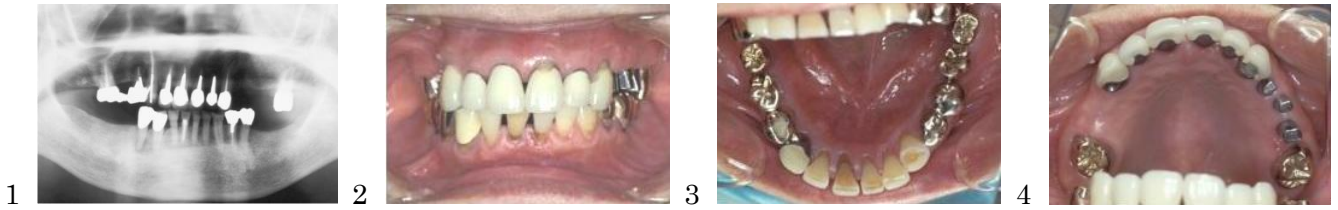
Image-1: Panorama radiograph before starting the implant treatment (12.28.1994).

Image-2,3,4: The state after the patient was transferred to our clinic from Mitsui Memorial hospital, having undergone implant installation and superstructure placement to No. 19, 20, 30,31 and to No. 3, 4, 5 (14.12.1997).

This is a case where the occlusion is formed by the implant prosthesis on molars of both the upper and lower jaws. Since the mandible consists of cortical bone, single crown prosthetics can be fitted provided that 5 mm diameter AQB implant can be inserted, but, implantations to the maxilla needs further considerations as it is made of cancellous bone.

Particularly with example, the occluding teeth in the molar region were both implants on the upper and lower mandible, therefore the prosthesis on the maxilla were be connected. This consideration might have been the key to its long-term success.

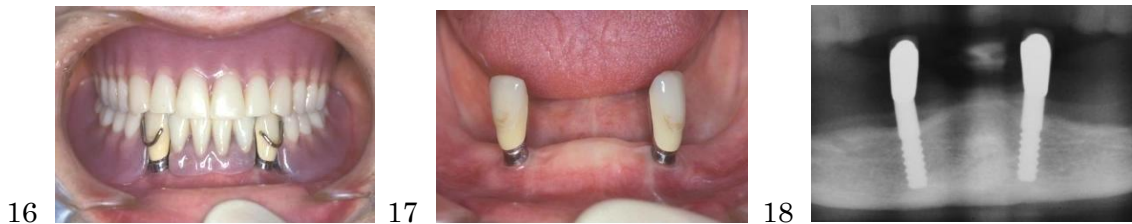
Image-16,17,18: Four years later (02.25.2002), the mucosa surrounding the implants was shown to have constricted in comparison to when the alveolar mucosa was covered with a plate denture. For this reason, the degree of titanium metal exposed appeared to have increased, and it is not a result of bone resorption.

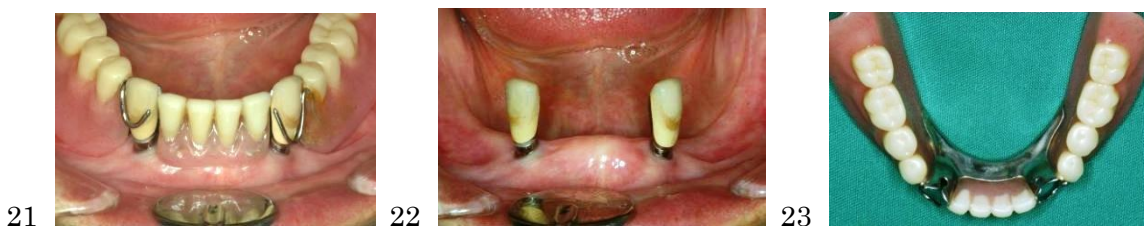
Image-21,22,23: 12 years later (04.30.2008). There have not been any major issues with the prosthesis, apart from the fracturing of the clasp on the labial side, and had been simply repaired. The prosthetics, the dentures to the maxilla and mandible as well as the two implants are shown to be in good condition.
